**KANDİLLİ OBSERVATORY and EARTHQUAKE
RESEARCH INSTITUTE**

***March 08, 2010 BAŞYURT-KARAKOÇAN
(ELAZIĞ) EARTHQUAKE***

**Prepared by; Dr. Doğan Kalafat
Dr. Can Zülfikar
Res. Assist. Eren Vuran
Res. Assist. Yaver Kamer**

**March, 2010
İSTANBUL**

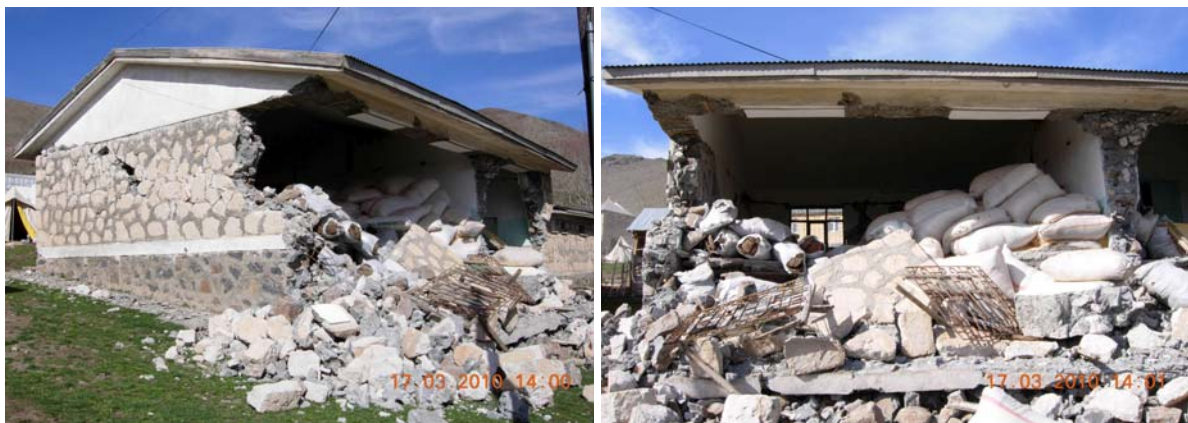
- The most common damage type is partial collapse of load bearing walls due to “out of plane” behaviour.
 - One reason of this failure type is “incapable connections” between outer walls and outer walls with perpendicularly connected inside walls.

Figure 73: Out of plane failure in one story, stone school building (being used for storage), Gocmezler village

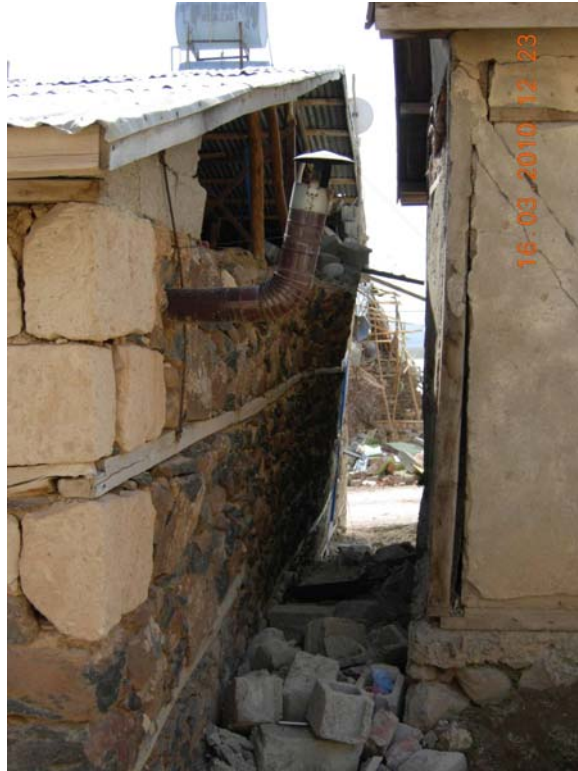
- Length of walls is another parameter, causing out of plane behaviour. In other words, longer the wall length is, easier the out of plane failure occurs.

Figure 74: *Out of plane failure due to length of wall in two story stone house, Okcular village*

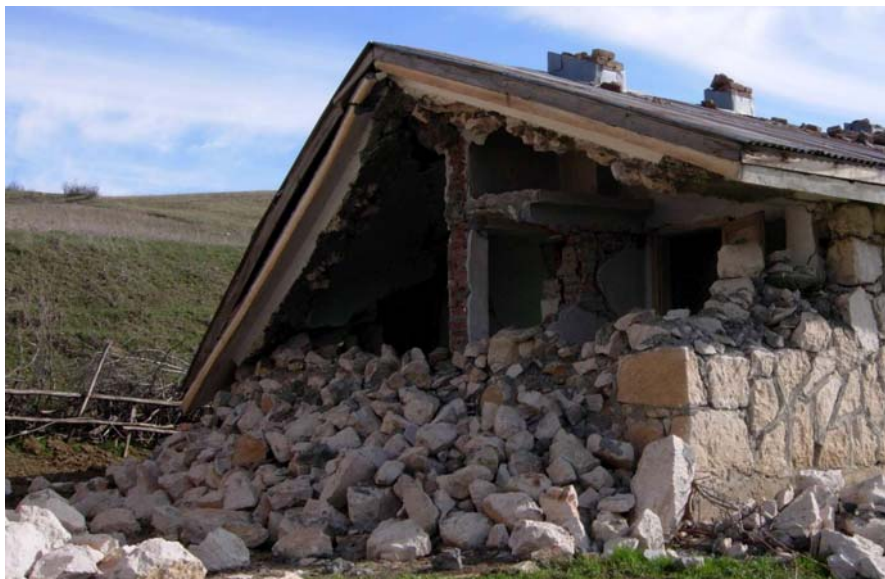
- Also, using different material for outer and inner walls, such as soil bricks for inner walls and stones for outer walls, decreases the integrity among the walls due to incompatible element (stone vs. brick) dimensions as well as different dynamic behaviour of the stone or brick walls.

Figure 75: *Out of plane failure due to lack of integrity between soil brick and stone walls in one story house, Aşağıkanatlı village*

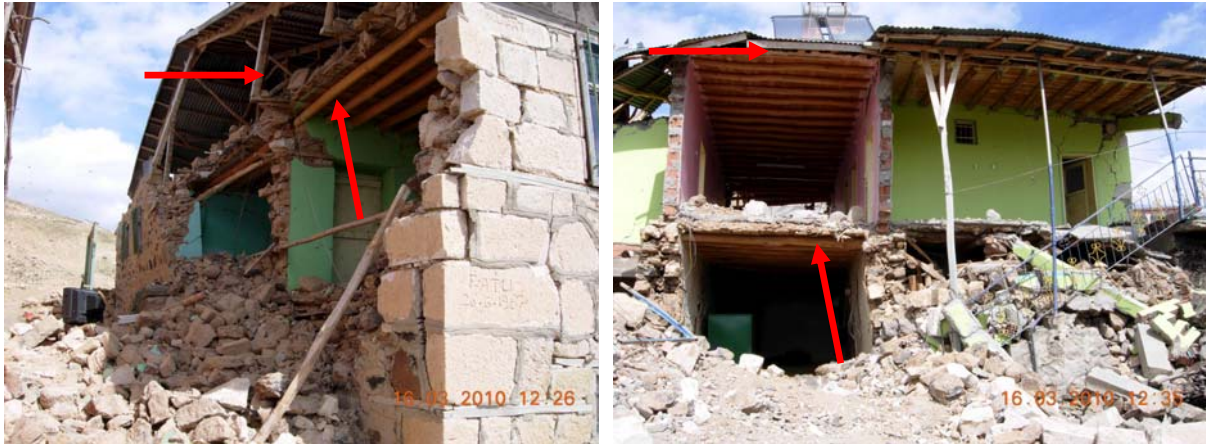
- Another reason, triggering out of plane behaviour is the lack of rigid diaphragm effect of slabs at floor levels, and deficiency of roof-wall connections, no matter it is a truss-roof system or composed with timbers. Usually slabs are constructed as rigid in one direction, so they are not capable of “holding” the walls together and transmit the lateral forces. Also, in timber roofs, there is soil layer in most of the houses, having a thickness about 25 cm, which increases the weight at roof level.

Figure 76: *Out of plane failure in two story stone houses, Okcular village, in both pictures “lack” of rigid diaphragm effect is visible, as well as bad integrity of walls constructed with different materials.*

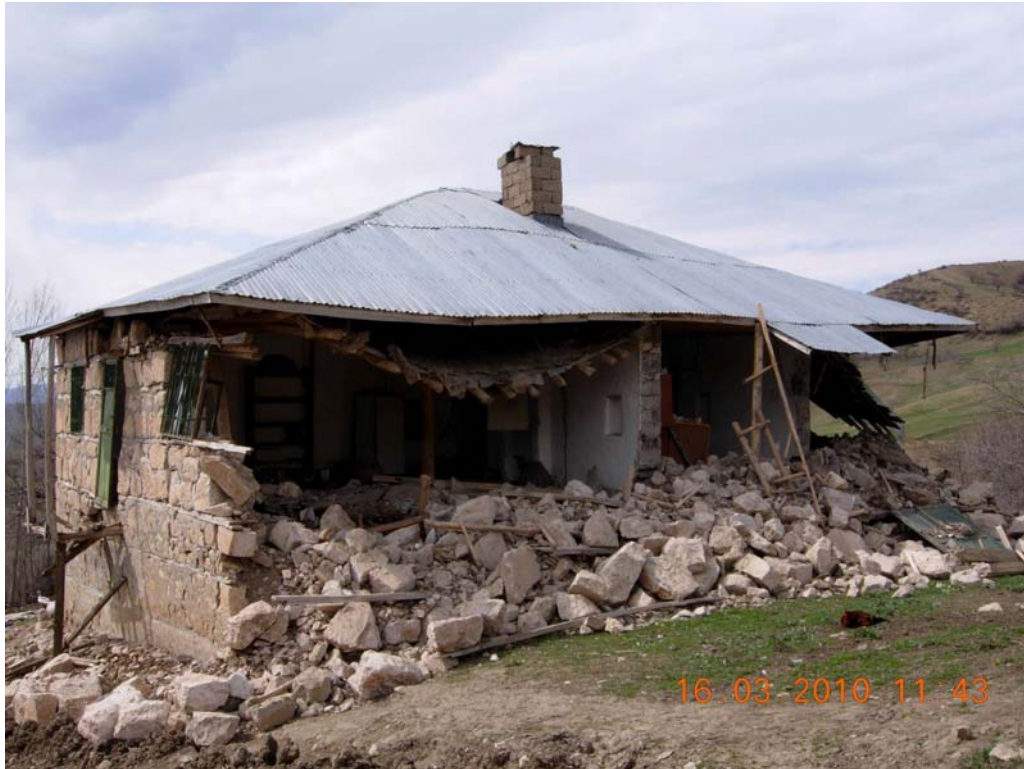
Figure 77: *Out of plane failure in one story stone house, Yukarıkanath village*

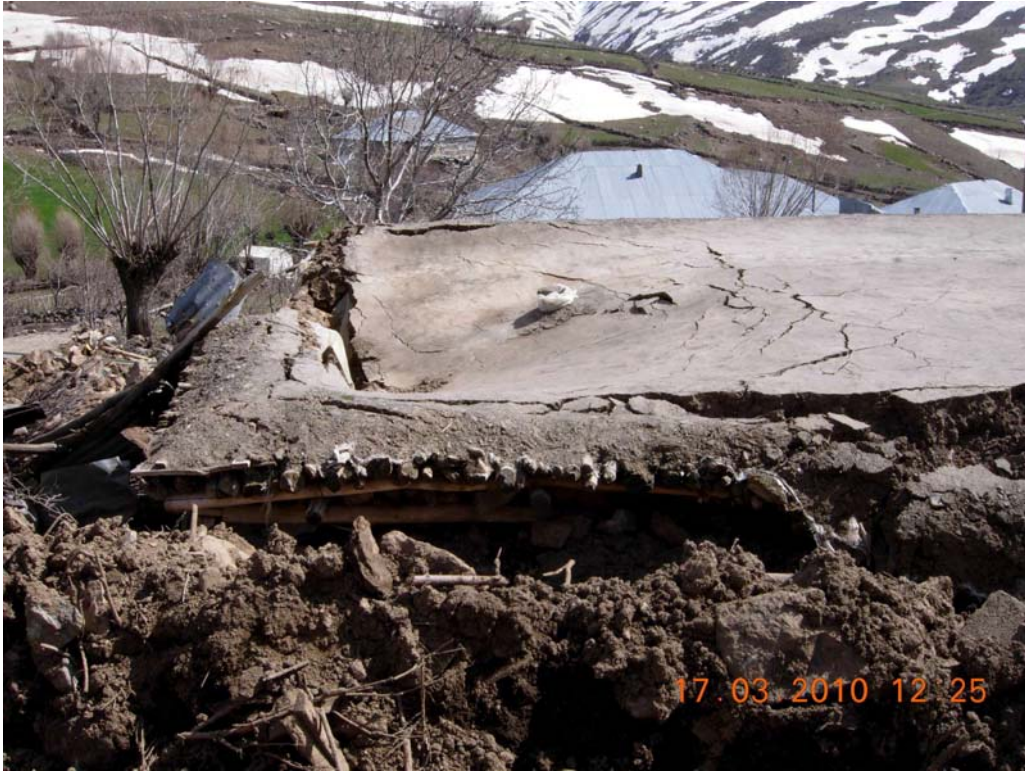
Figure 78: *Thick soil layer on the roof, Kayalık village*

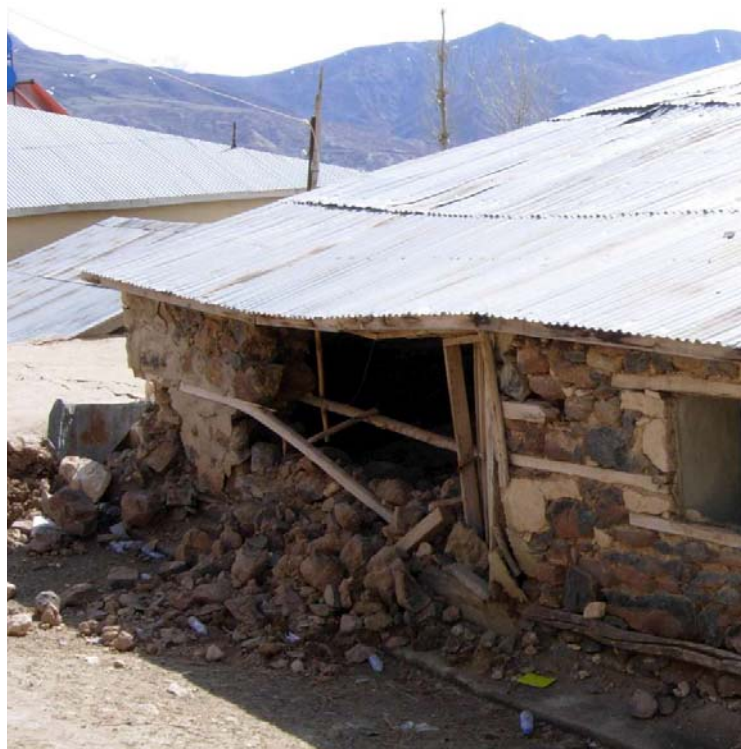
- Insufficient “interlock” among the rounded, heavy stones in outer walls, or between the smaller rounded ones, used inside the double layered outer walls.

Figure 79: *Insufficient interlock among the rounded stones, Okçular village*

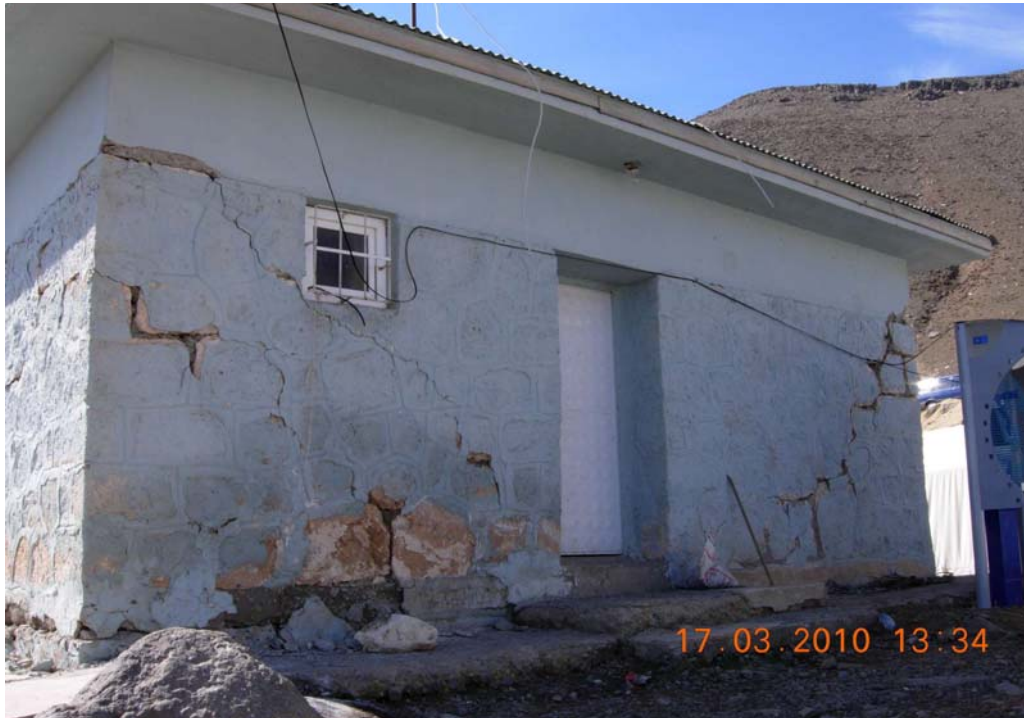
- Even if load bearing walls could stand after earthquake without total or partial collapse, wide cracks prevents usability of the buildings.
 - Bad quality of mortar is one of the reasons for wide cracks.

Figure 80: *Wide cracks following the mortar, Yukarıdemirci village*

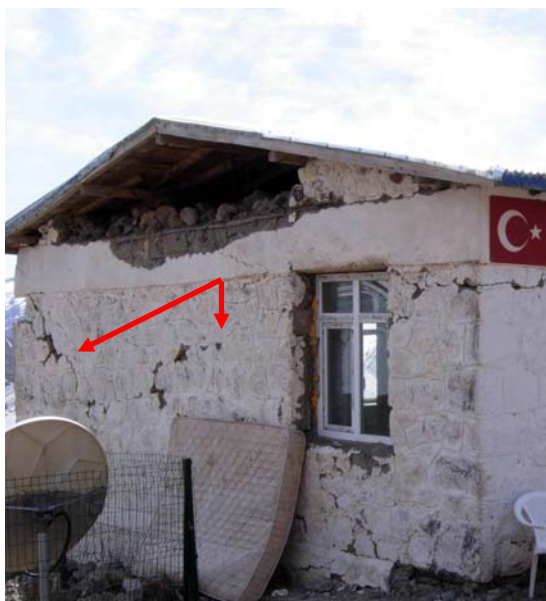
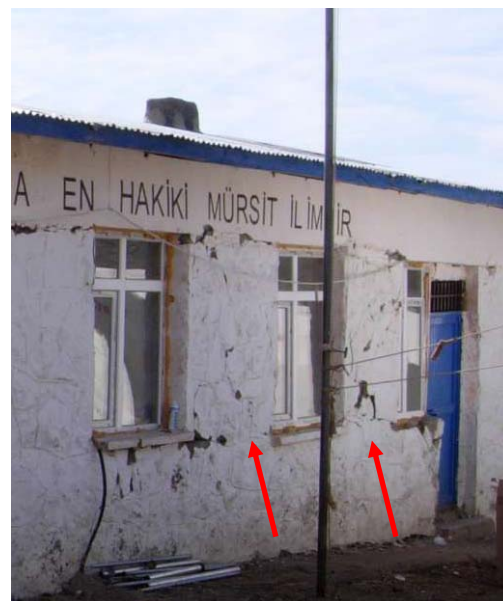
Figure 81: *Wide cracks following the mortar, school building side view, Kayalık village*

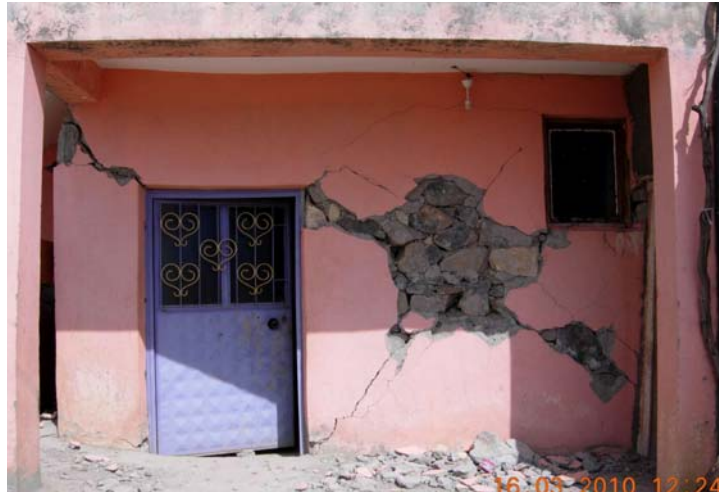
Figure 82: *Wide cracks following the mortar, Okcular village*

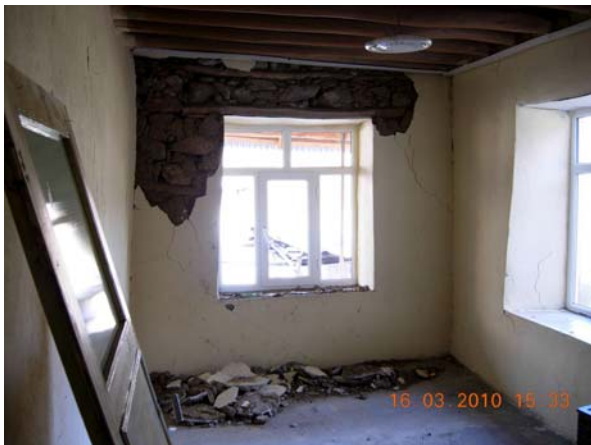
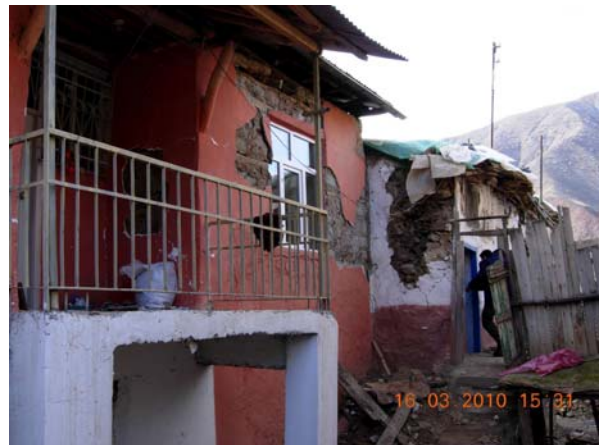
- Thin, wooden, horizontal lintels would not be sufficient to strengthen the weak corners of the openings. Also, in some cases, they were so widely spaced.

Figure 83: *Wide cracks around openings, Beyhan-Palu*

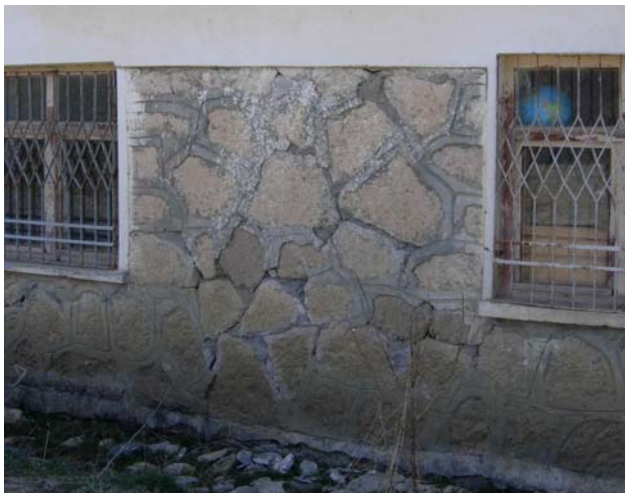
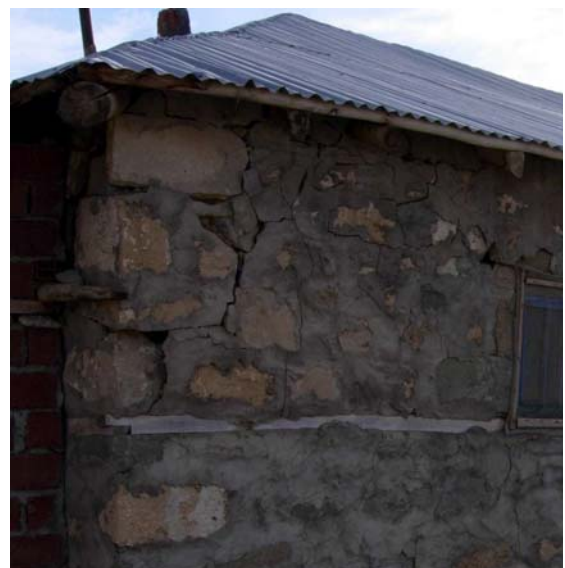
- In most of the stone walls, stones were not properly arranged.

Figure 84: *Improperly arranged stone walls, İncedal village*

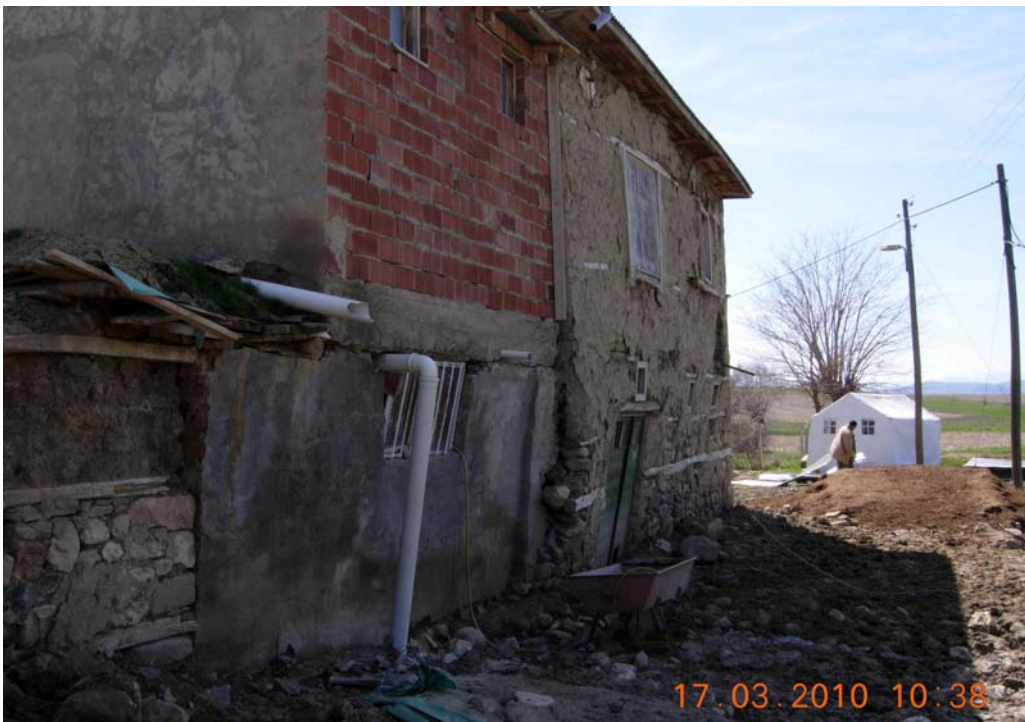
- Soft story mechanisms, due to lower ground floor height. Actually, this irregularity type can easily cause total collapse as it is the case in higher altitude villages. However, the picture below belongs to İncedal, which is located at the bottom lowland.

Figure 86: *Lower ground floor, being used as a stall, İncedal village*

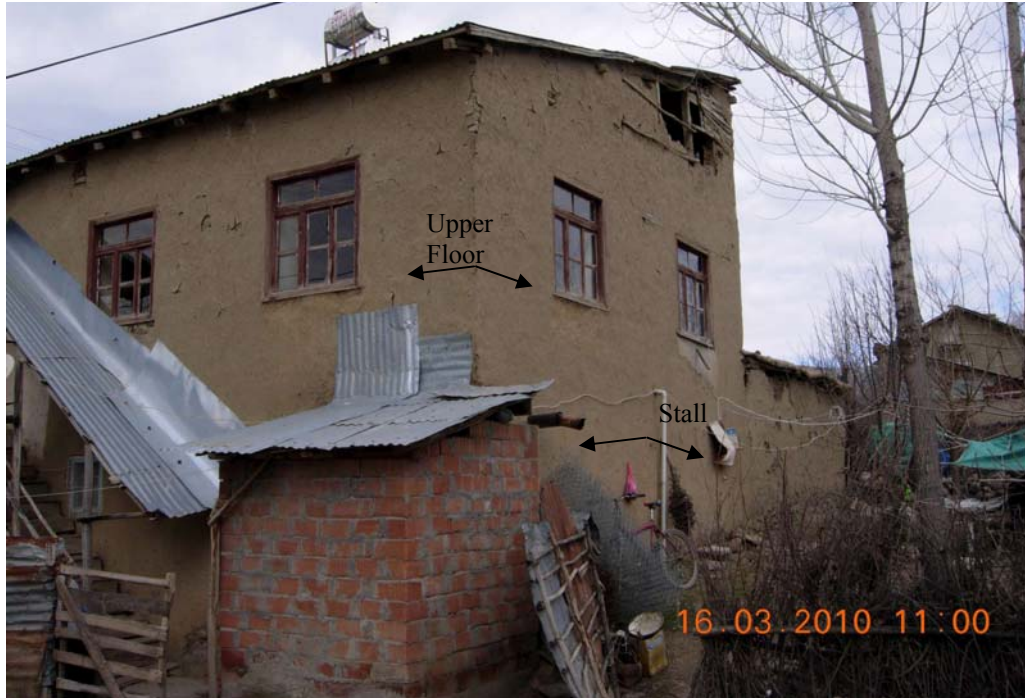
- In the following nine figures, damage patterns on walls of a two storey sun-dried soil brick house are shown. Heavy damage is not so obvious from outside, however, inside pictures show the inconvenience for usage.

Figure 87: Outside view of two storey soil brick house in Kökan-Bayramyazı-1
