Newsletter of **Environmental, Disaster, and Crises Management Strategies**

Issue No.13 | September 2019

The September 21, 2019 Mw 5.6 Durrës (Albania) earthquake

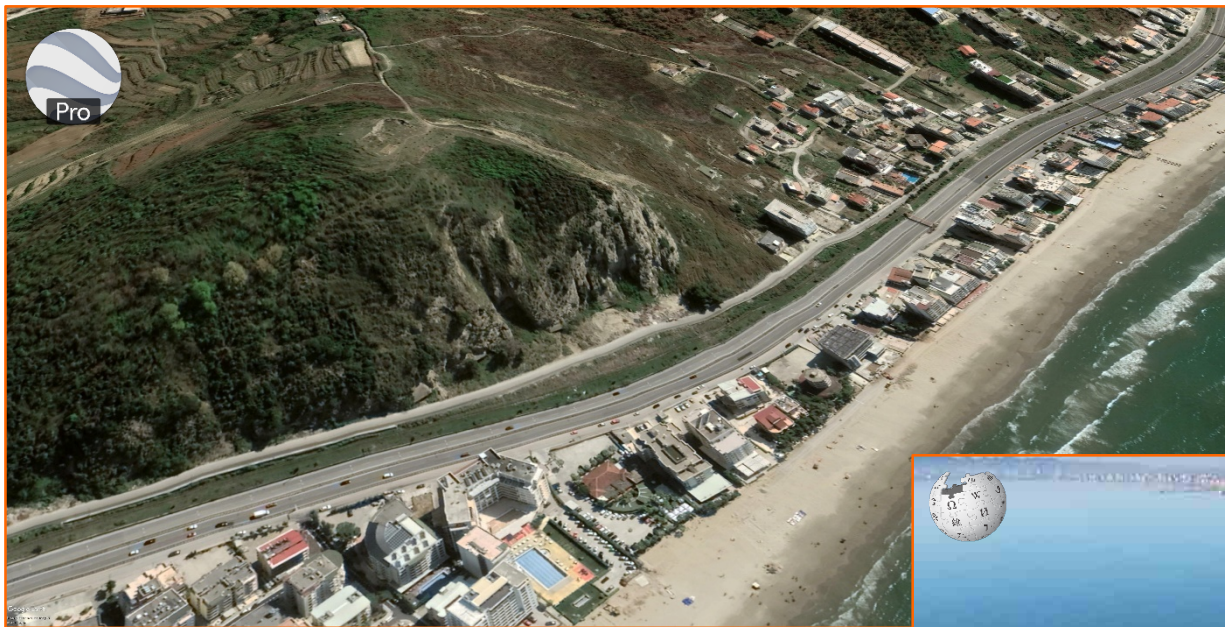
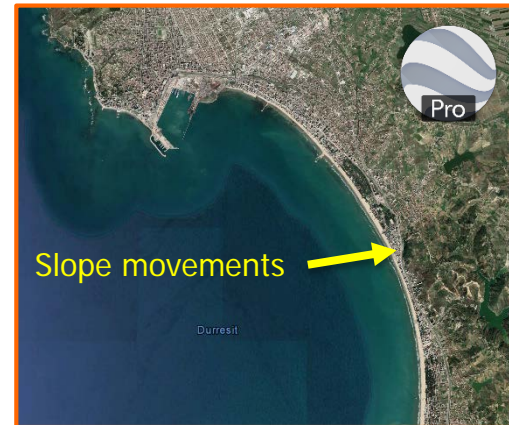
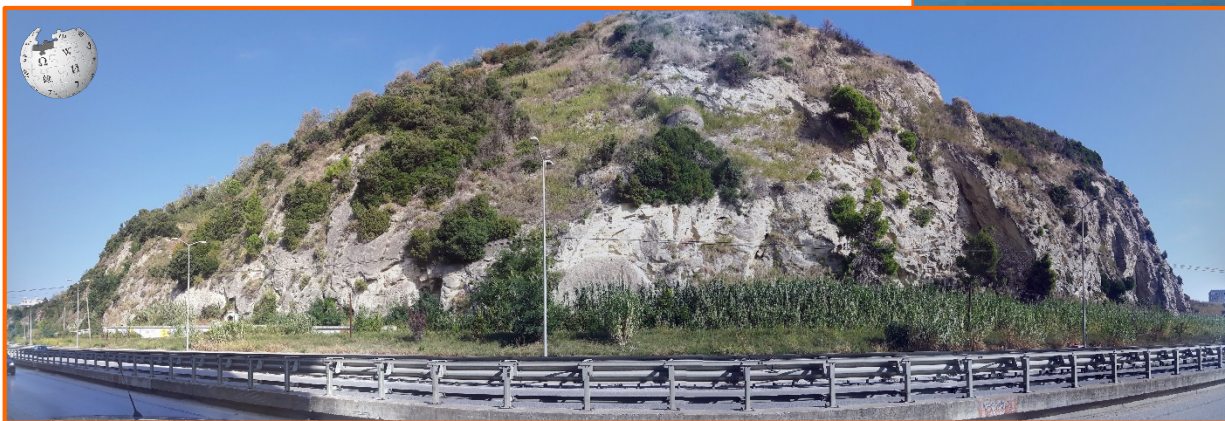
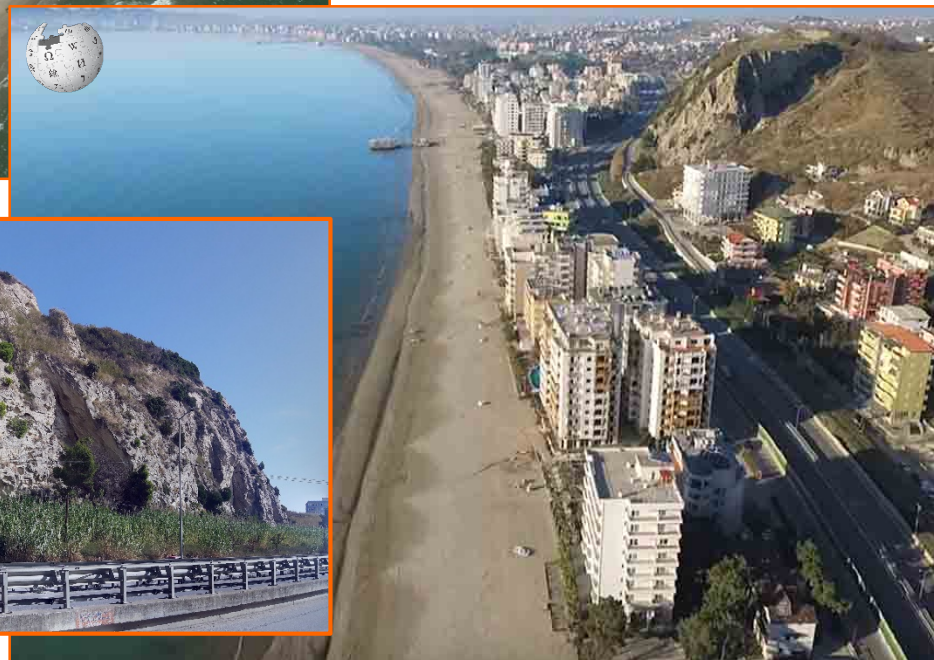
Slope movements in Shkëmbi i Kavajës

Landslides were induced along the road leading from Durrës to Kavaje, located southeast of Durrës. The landslide affected area comprises steep slopes formed by Pliocene clays. The mobilized material temporarily blocked the road without any other serious effects on the road asphalt surface, vehicles and drivers.

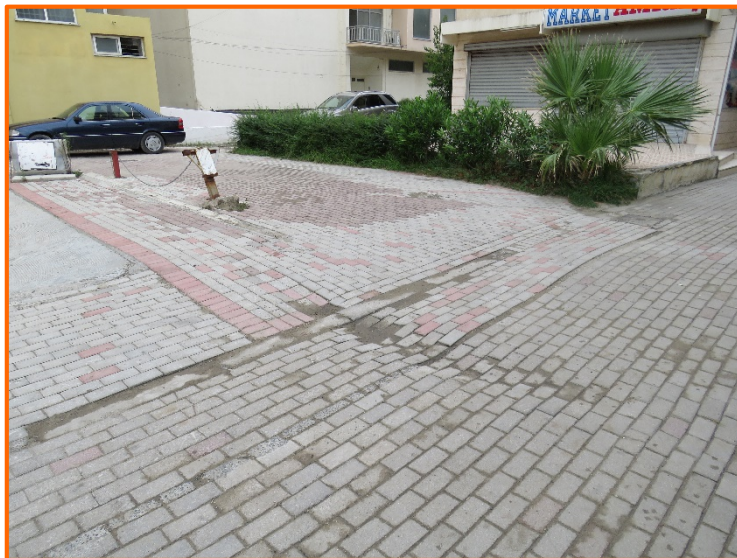
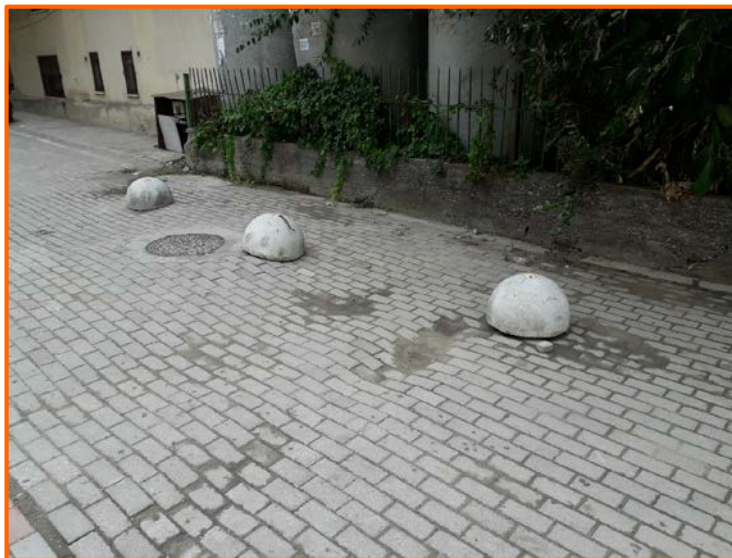
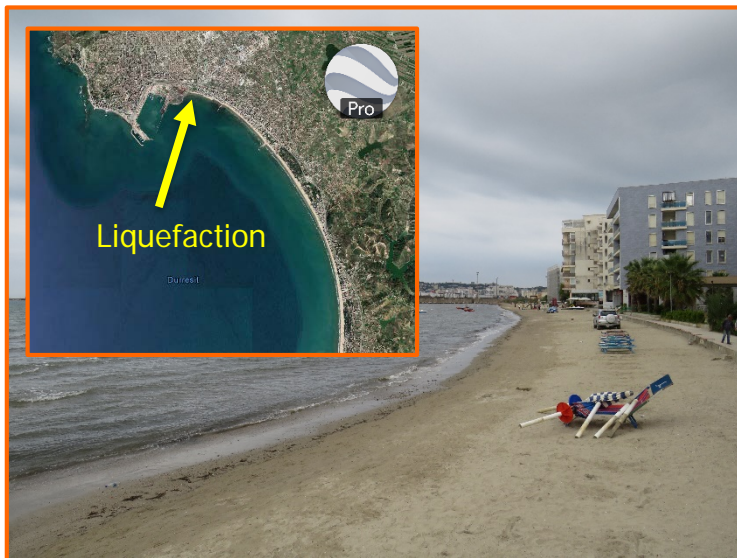
Liquefaction phenomena were observed along the coastal area of Durrës and more specifically in the area located east of Durrës port. They were of local character and comprises mixture of ejected sand and water as well as small scale subsidence observed on pavement.

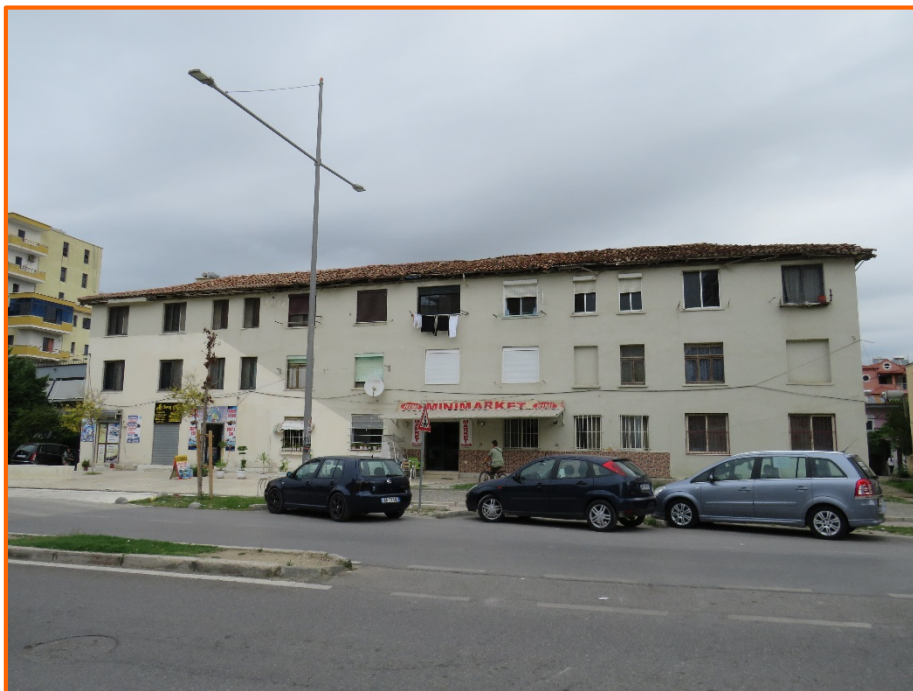
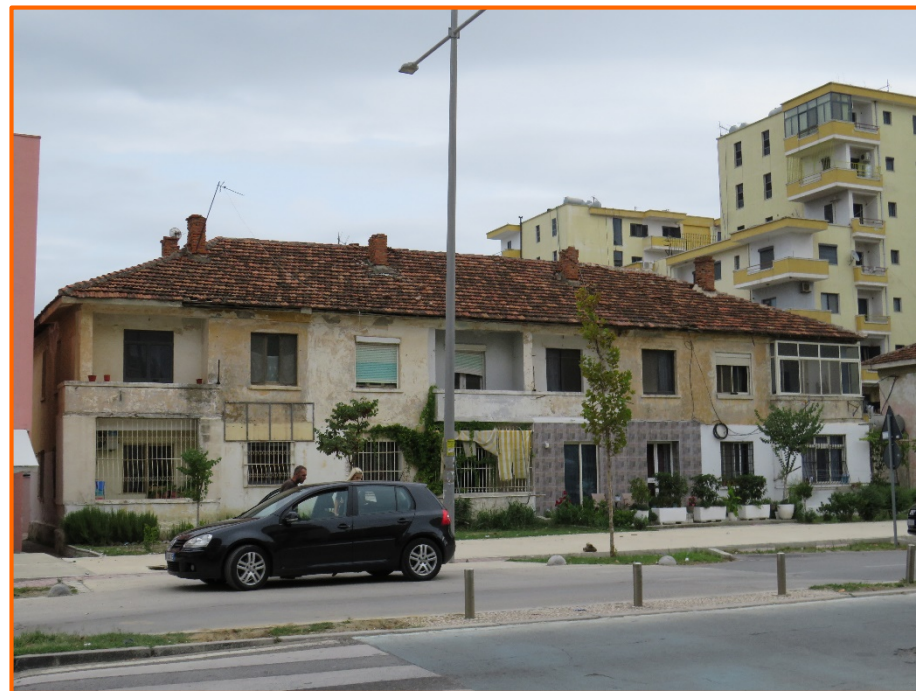
Unreinforced masonry buildings in Durrës

*3D view
of URM building*

Unreinforced masonry (URM) is one of the most common structural types for low-rise construction in Albania. The construction of these buildings took place during the communist period (1944-1990).

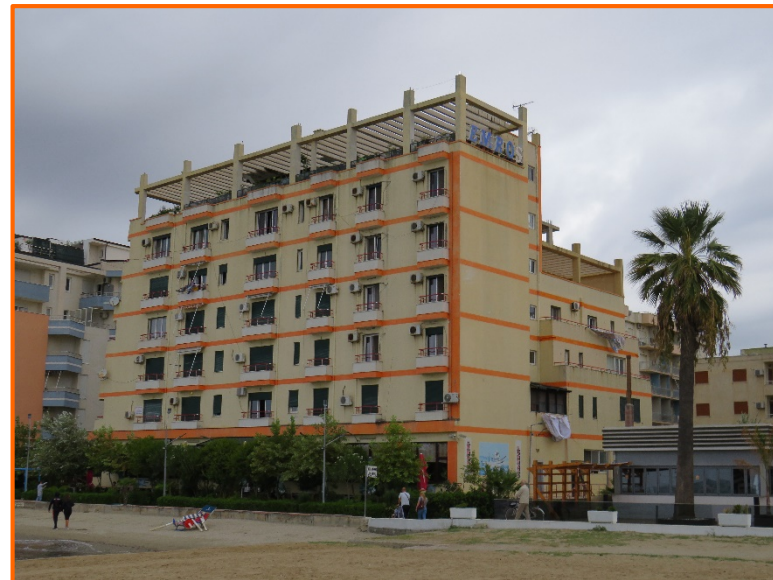
Recent reinforced concrete structures in Durrës

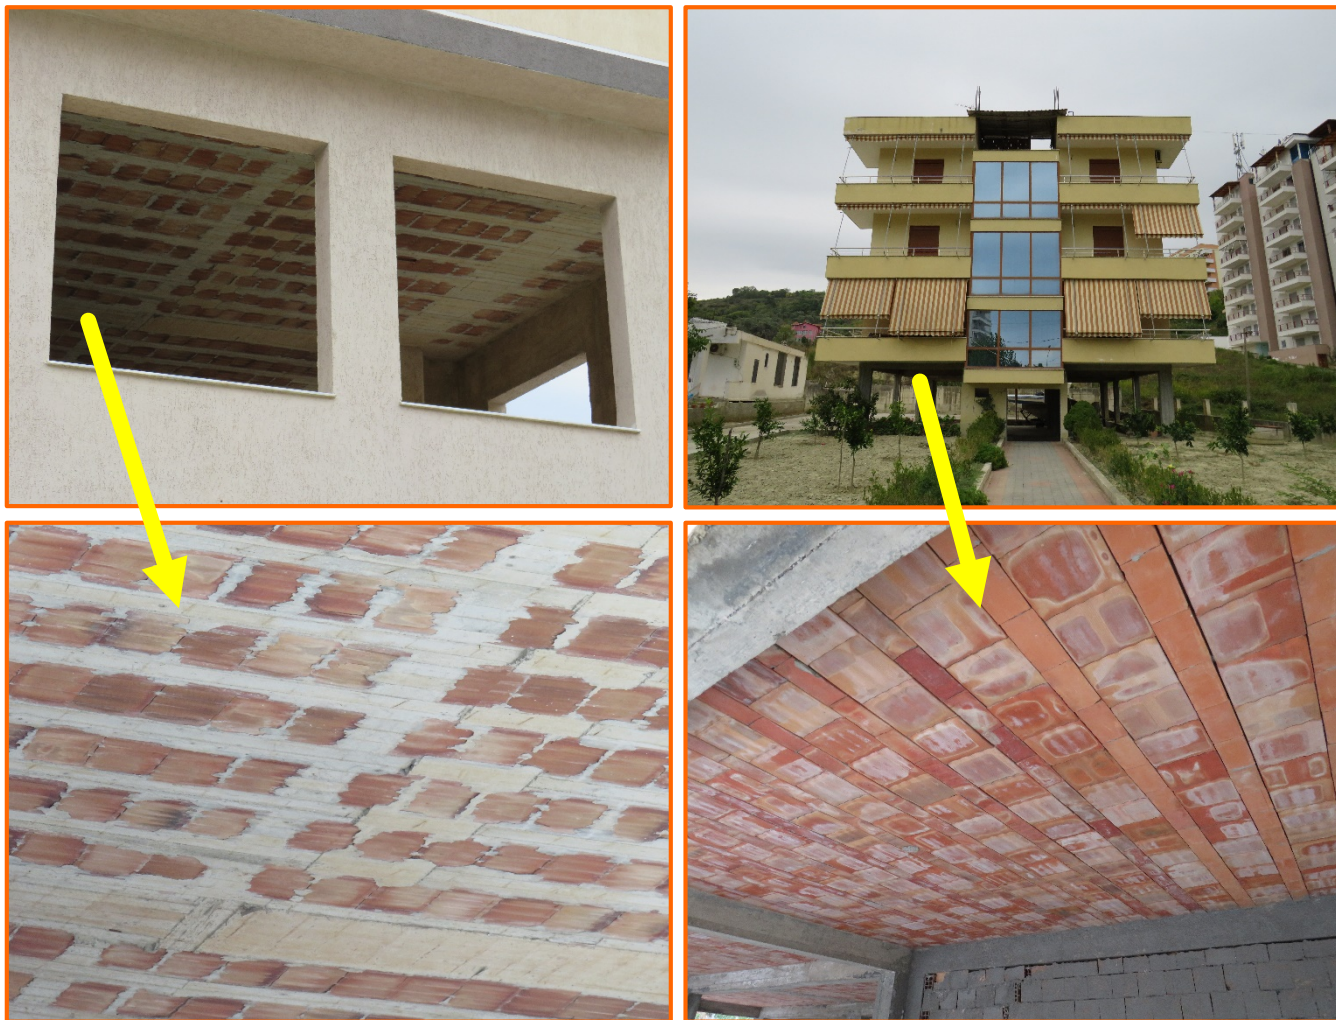
DOMINANT BUILDING TYPES IN THE AFFECTED AREA

Floor and ceiling systems consist mainly of brick units and concrete beams. In most of the cases, a flat slab system is employed, resulting thus, to a more flexible structure.

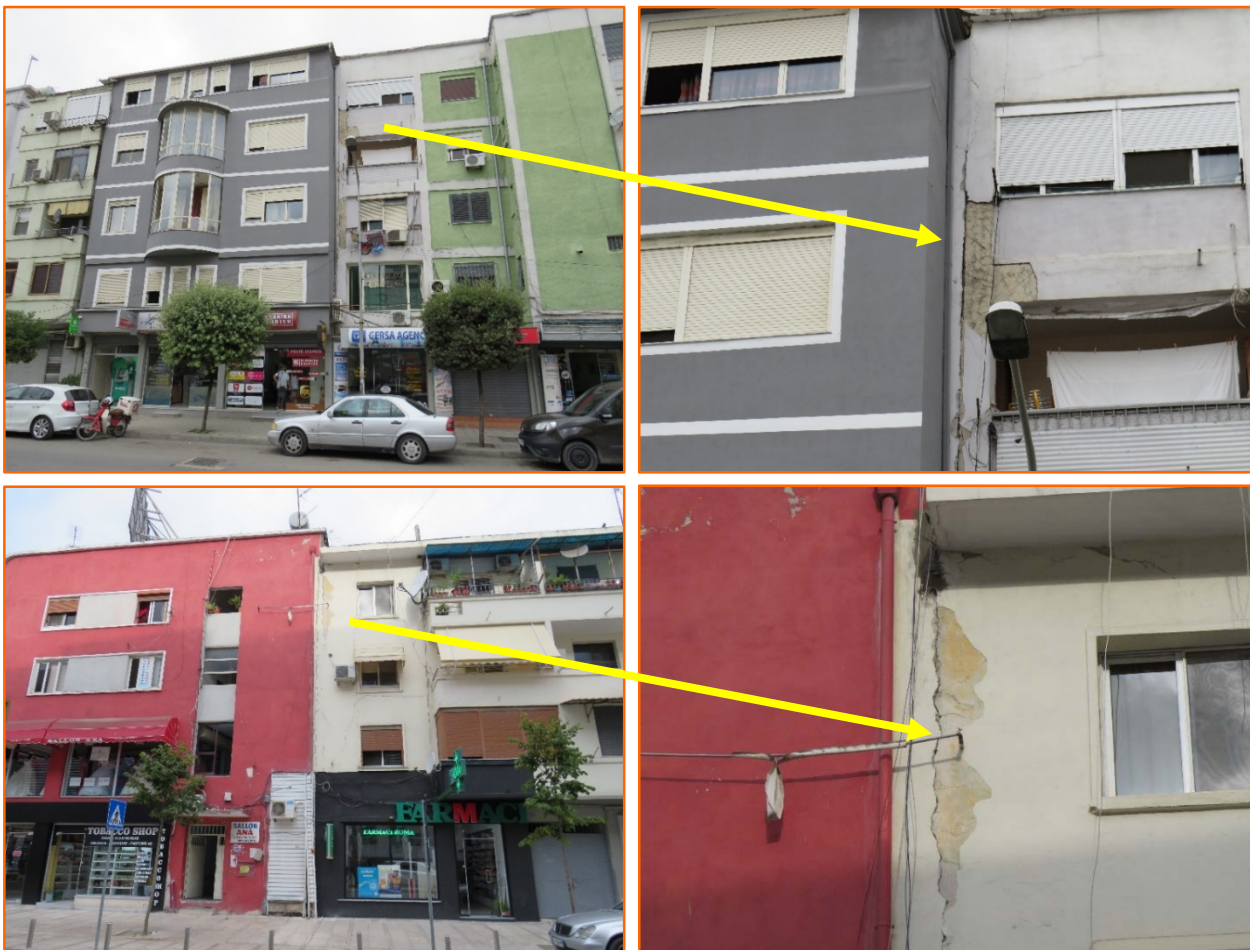
EARTHQUAKE DAMAGE TO BUILDINGS IN DURRËS

Detachment of plasters from the infill walls close to the contact with the surrounding RC frame or detachment of plasters from the RC frame close to the junction line attributed to buildings' pounding were observed. Some of this damage occurred at intermediate levels may be attributed to the development of higher modes of vibration (due to the higher flexibility of one or both of the structures).

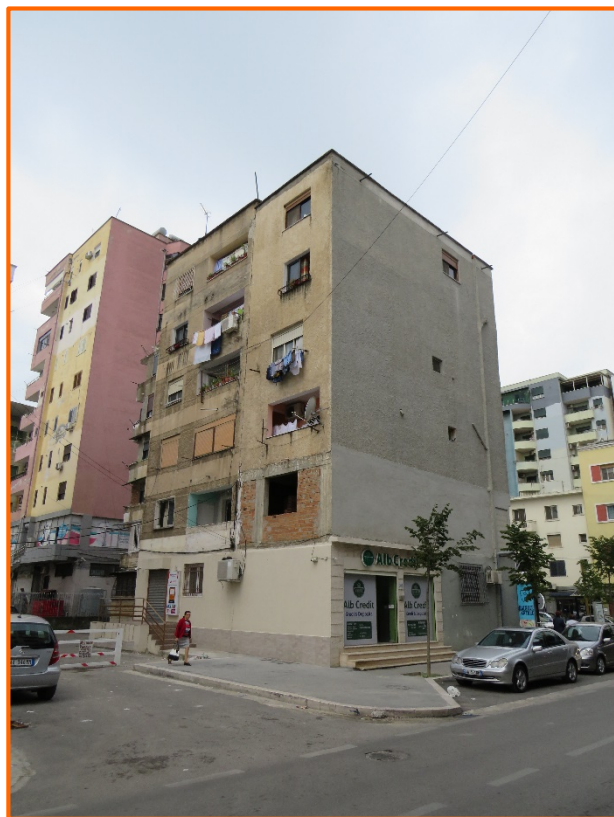
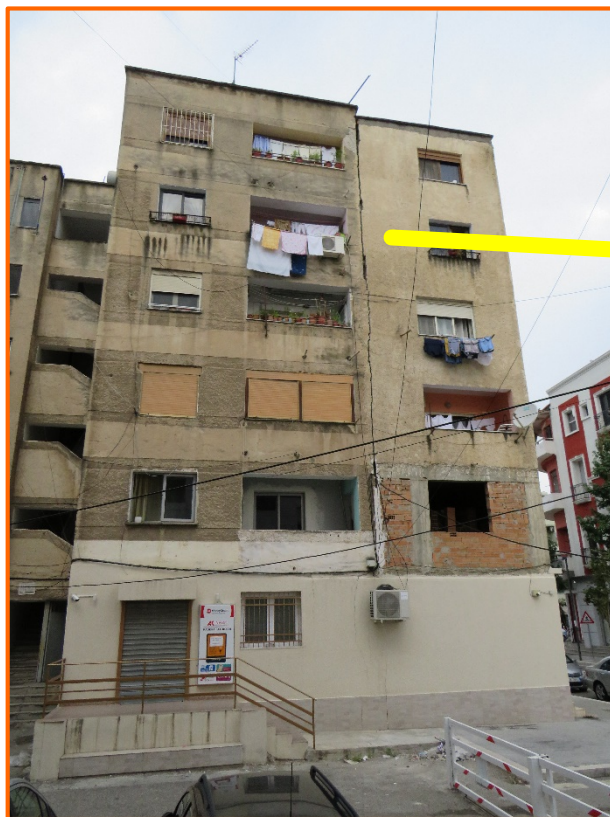
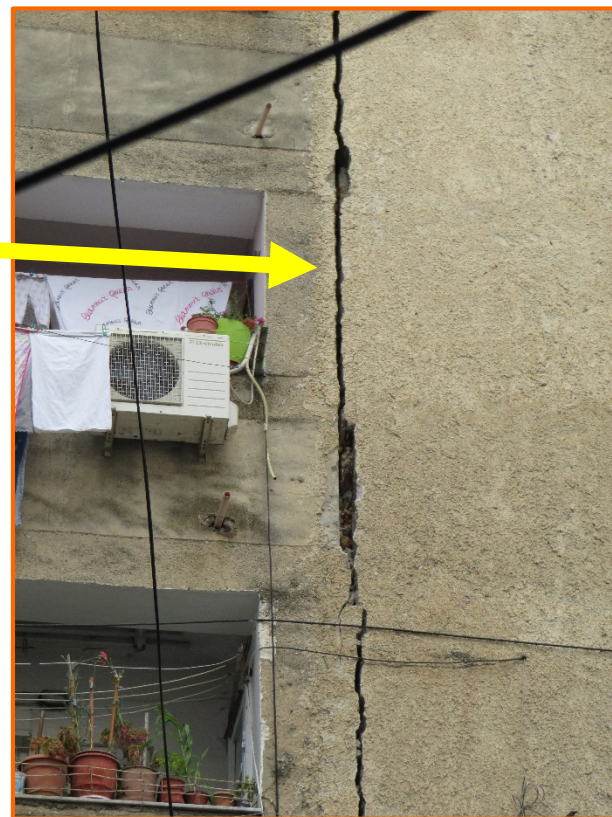
EARTHQUAKE DAMAGE TO BUILDINGS IN DURRËS

The pounding phenomena in this case resulted in impact and creation of a gap at the upper levels of the buildings. This damage is due to the development of the lowest mode of vibration (the first mode), in opposition to the case presented just before. This phenomenon occurs in more stiff structures.

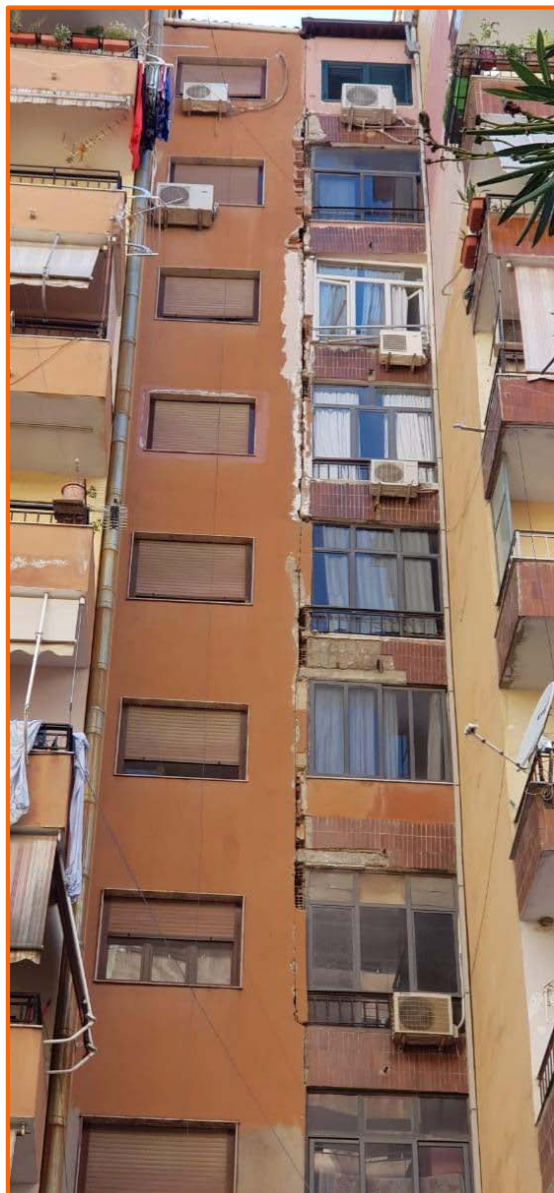
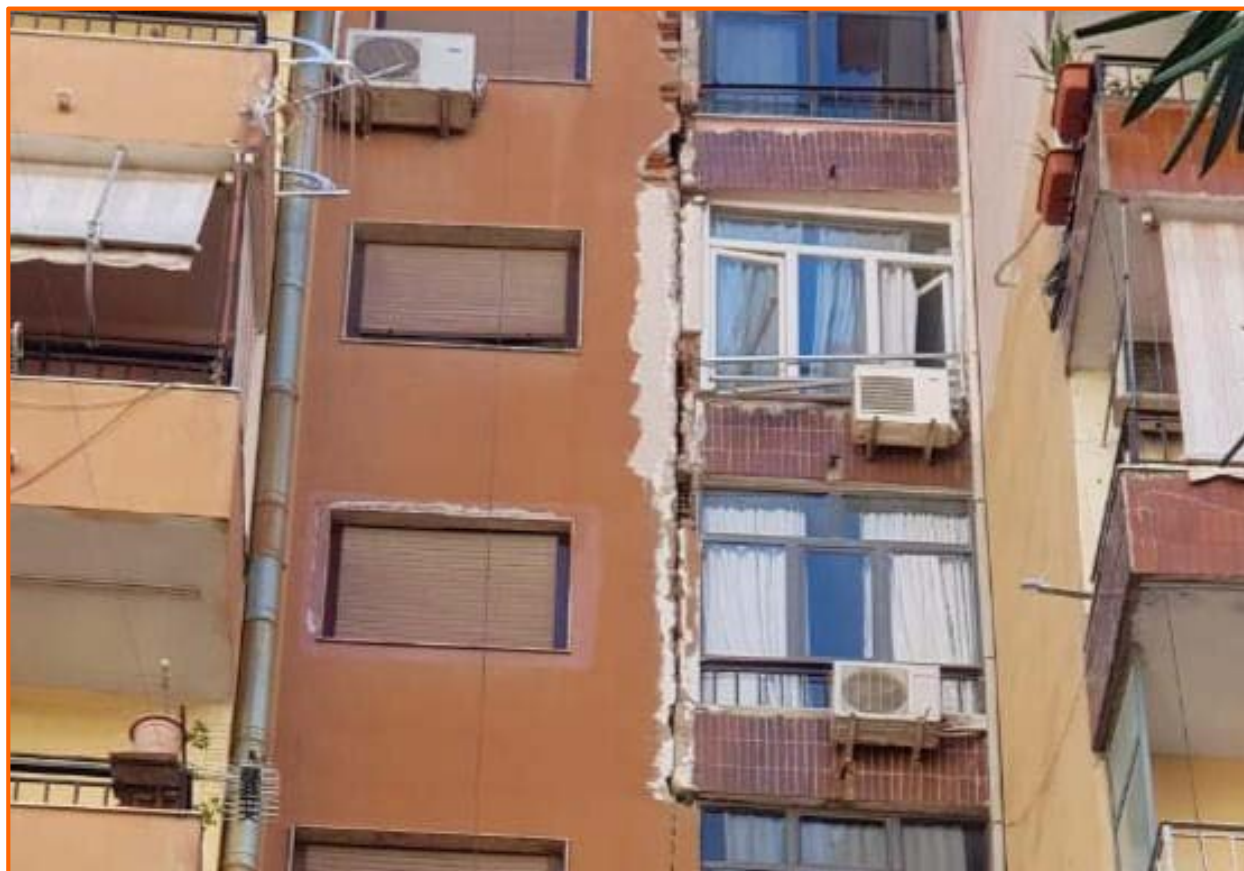
EARTHQUAKE DAMAGE TO BUILDINGS IN TIRANA

This type of pounding is similar to the one presented in previous photos from Durrës. All those cases indicate that many structures in Albania are quite flexible characterized mainly by lack of stiffening elements, shear walls etc.

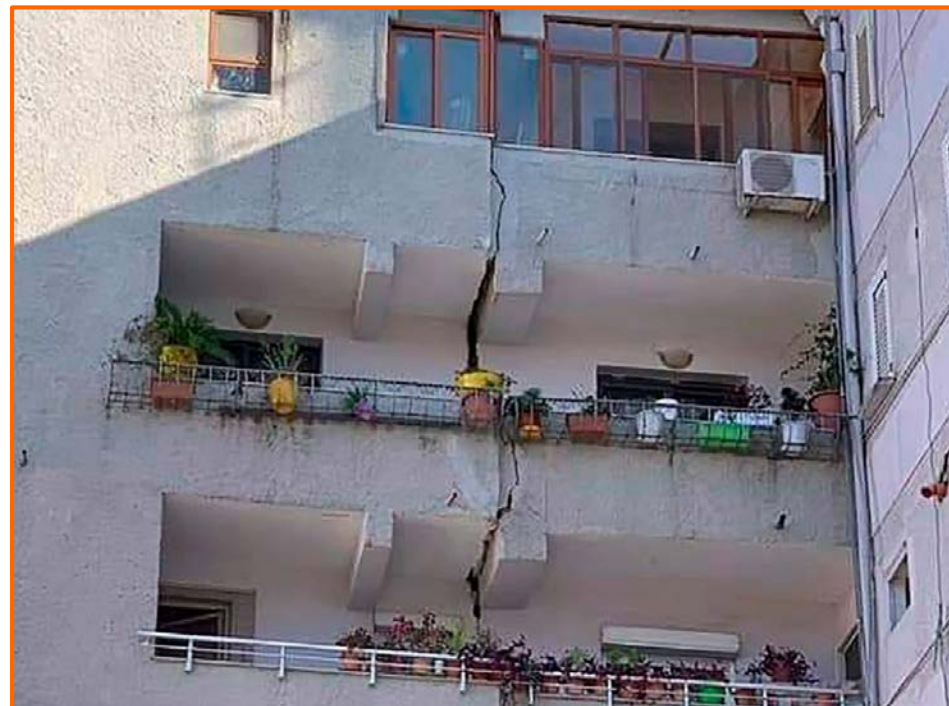
EARTHQUAKE DAMAGE TO BUILDINGS IN TIRANA

Pounding of a more flexible structural addition (due to its high aspect ratio: height/base) over a more rigid structure, during which higher modes of vibration are created.

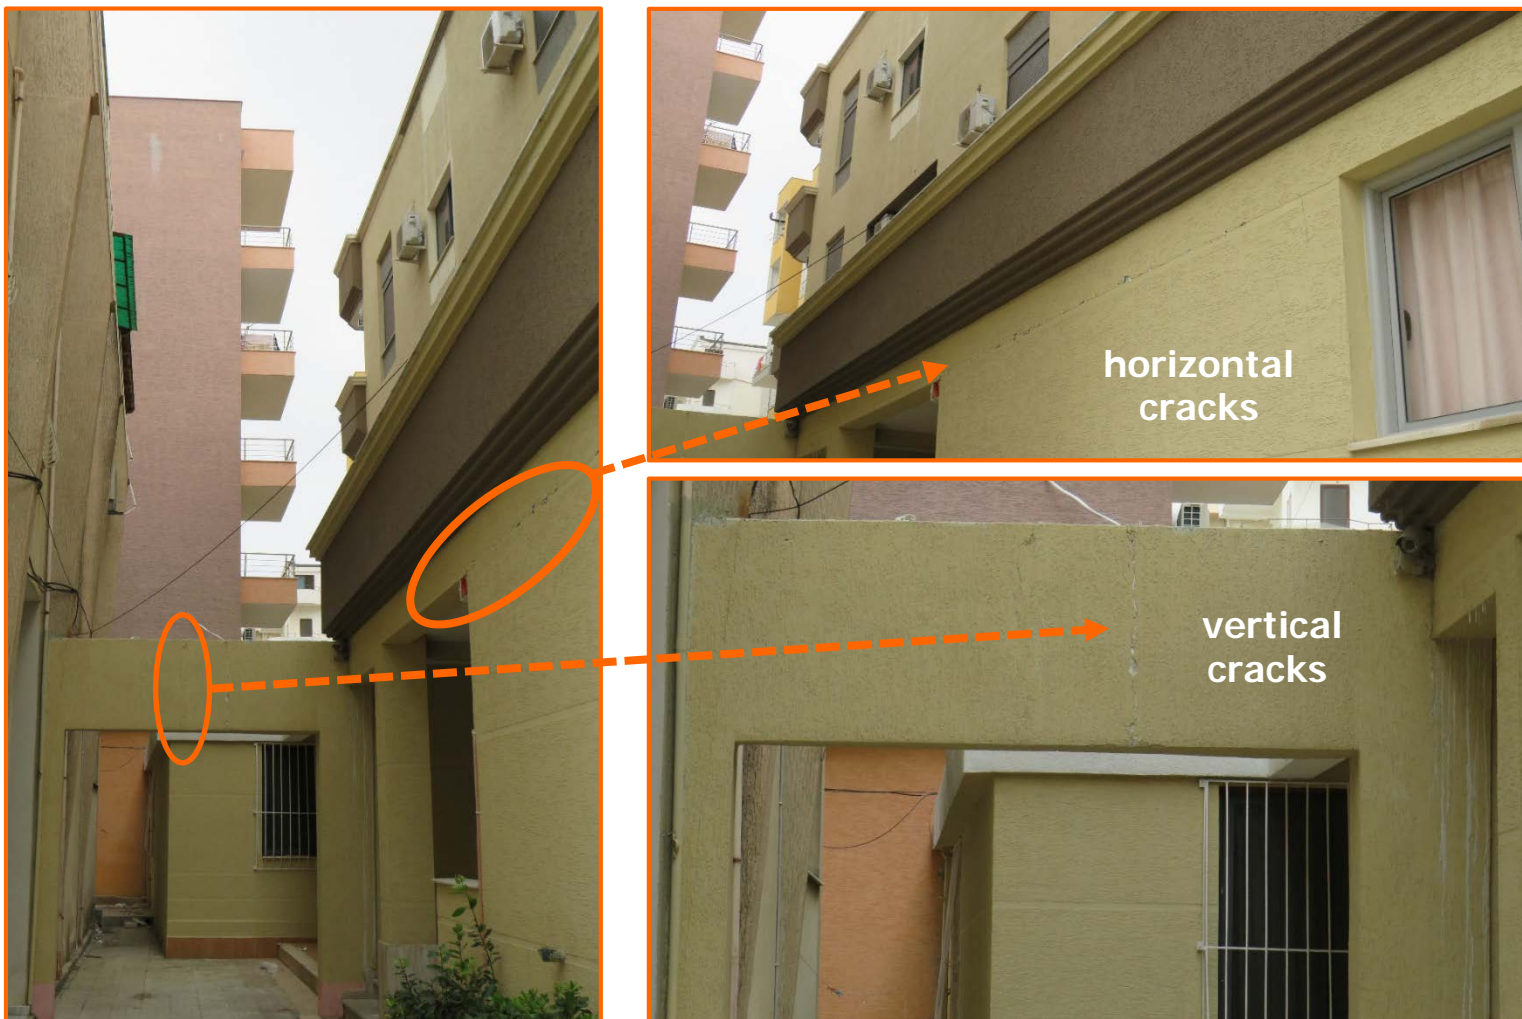
EARTHQUAKE DAMAGE TO BUILDINGS IN DURRËS

The effect of the vertical component of the earthquake ground motion is obvious: horizontal cracks (top right figure) combined with vertical cracks in the middle of the span of the beam (bottom right figure).

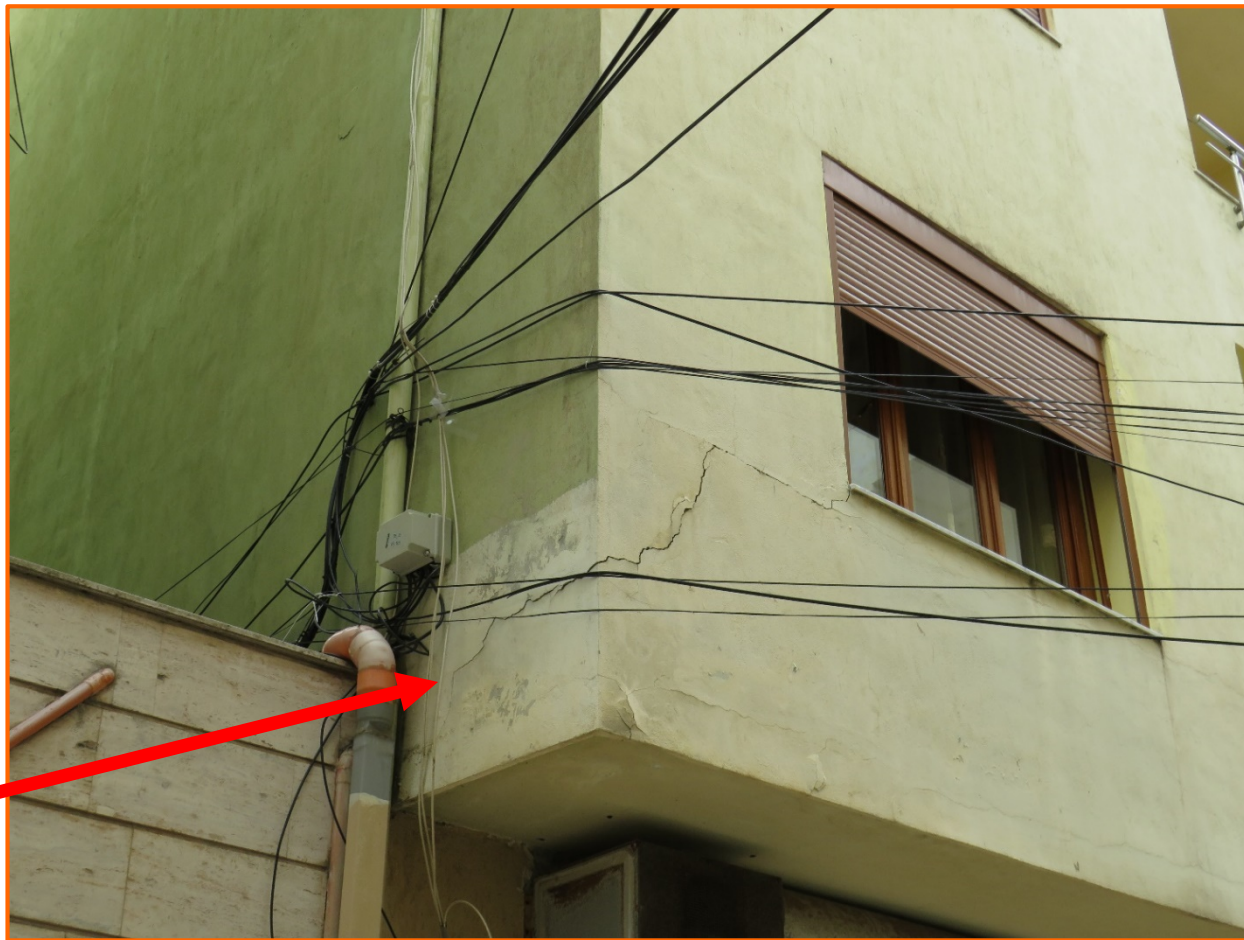
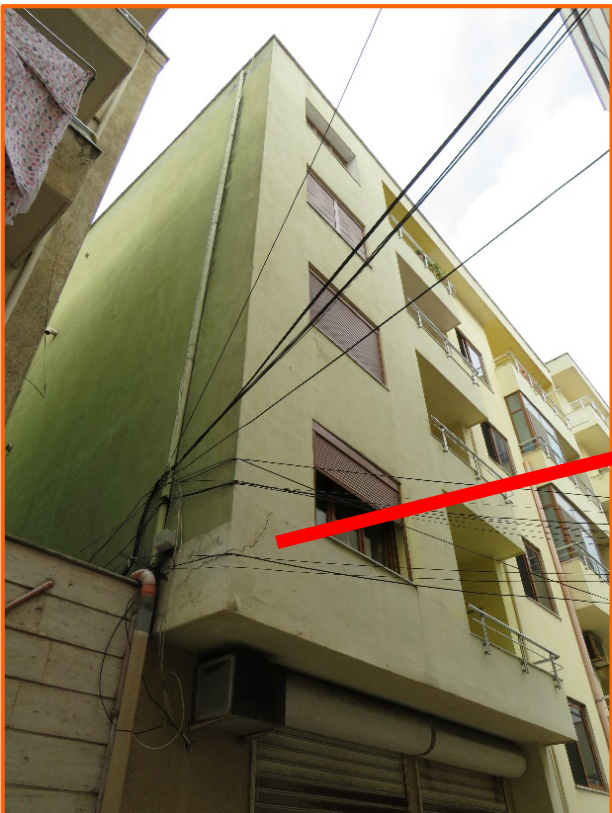
EARTHQUAKE DAMAGE TO BUILDINGS IN DURRËS

Effect of the vertical shaking component on the brick wall standing on the RC cantilever (that is excited vertically)

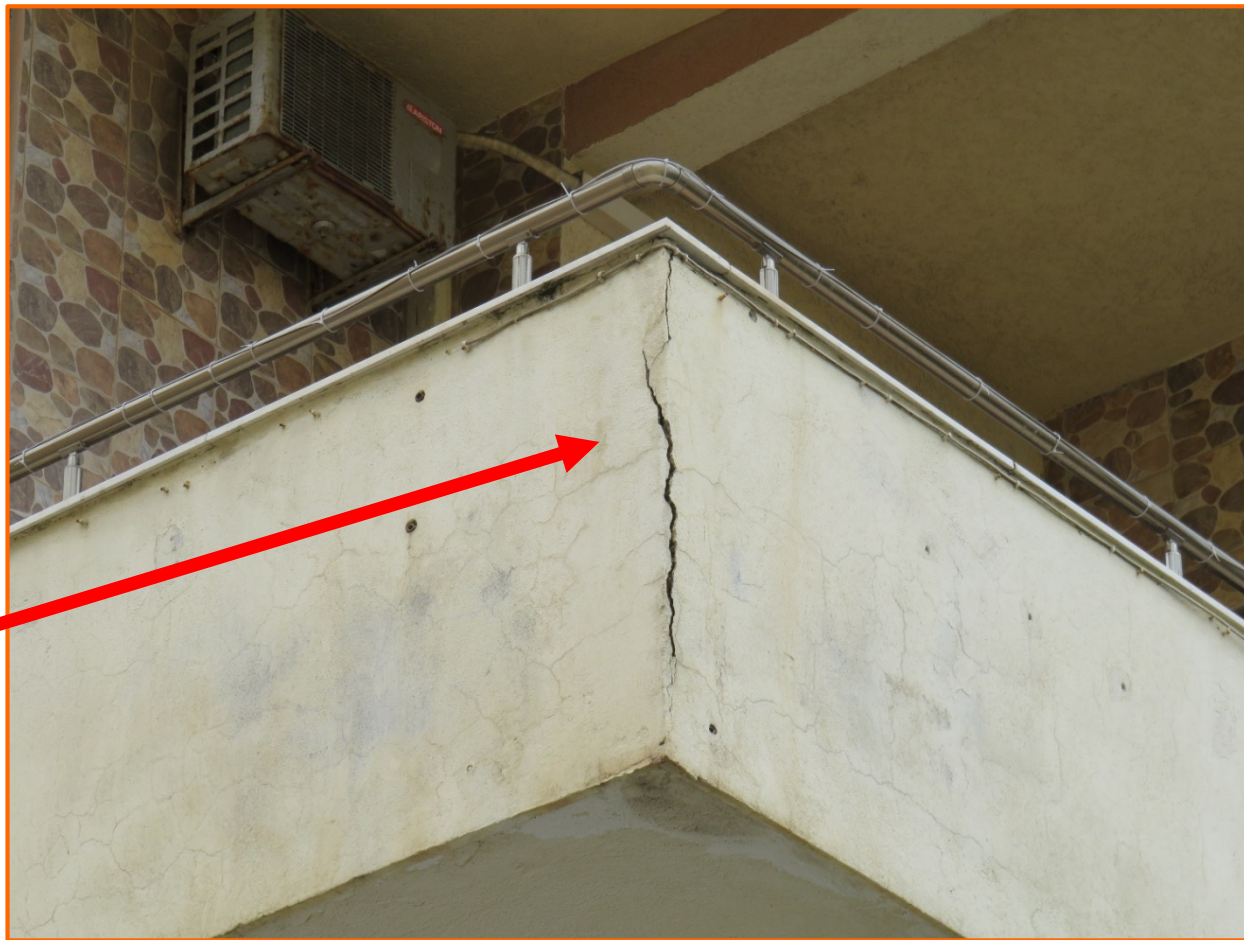
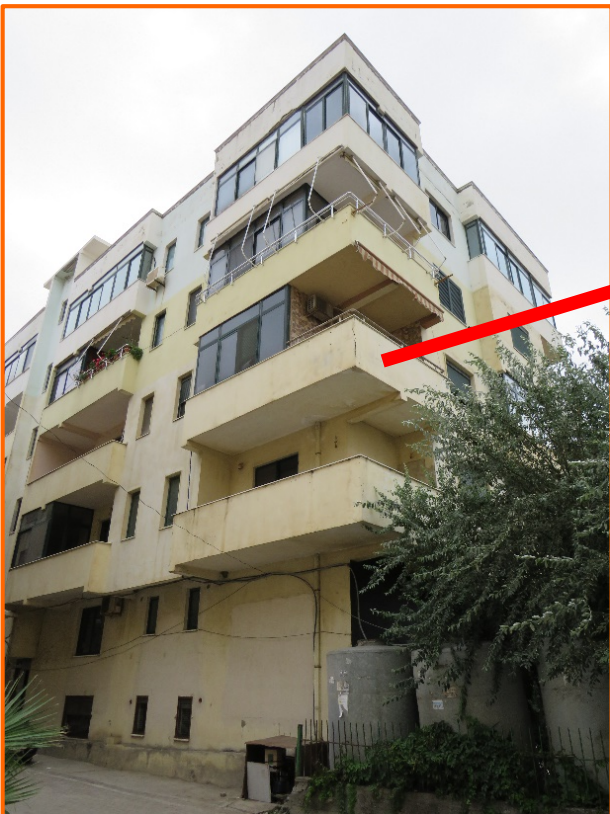
EARTHQUAKE DAMAGE TO BUILDINGS IN DURRËS

Effect of the vertical component of the earthquake ground motion on the brick wall parapet standing on the RC cantilever (similar to the previously presented case). The opening of the crack is diminished at the top due to the rails fastening.

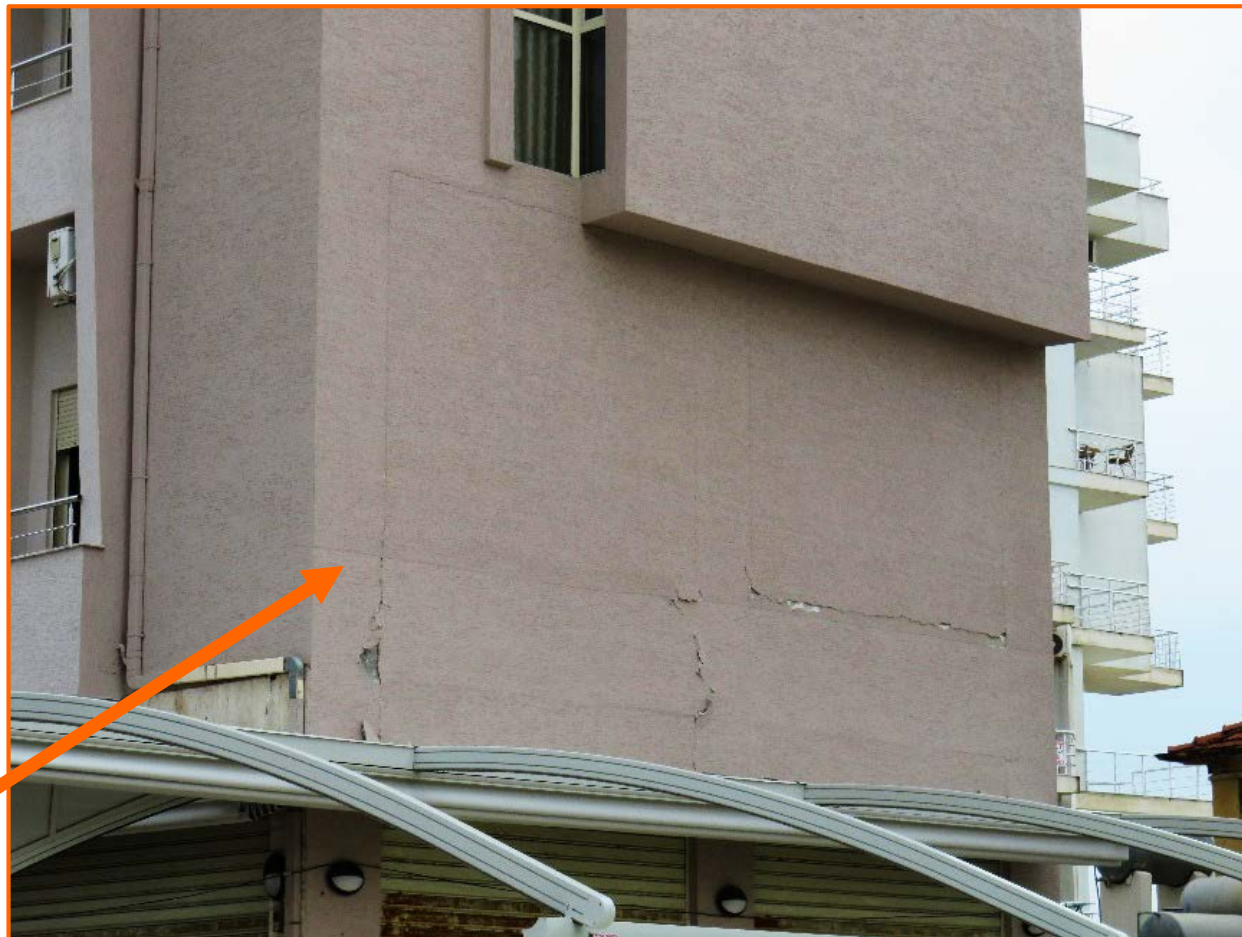
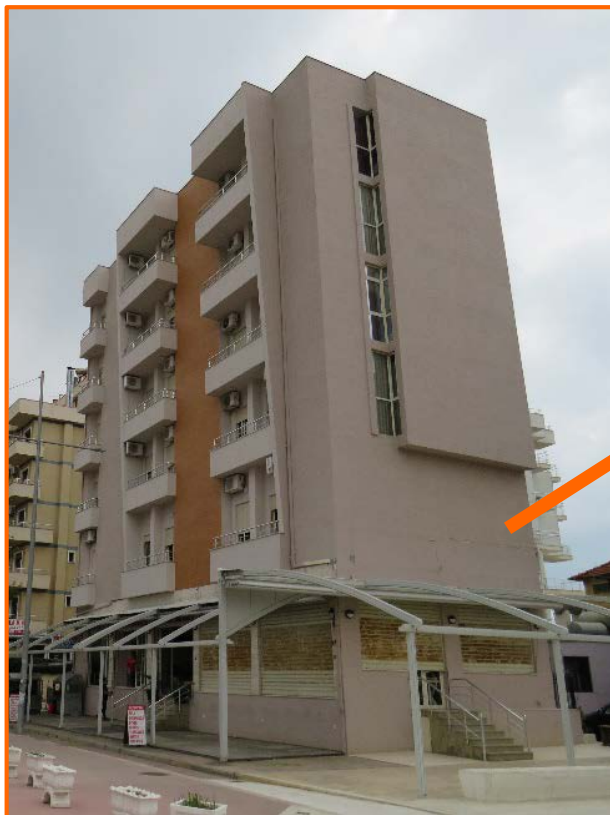
EARTHQUAKE DAMAGE TO BUILDINGS IN DURRËS

Separation of brick walls from the members of the RC framing system, which is a common phenomenon due to the deformational incompatibility between the two structural elements.

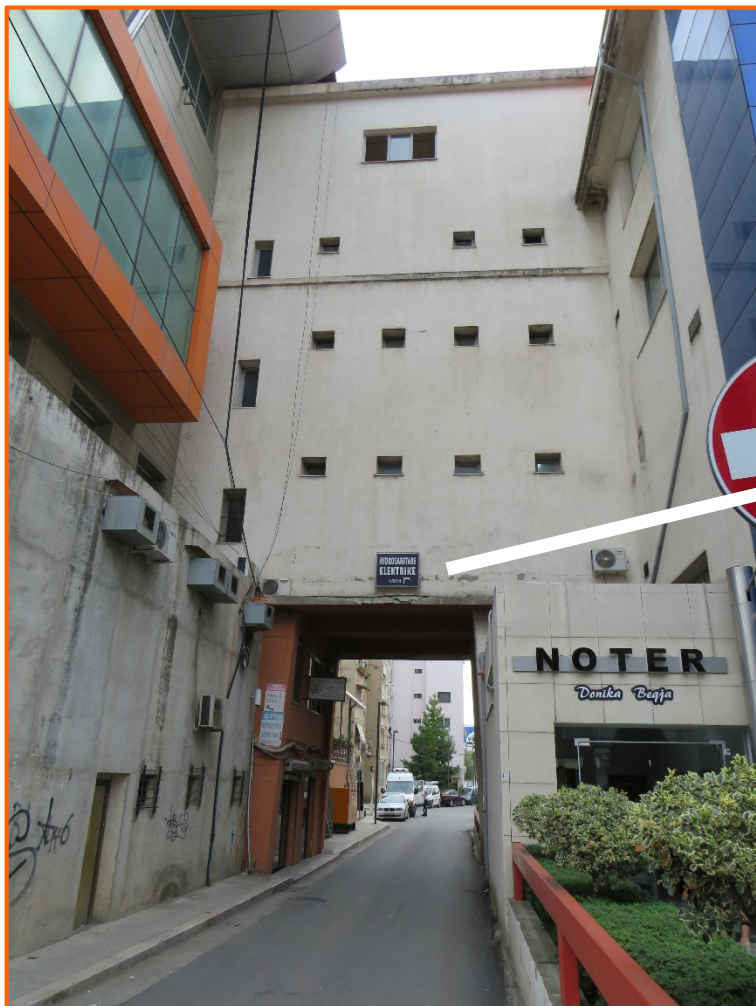
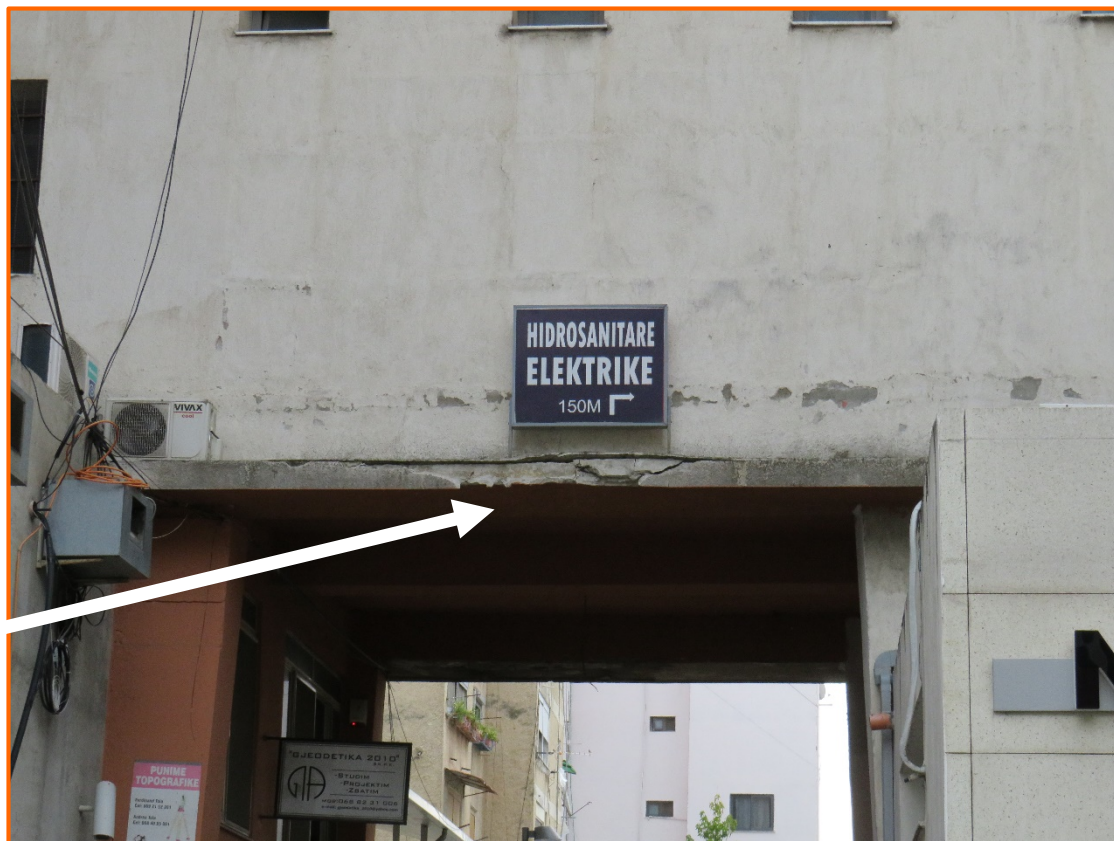
EARTHQUAKE DAMAGE TO BUILDINGS IN DURRËS

Strong indication of the dominance of the vertical component of the earthquake ground motion at Durrës city located in the epicentral region.

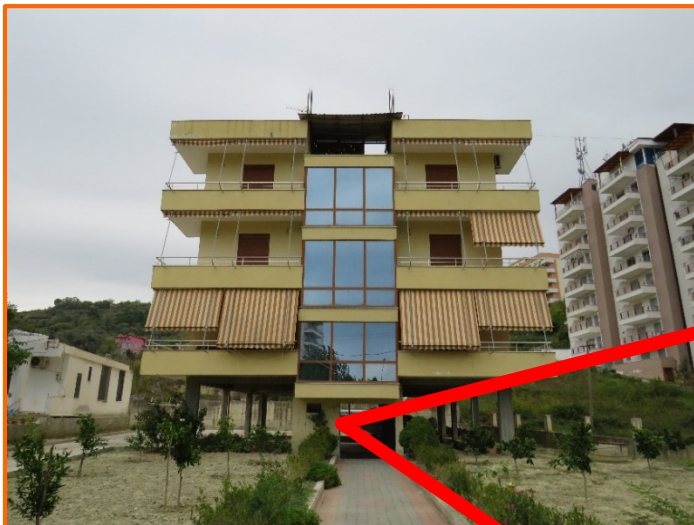
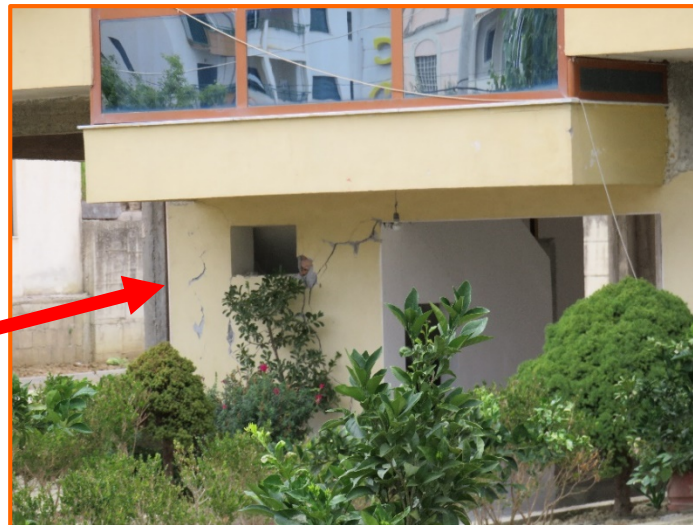
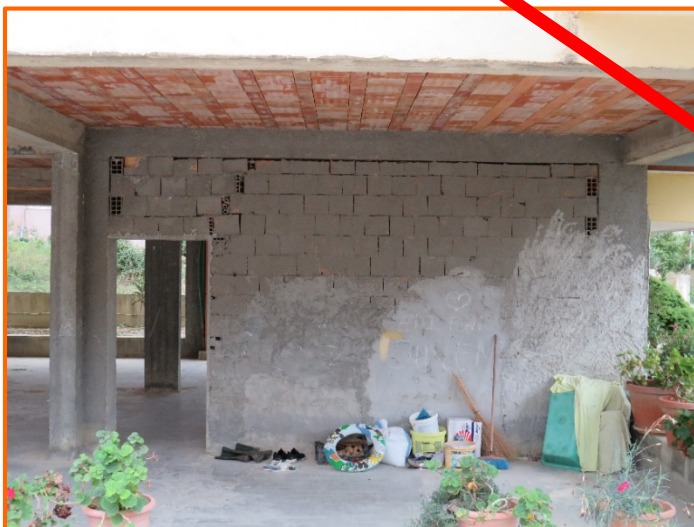
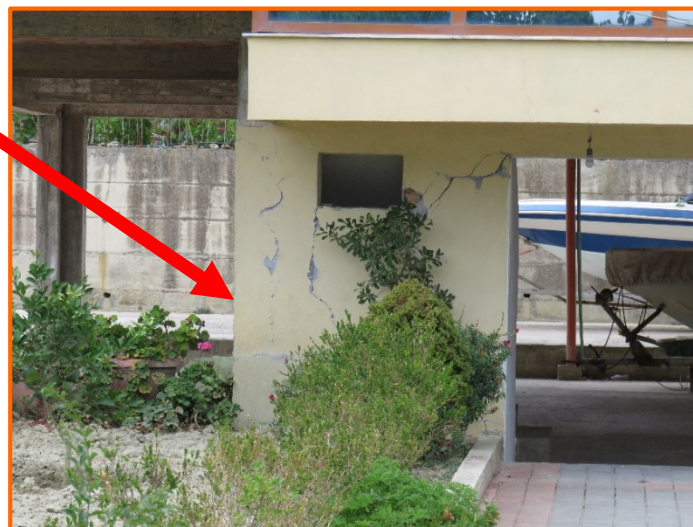
EARTHQUAKE DAMAGE TO BUILDINGS IN DURRËS

Separation of the infill brick walls from the R/C framing system
