Newsletter of **Environmental, Disaster, and Crises Management Strategies**

Issue No.13 | September 2019

The September 21, 2019 Mw 5.6 Durrës (Albania) earthquake

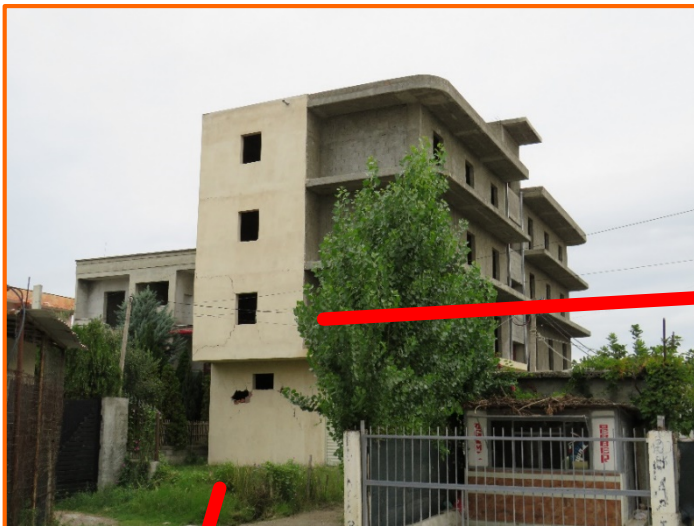
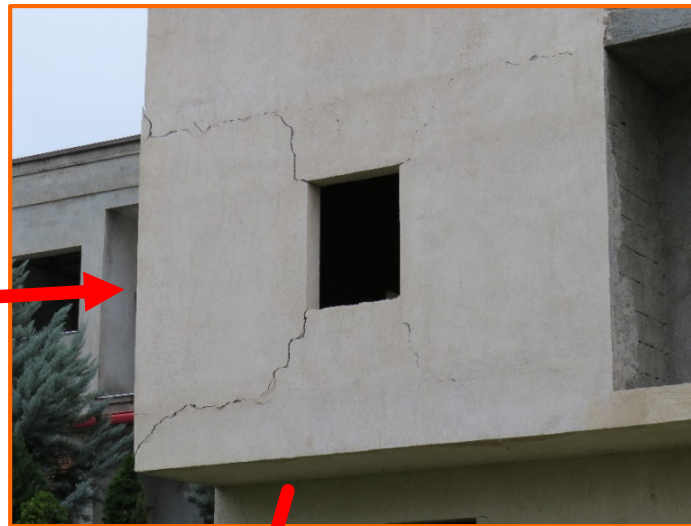
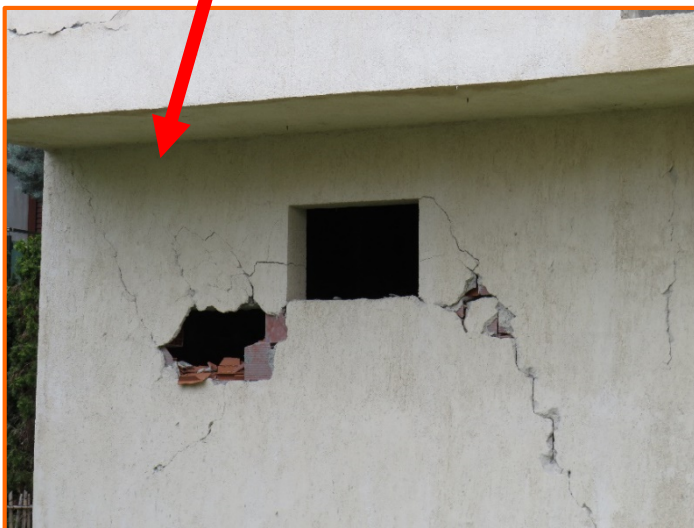
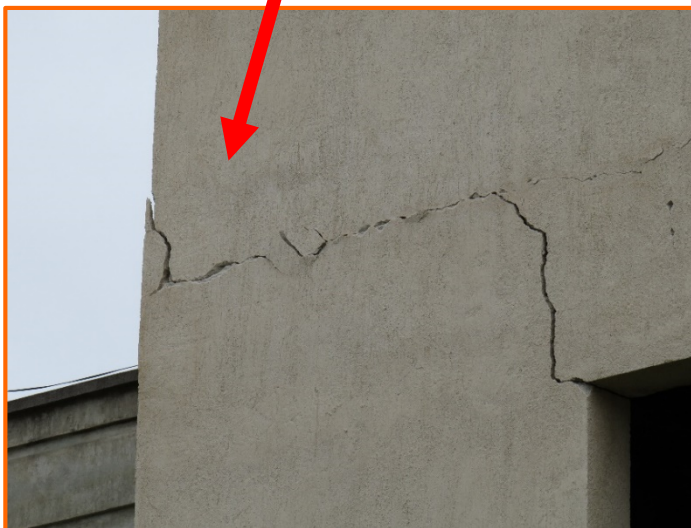
EARTHQUAKE DAMAGE TO BUILDINGS IN DURRËS

Effect of the vertical component of the earthquake ground motion in combination with the horizontal one on brick walls on an RC cantilever.

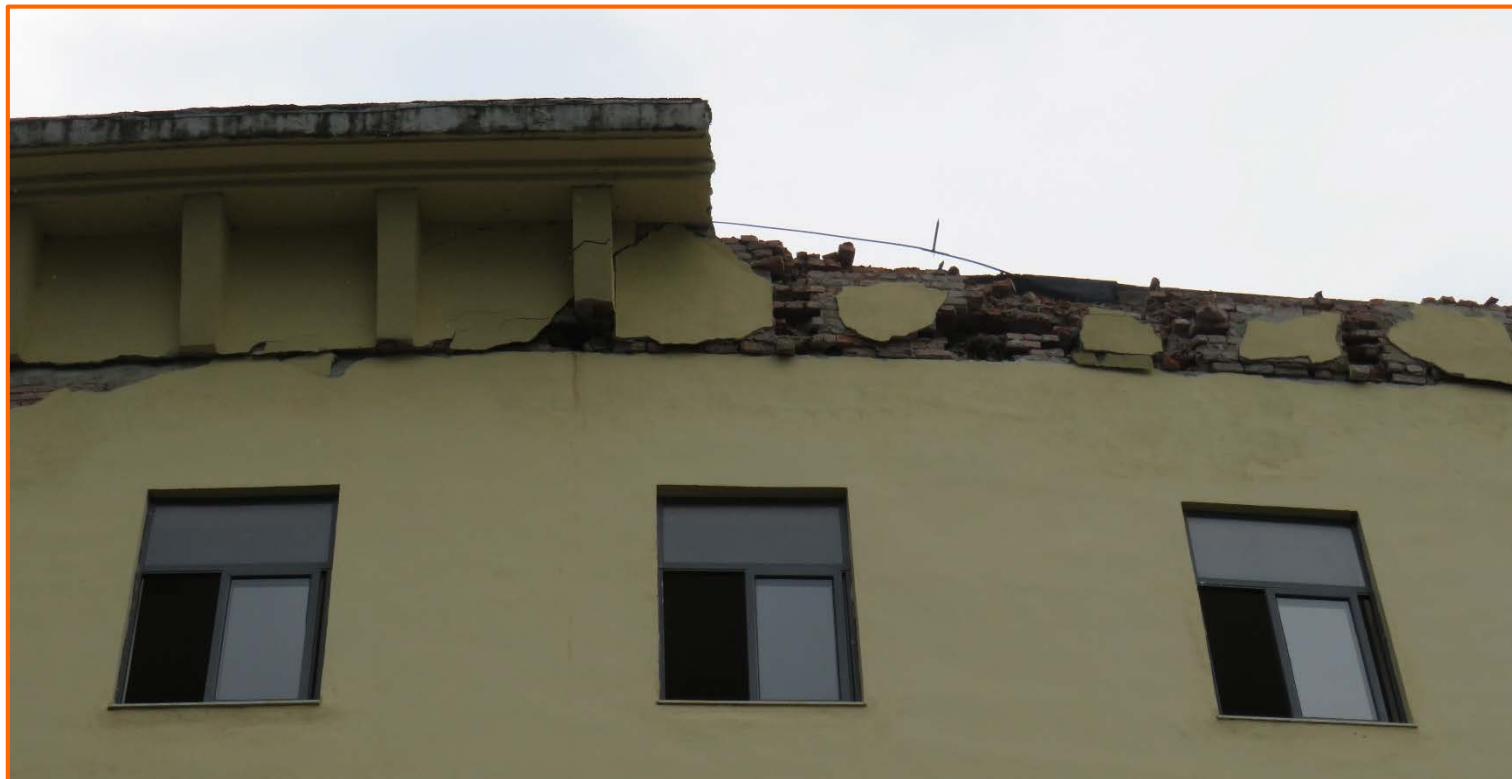
EARTHQUAKE DAMAGE TO BUILDINGS IN TIRANA

One may observe that the cantilever is supported by the triangle ribs. The ribs are superficially connected to the back standing masonry wall (justified by the well distinguished imprints of the fallen ribs). This is an inherent problem of improper workmanship, which must be locally checked and repaired, not only at the case shown, but also in other similar parts of the Faculty. The resulting risk is quite obvious and high, since the aforementioned cantilevers may fall down any time, even without any seismic motion.

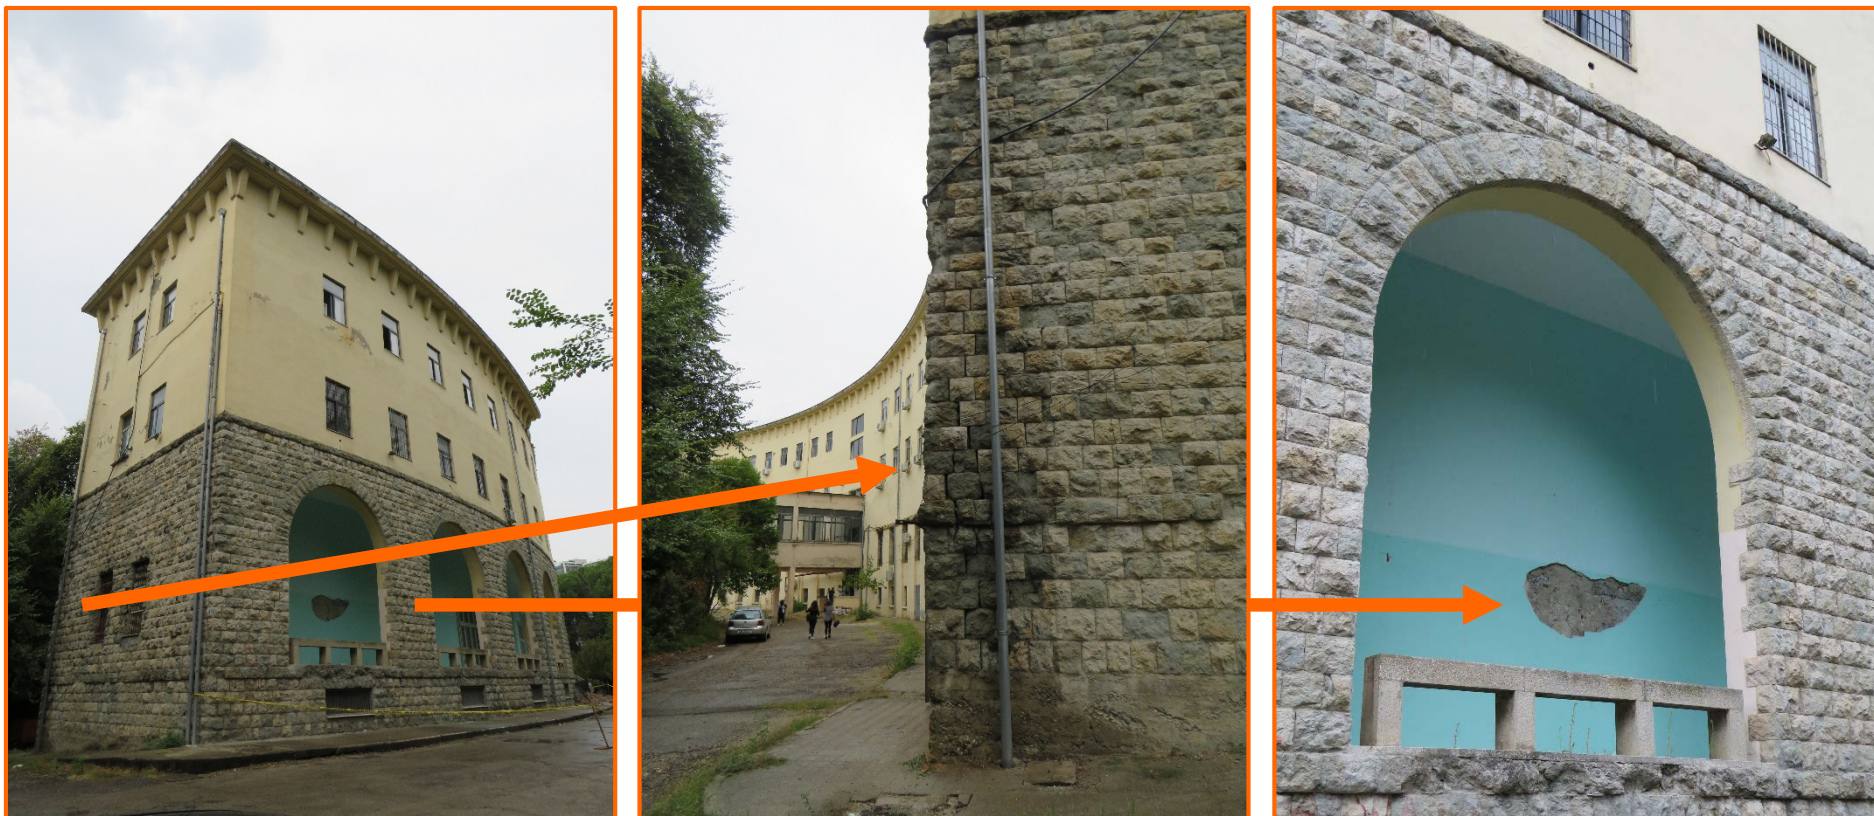
EARTHQUAKE DAMAGE TO BUILDINGS IN TIRANA

In the Faculty of Geology and Mining of the Polytechnic University of Tirana, detachment of large pieces of plaster from the masonry walls was also observed. Large vertical cracks were also detected along the corners of the building resulting in separation of stones.

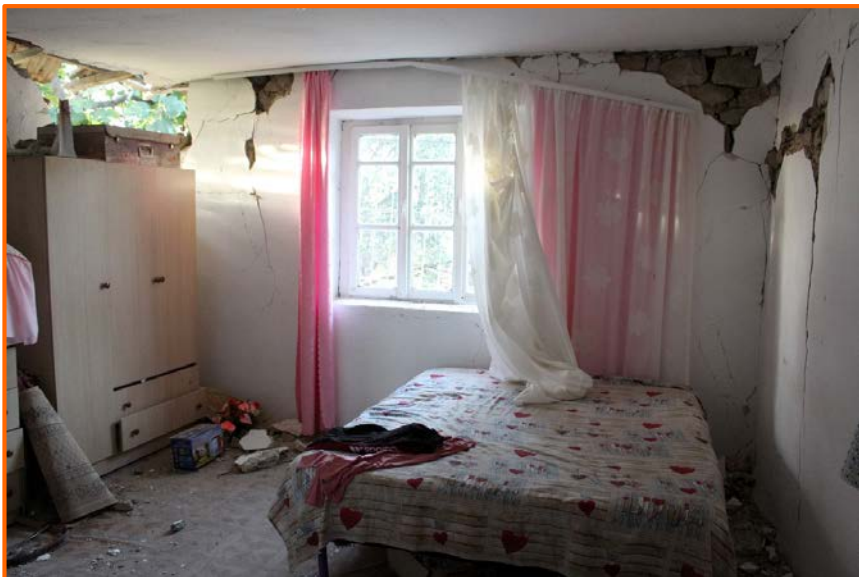
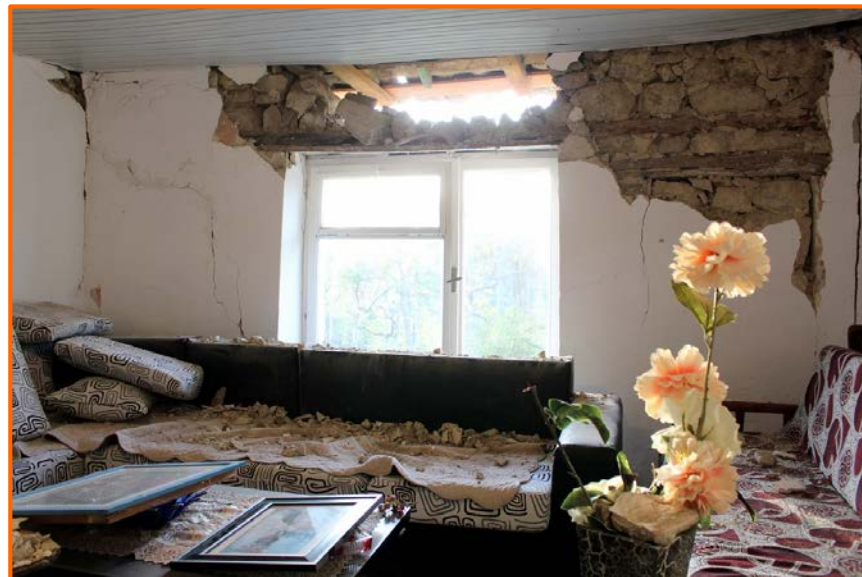
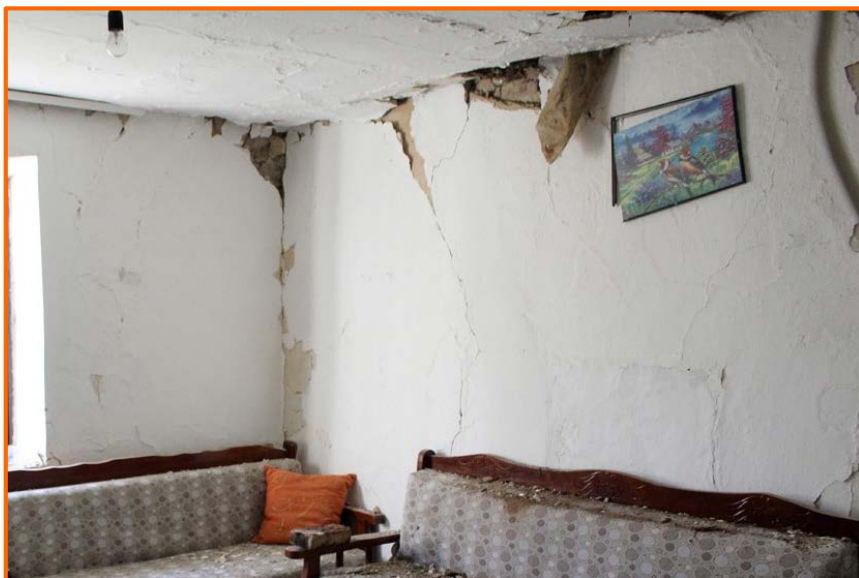
EARTHQUAKE DAMAGE TO BUILDINGS IN ZHUR VILLAGE

Non-structural and structural damage to an unreinforced masonry building in Zhur village comprising detachment of plaster pieces from the masonry load-bearing walls and partial collapse of the masonry walls respectively.
