**KANDİLLİ OBSERVATORY and EARTHQUAKE
RESEARCH INSTITUTE**

***March 08, 2010 BAŞYURT-KARAKOÇAN
(ELAZIĞ) EARTHQUAKE***

**Prepared by; Dr. Doğan Kalafat
Dr. Can Zülfikar
Res. Assist. Eren Vuran
Res. Assist. Yaver Kamer**

**March, 2010
İSTANBUL**

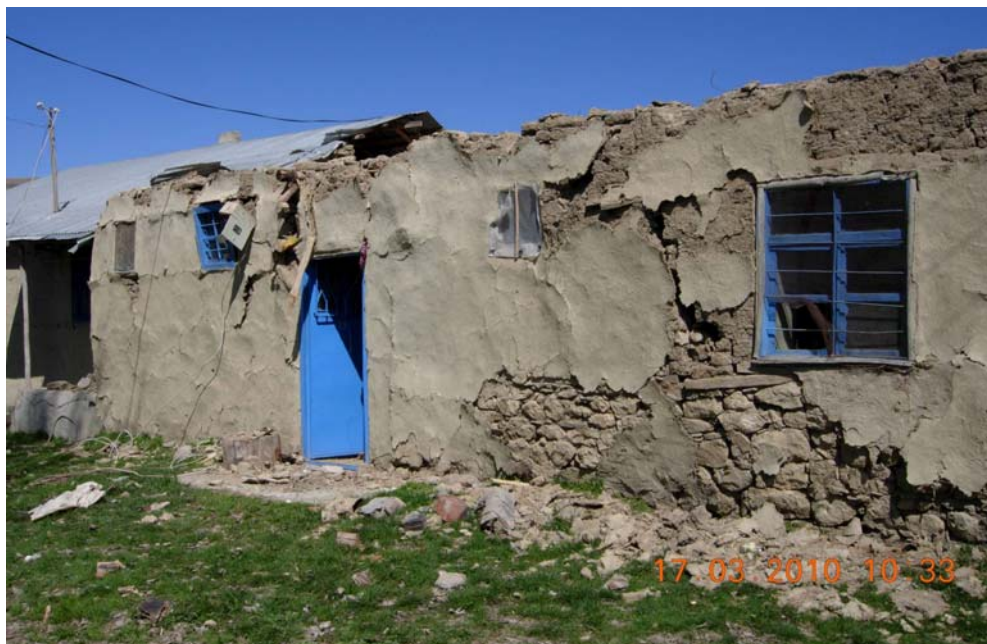
Figure 18: *One storey soil brick house in Incedal village-side view 1 (bottom part of the house, below window level is built with stones)*

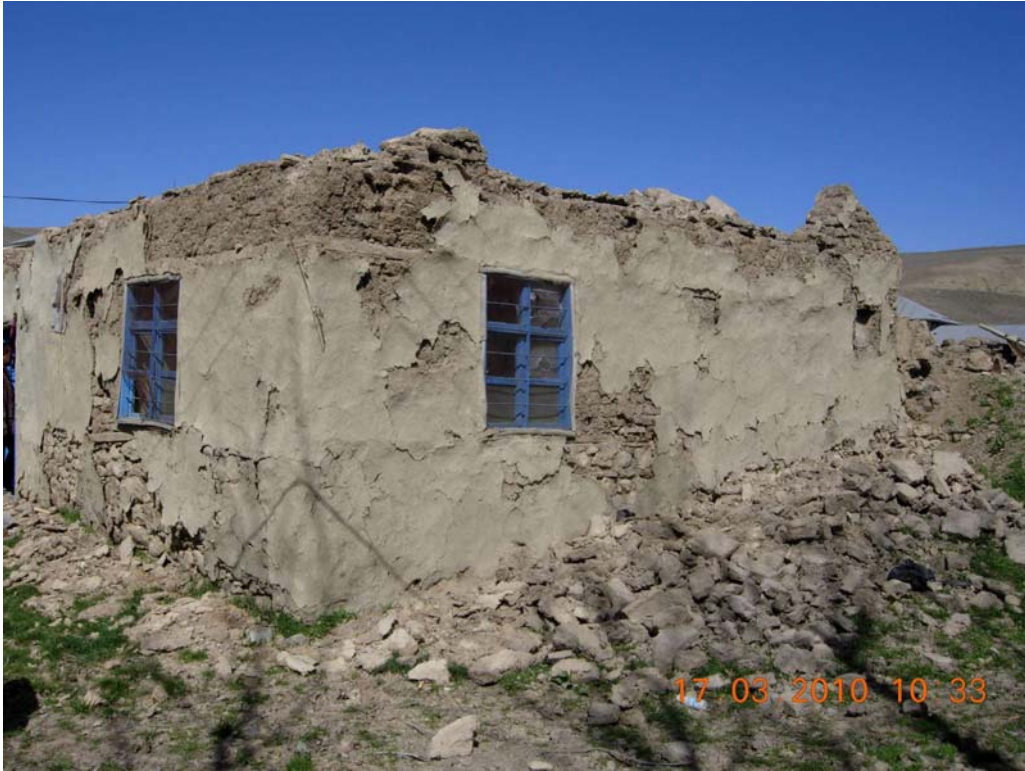
Figure 19: *One storey soil brick house in Incedal village-side view 2 (bottom part of the house, below window level is built with stones)*

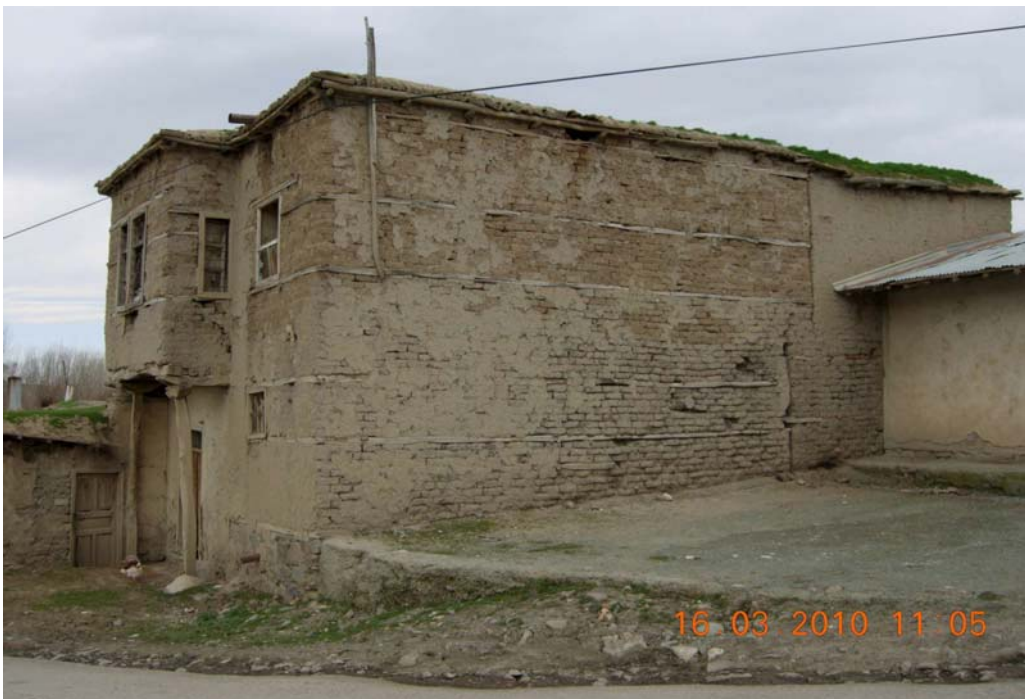
Figure 20: *Outside view of two storey soil brick house in Kökan-Bayramyazi*

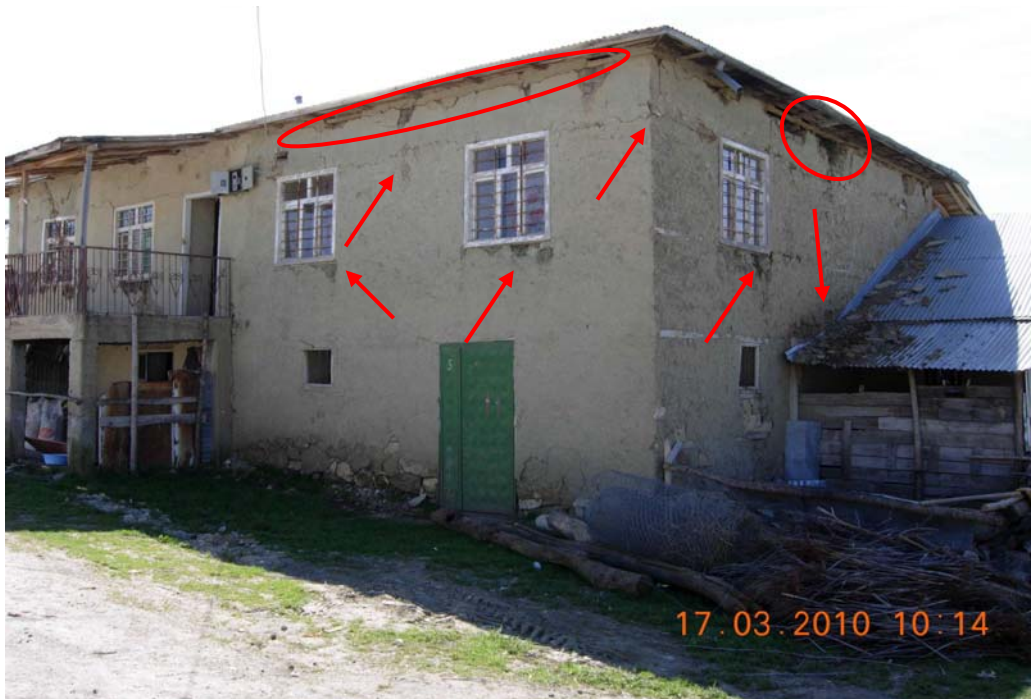
Figure 22: Two storey soil brick house in Incedal village-front view

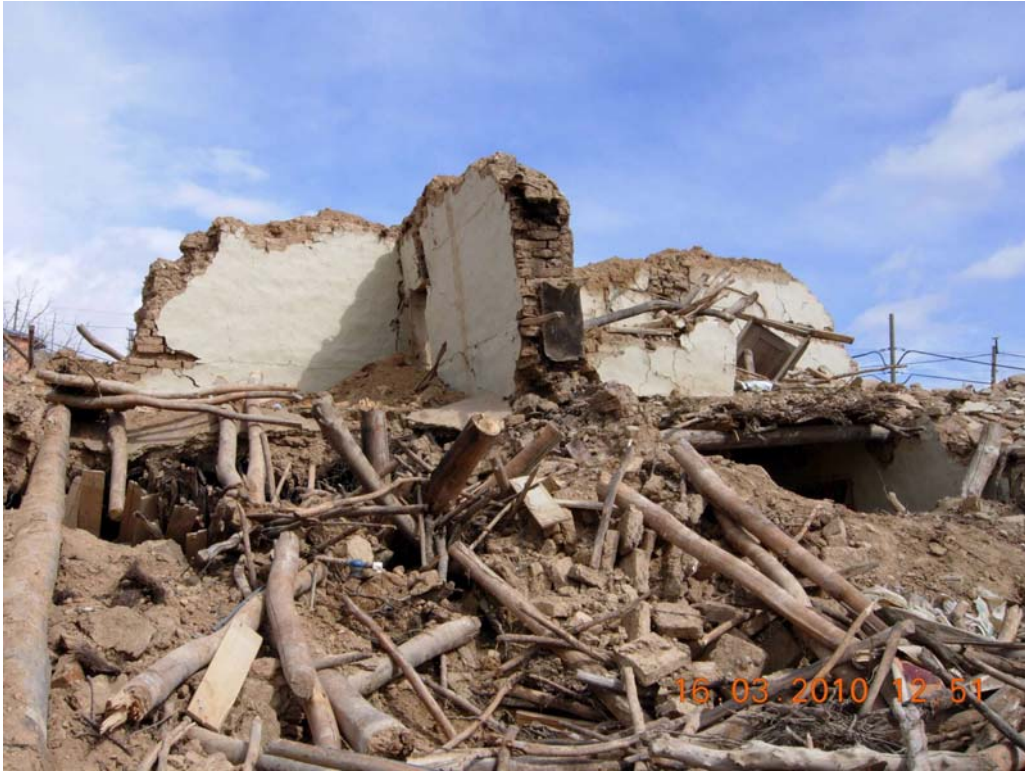
- Slabs are usually wooden, which are “simply supported” by stall floor. However, there is a lack of restraint on the slab boundaries; therefore it may be more convenient to consider them as “sliding support”. In other words, poorly constructed slabs and roofs are not capable to behave as a rigid diaphragm and transmit the lateral forces among the walls.

Figure 23: *Two storey soil brick house with a stall in the ground floor, front view, Okular*

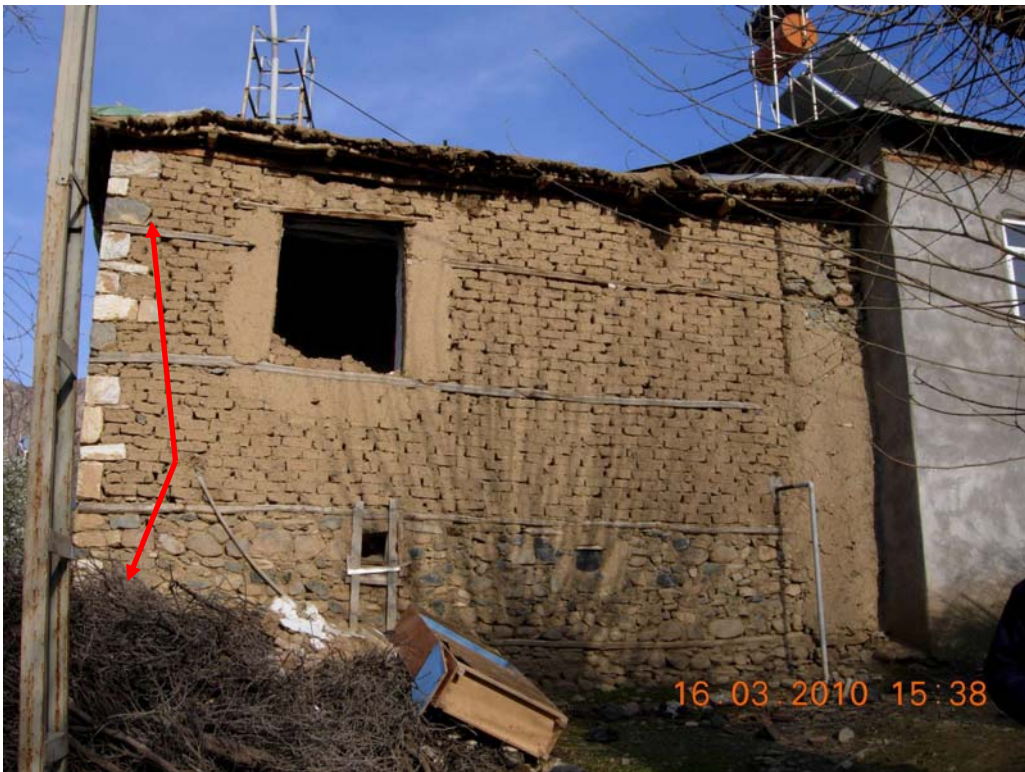
Figure 24: *Two storey soil brick house with a stall in the ground floor (only lintel application ever seen in that area), side view, Beyhani*

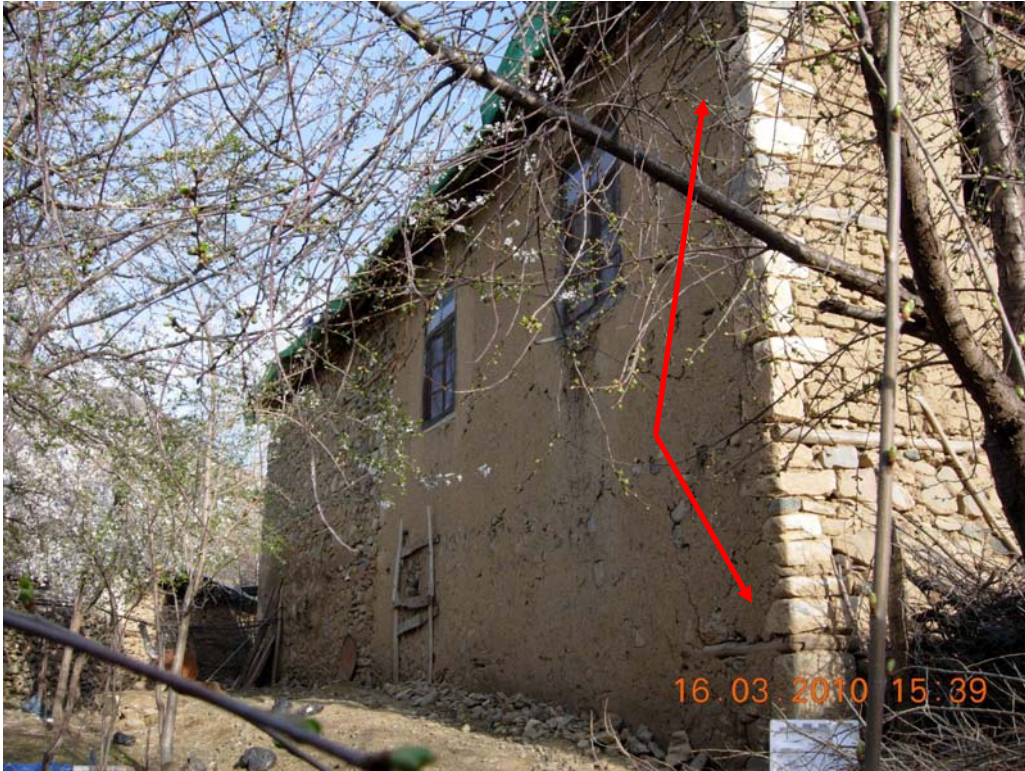
Figure 25: Two storey soil brick house with a stall in the ground floor (only lintel application ever seen in that area), side view, Beyhani

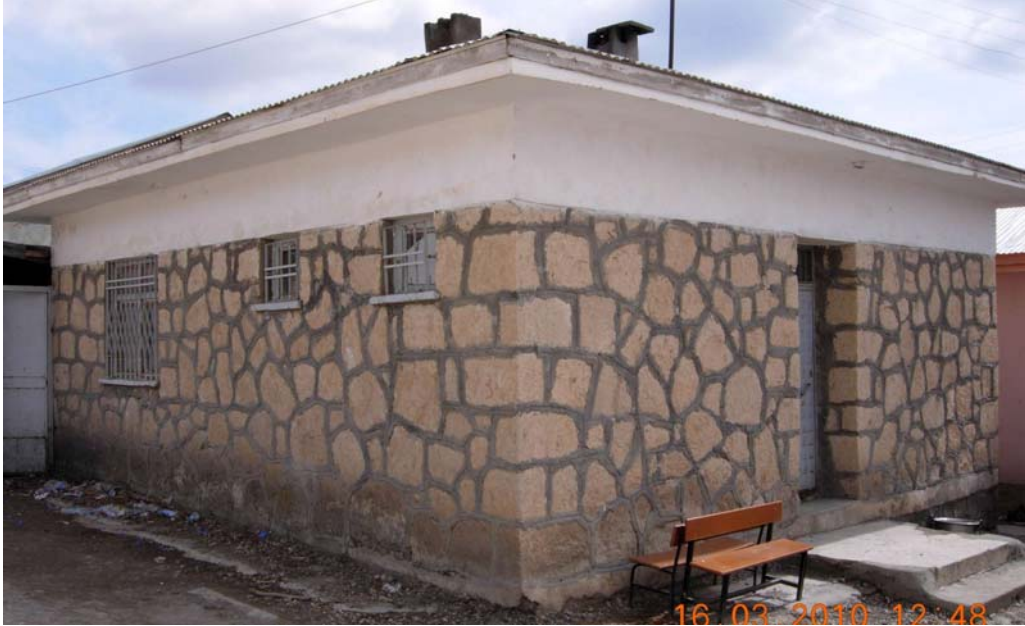
Figure 26: *One story typical school building, Okcular village*

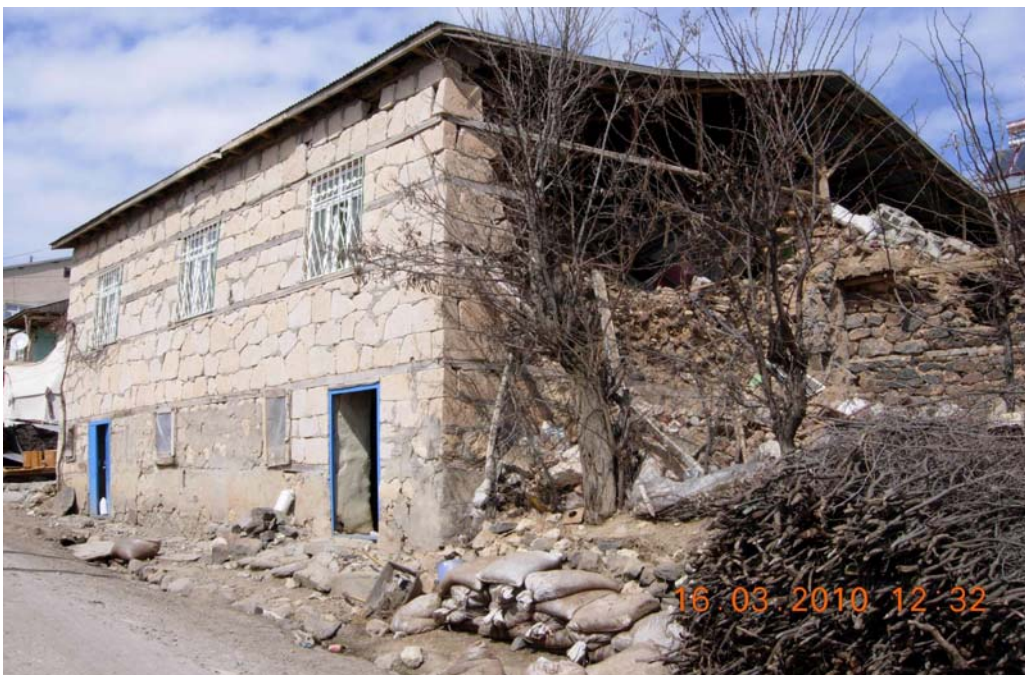
Figure 27: *Two storey light stone house, with a stall as ground floor, Okcular village*

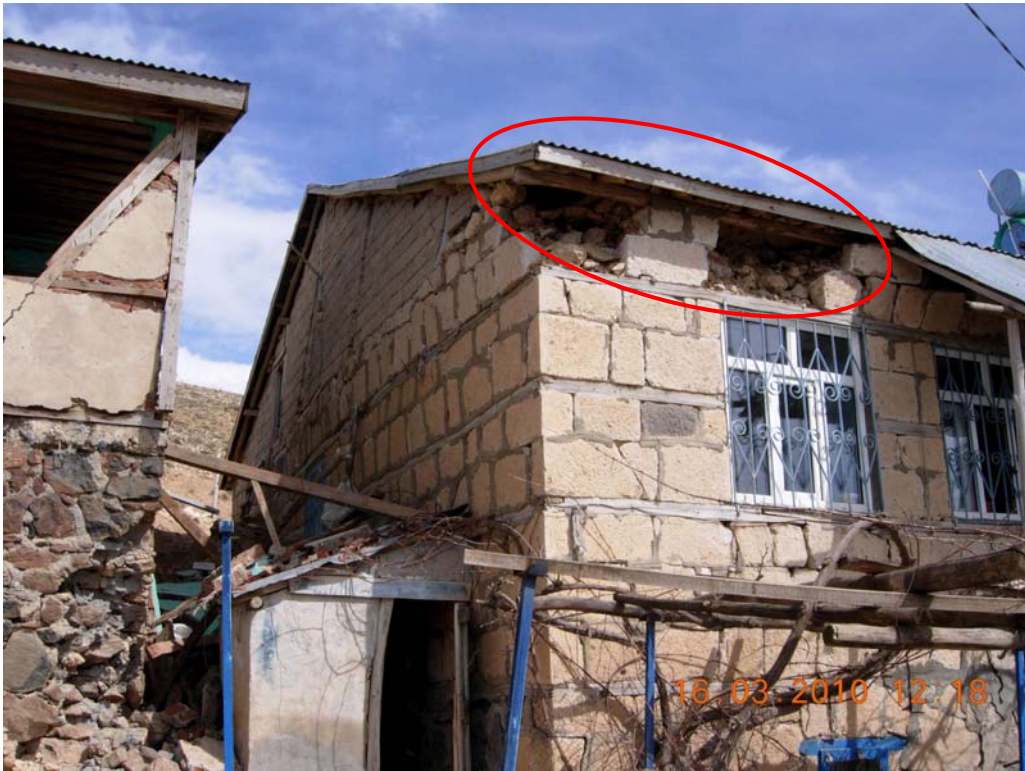
Figure 28: Upper floor of two storey light stone house, with a stall as ground floor, Okcular village

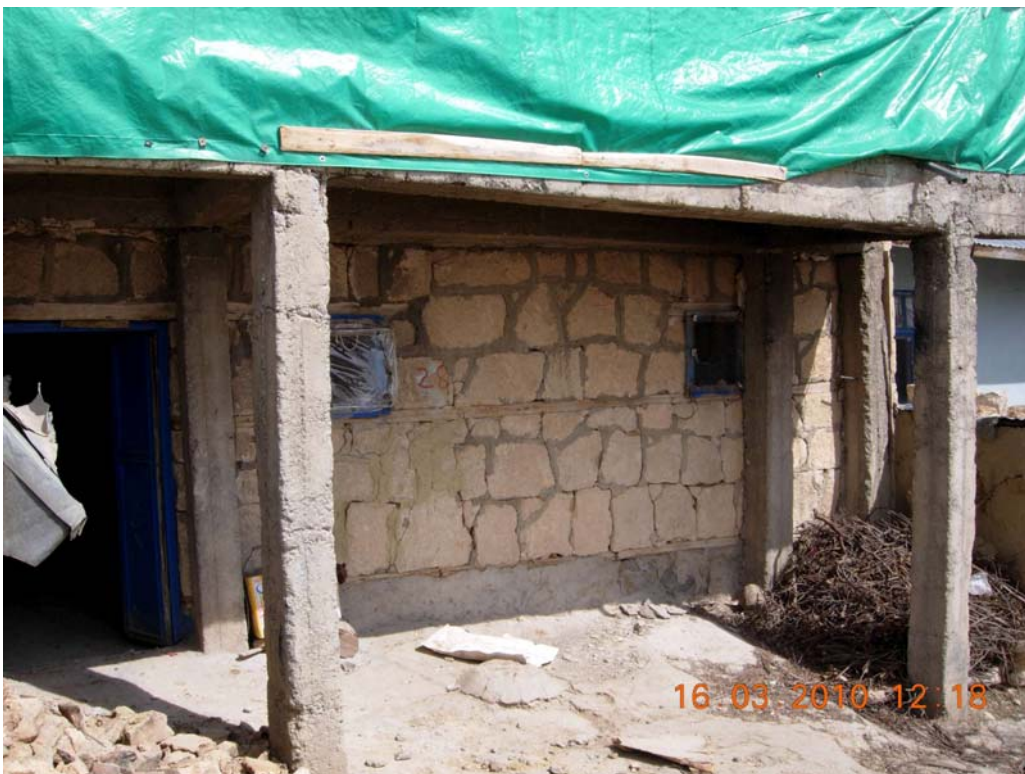
Figure 29: Ground floor of two storey light stone house, with a stall as ground floor, Okcular village

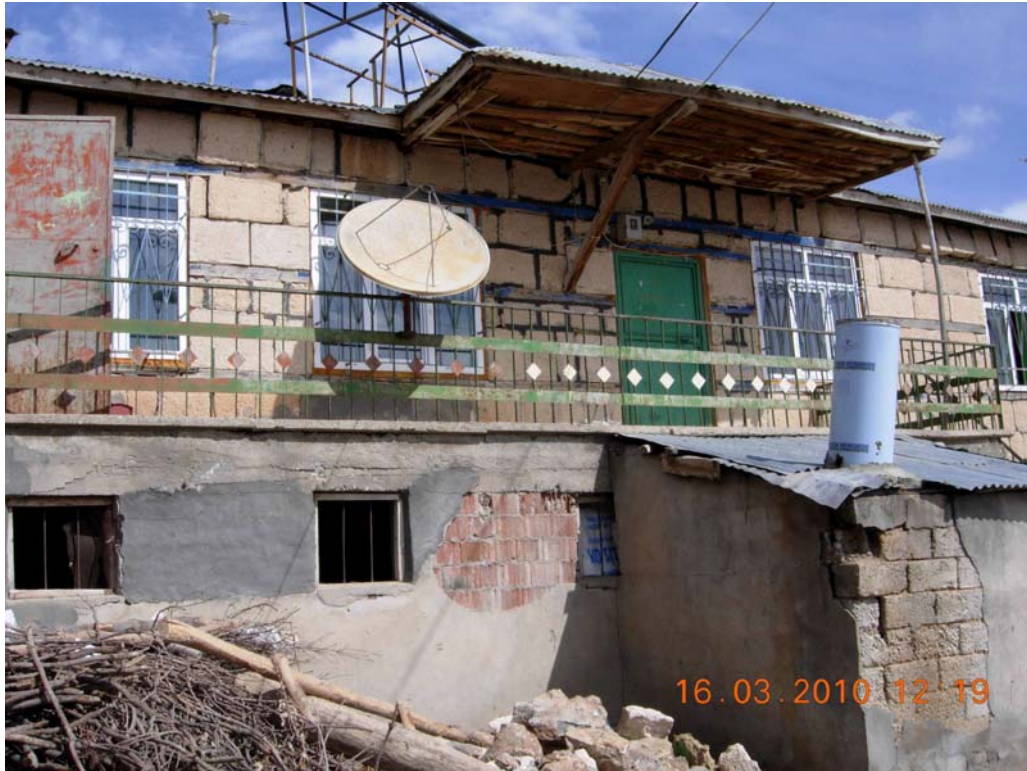
Figure 30: *Two storey light stone house, with a stall as ground floor, Okcular village*

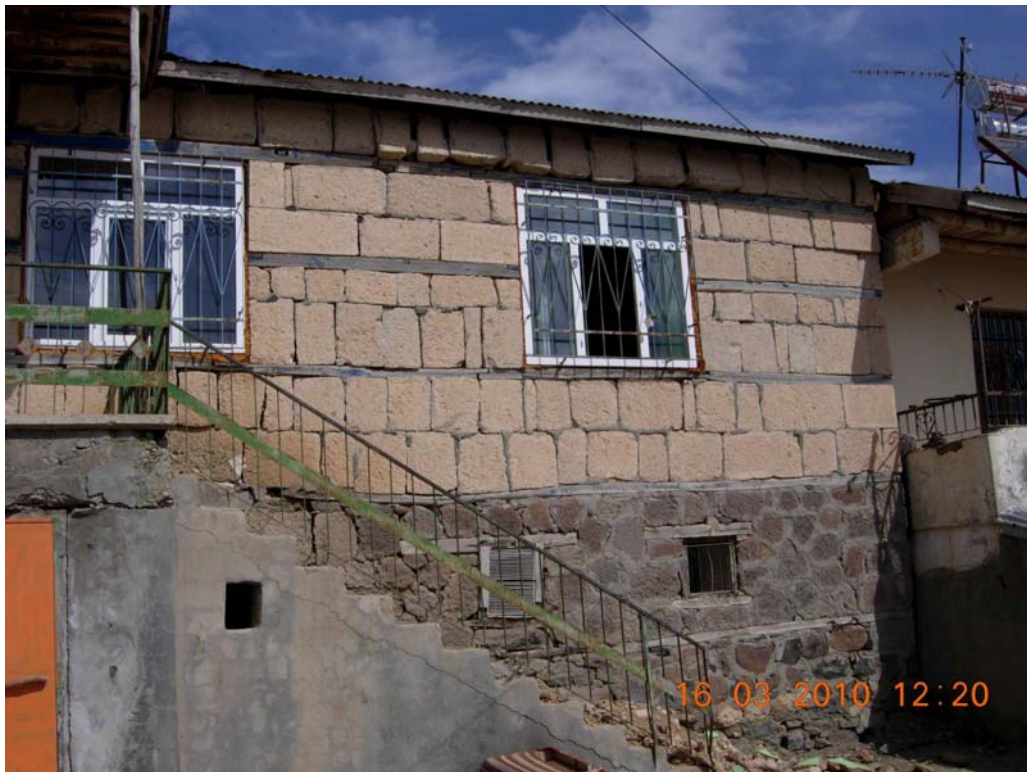
Figure 31: *Two storey house, with a combination of heavy stones in the ground floor, and light stones in the upper floor, Okcular village*

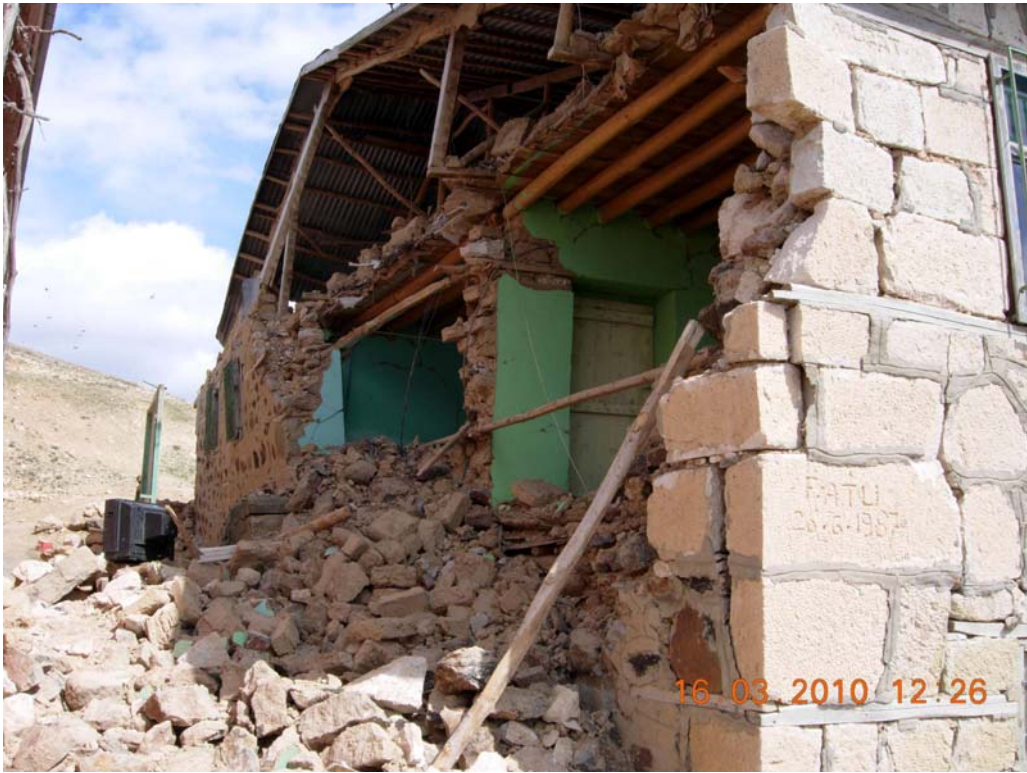
Figure 32: *Two storey light stone house, constructed in 1987, Okcular village*

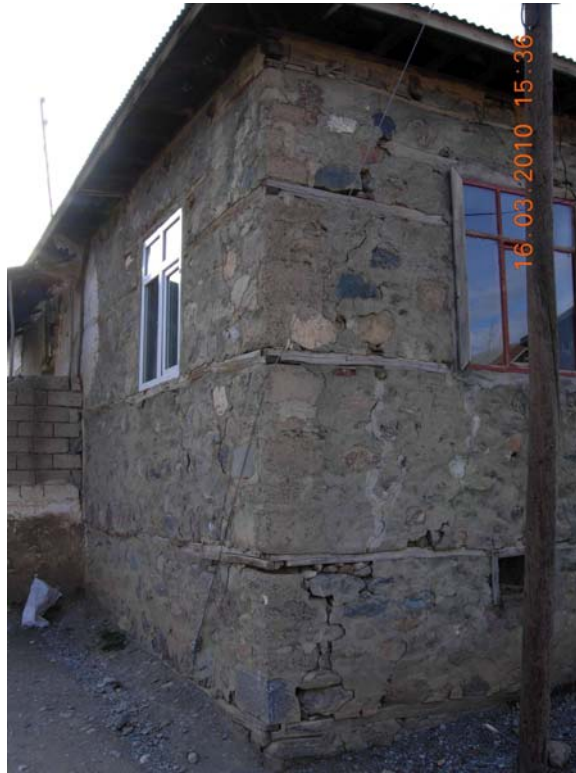
Figure 36: *Two storey heavy stone house, side view, Beyhani*

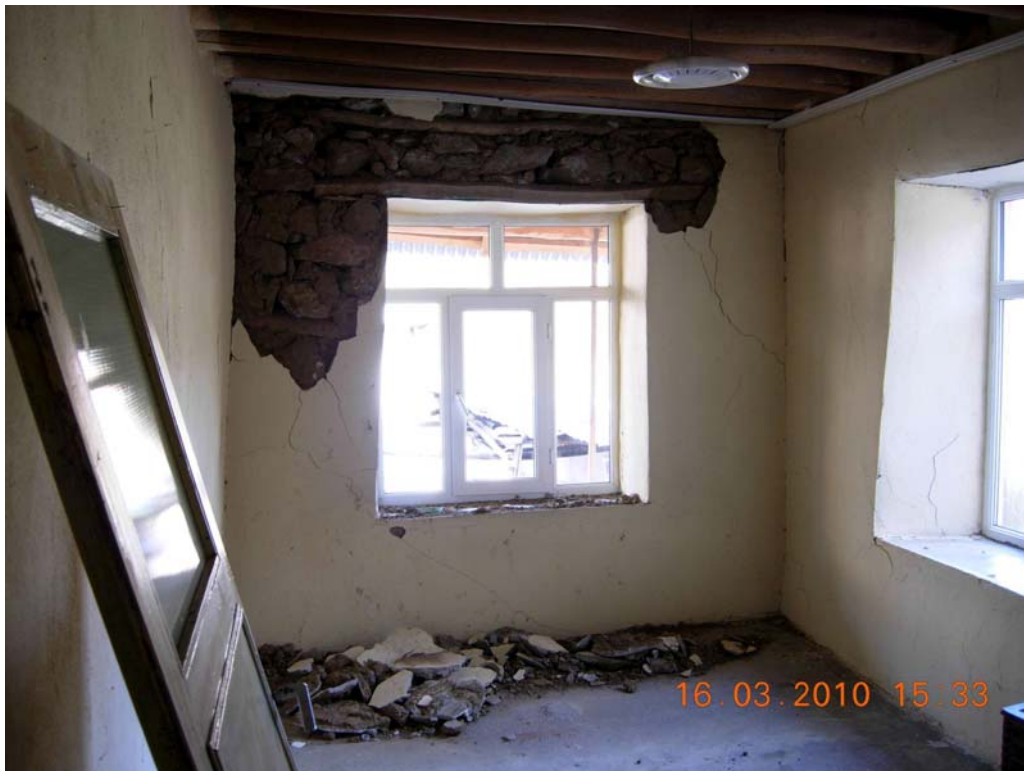
Figure 37: *Two storey heavy stone house, inside view, Beyhani*

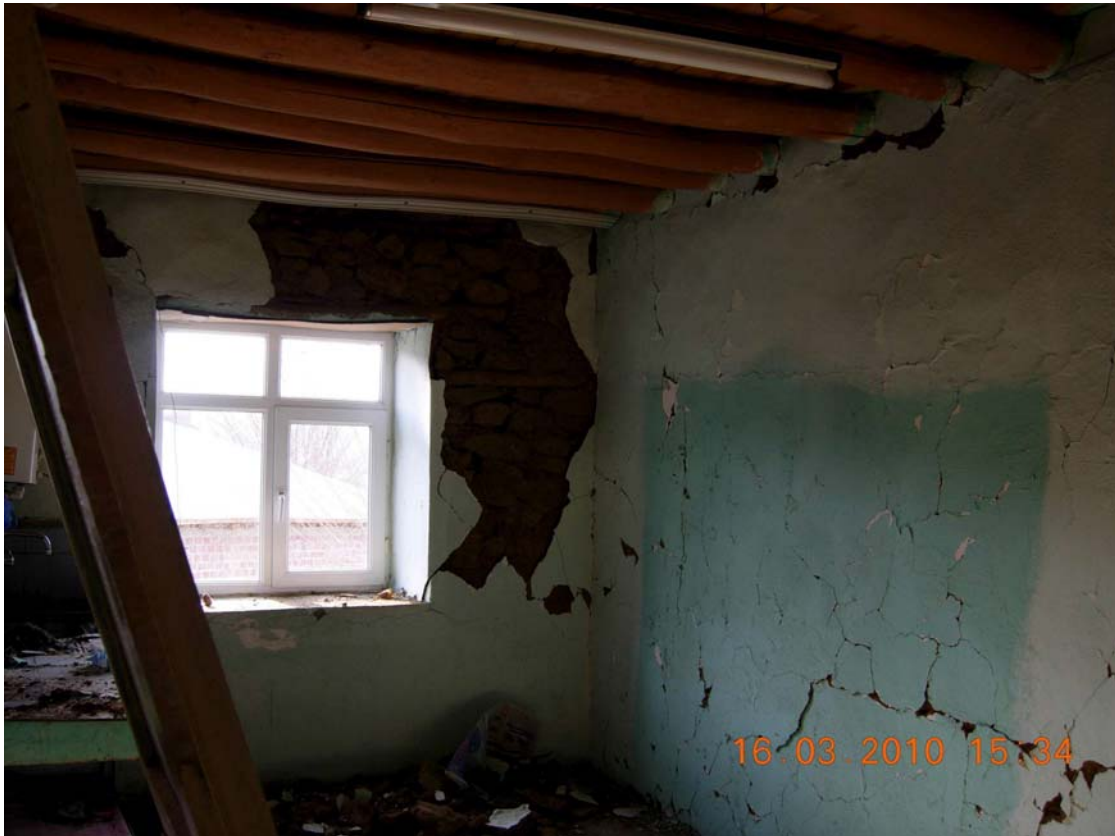
Figure 38: *Two storey heavy stone house, inside view, Beyhani*

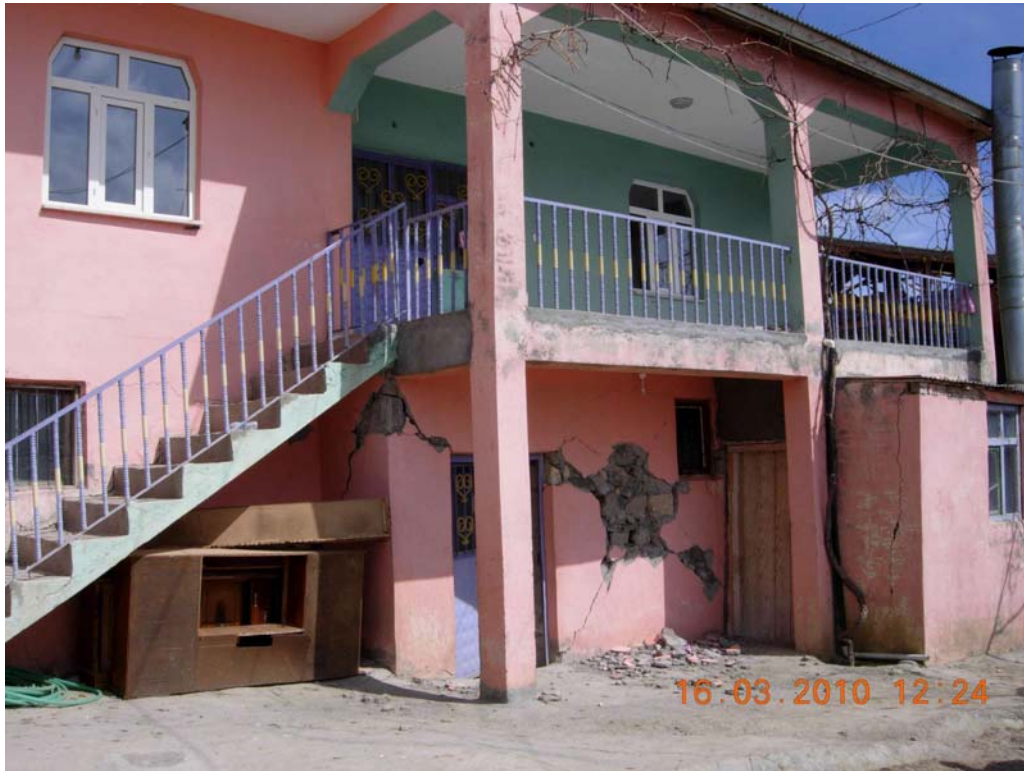
Figure 39: *Outside view of two storeys mixed structural system, Okcular village*

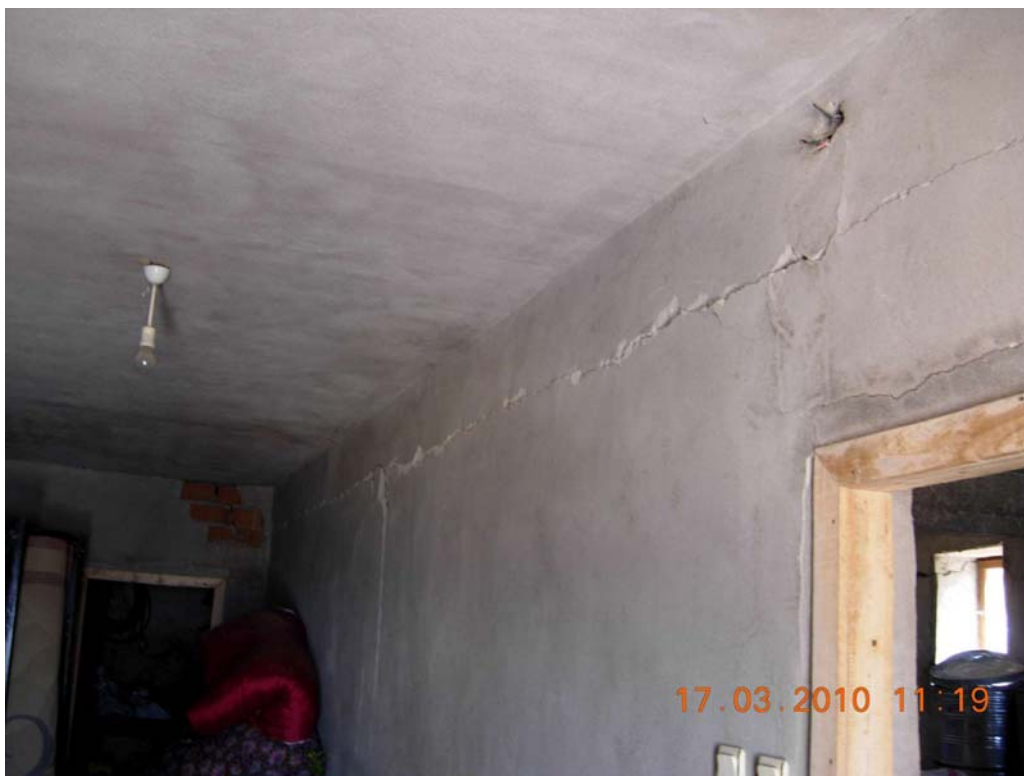
Figure 40: *Inside view of two storeys mixed structural system, RC beam, RC slab, infill brick wall, Okcular village*

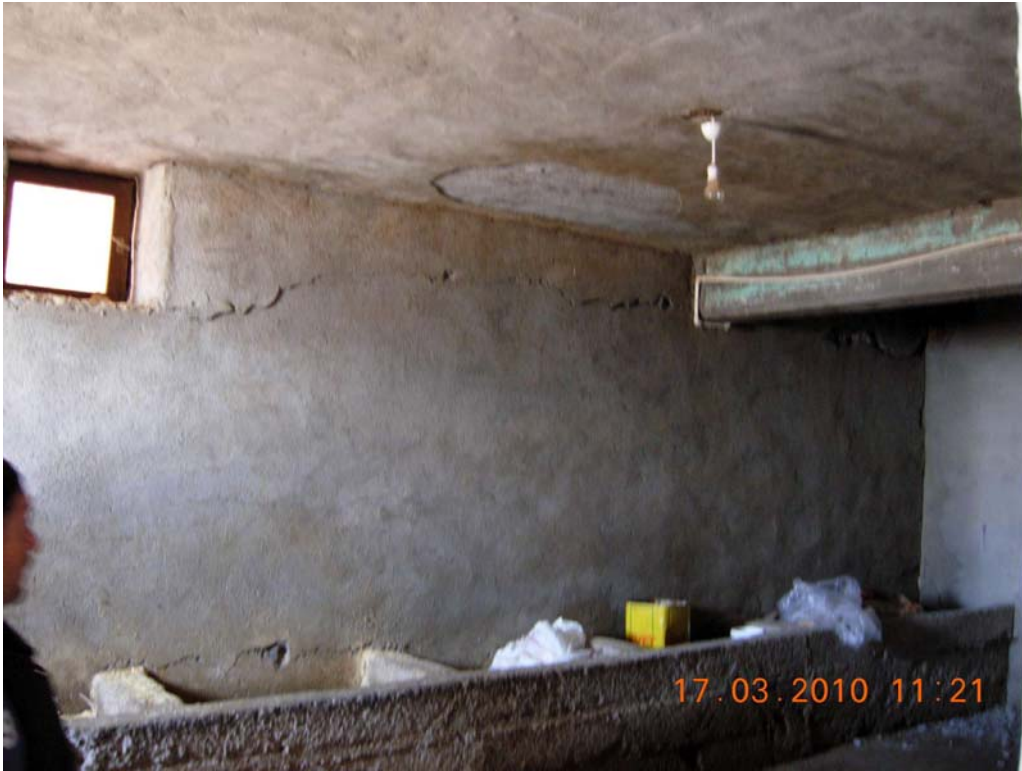
Figure 41: *Inside view of two storeys mixed structural system, RC beam, RC slab, heavy stone wall, Okular village*

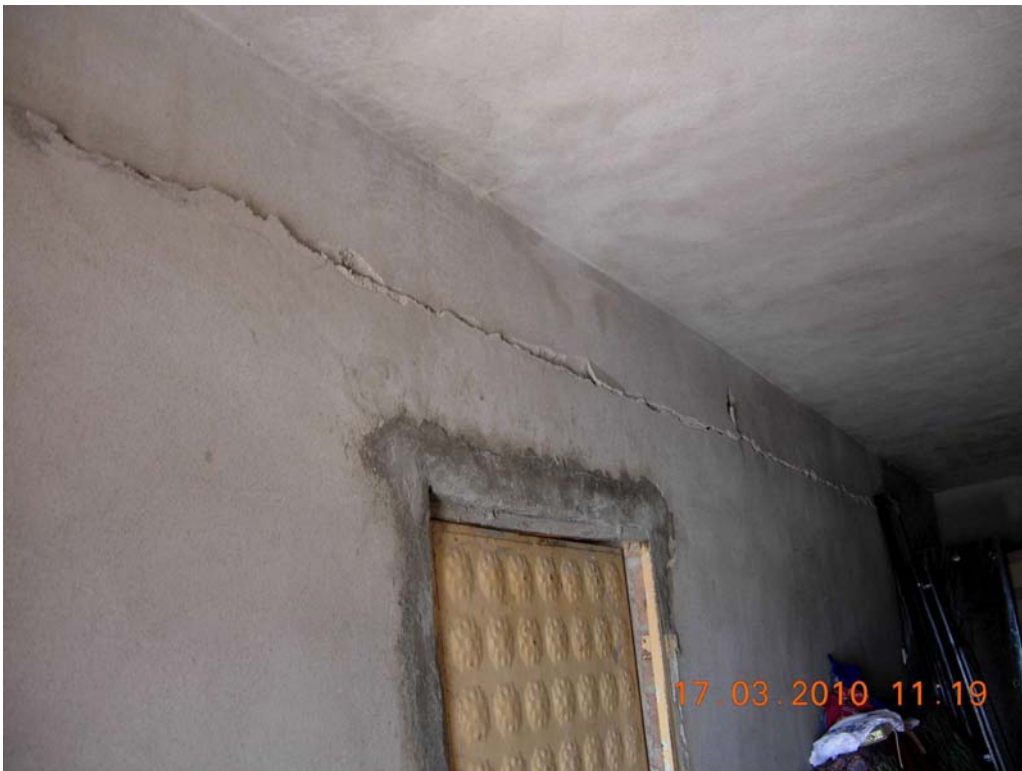
Figure 42: *Inside view of two storeys mixed structural system, RC beam, RC slab, heavy stone wall, Okular village*

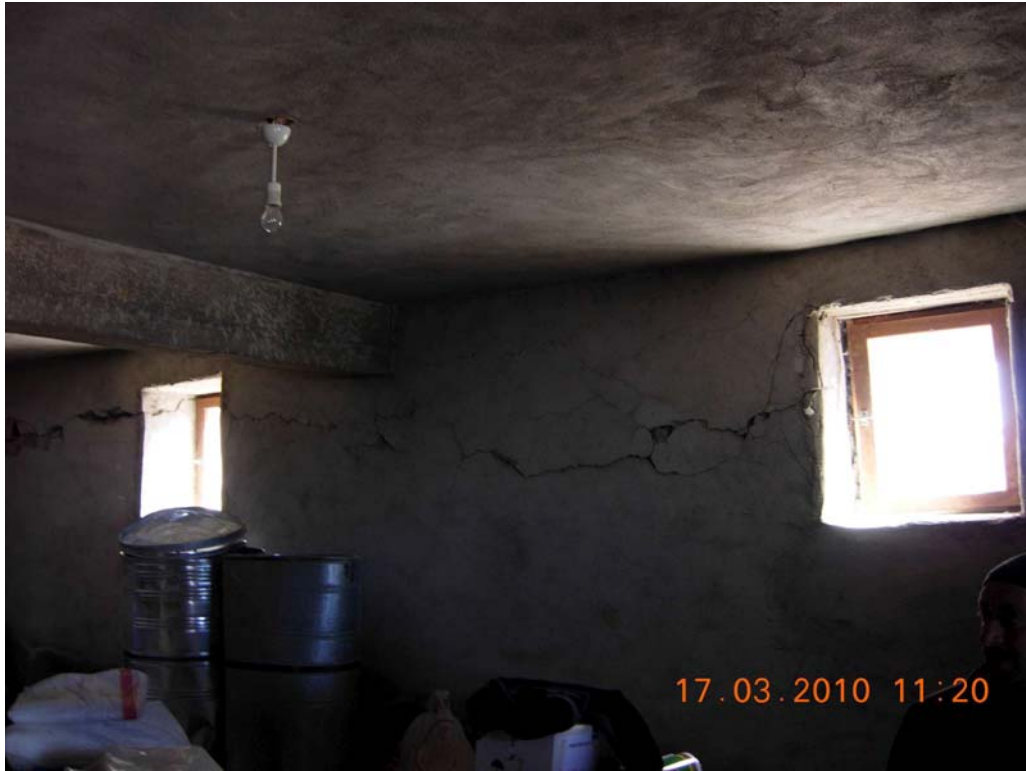
Figure 43: *Inside view of two storeys mixed structural system, RC beam, RC slab, heavy stone wall, Okcular village*

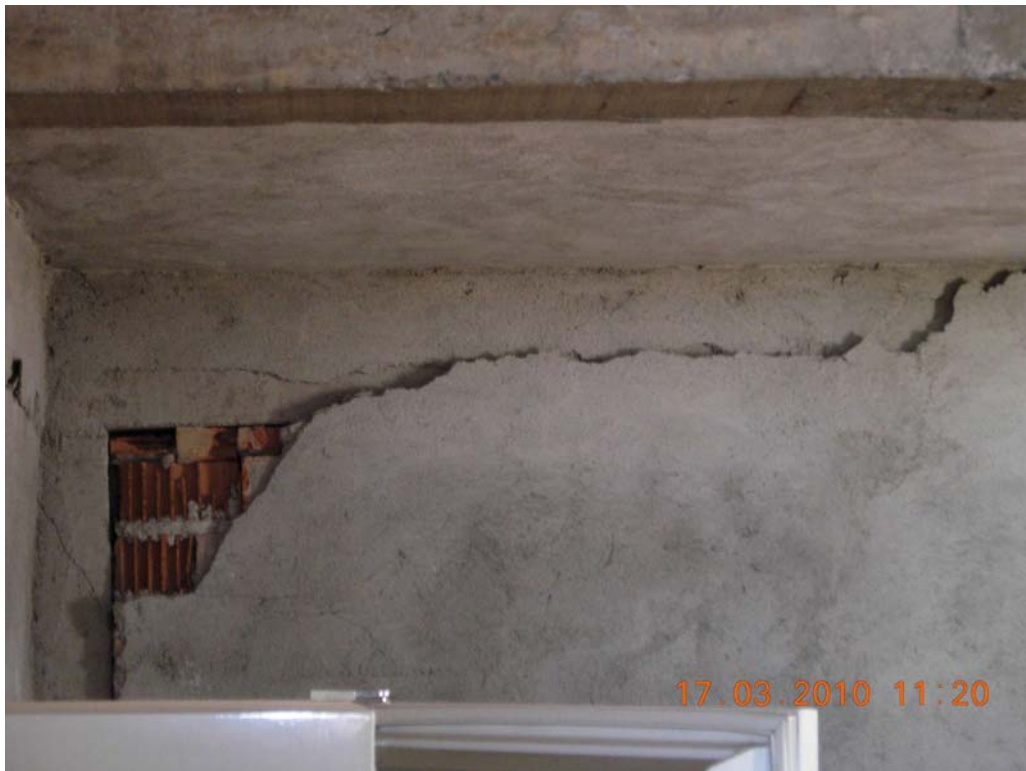
Figure 44: *Inside view of two storeys mixed structural system, RC beam, RC slab, heavy stone wall, Okcular village*

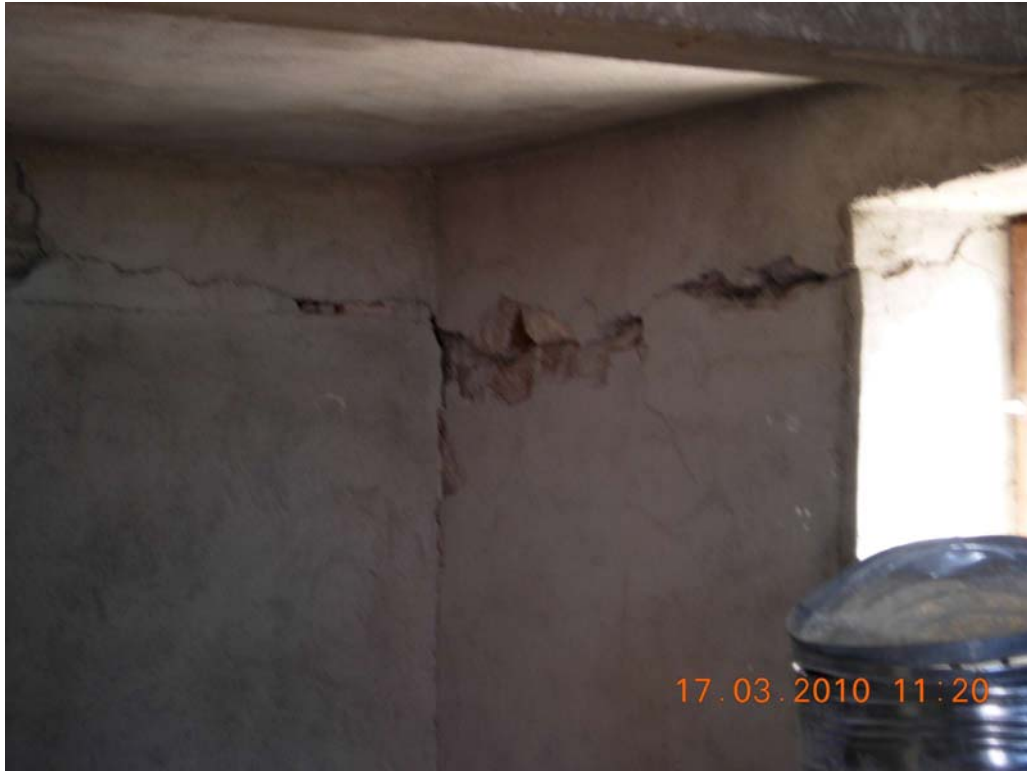
Figure 45: *Inside view of two storeys mixed structural system, RC beam, RC slab, heavy stone wall, Okular village*

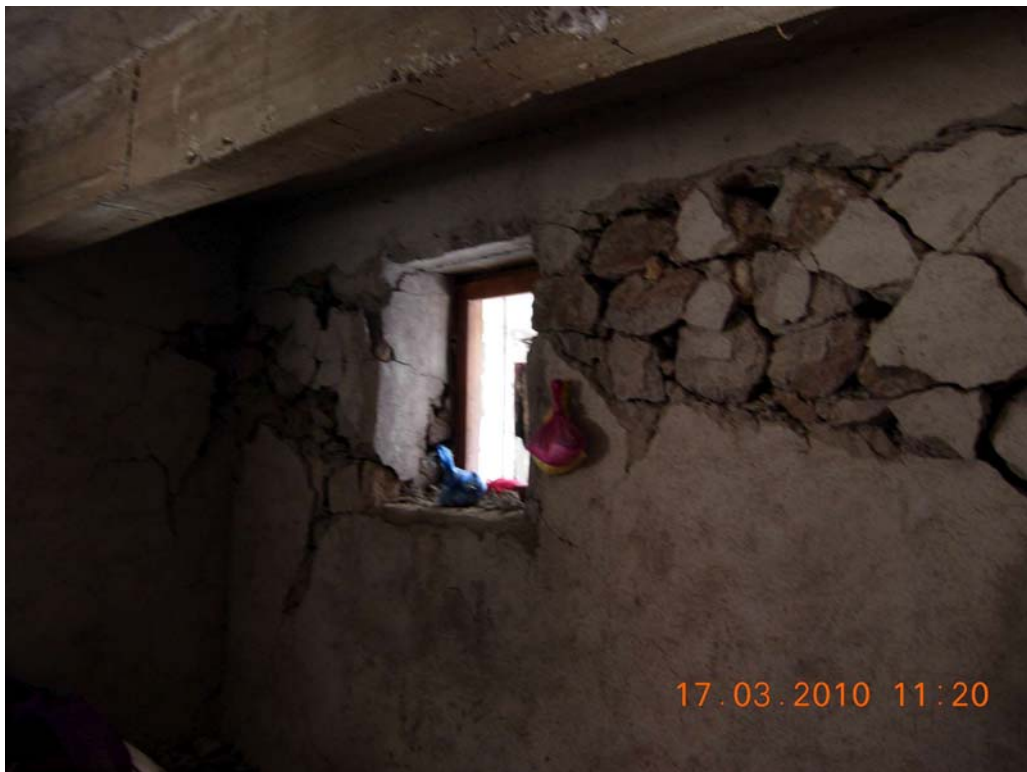
Figure 46: *Inside view of two storeys mixed structural system, RC beam, RC slab, heavy stone wall, Okular village*

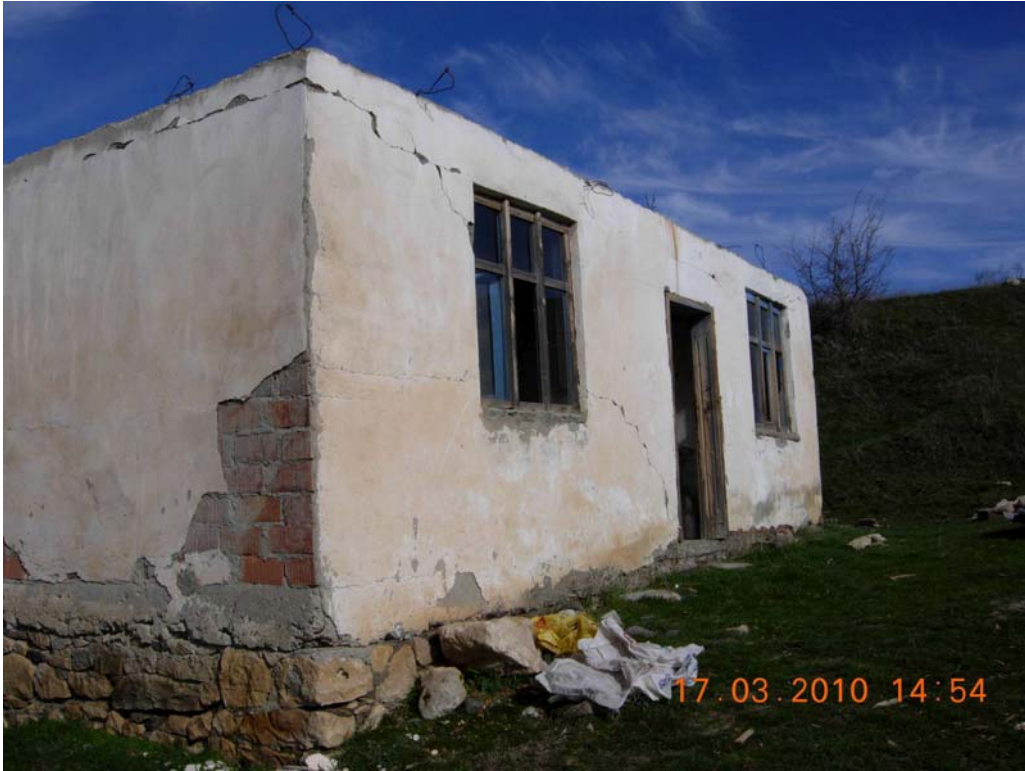
Figure 47: *One storey house, built with infill bricks, Aşağıkanathı village*

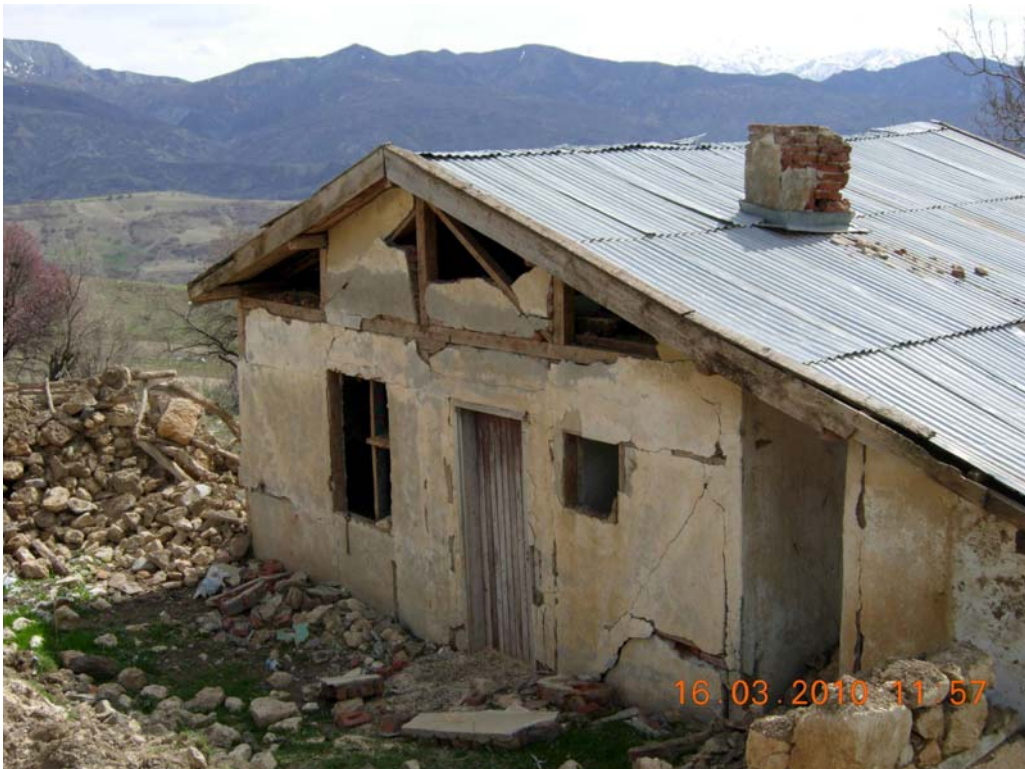
- Another building type, which is constructed with refractory bricks, is single story houses, constructed after 1971 Bingol earthquake. In higher altitude villages, these houses were constructed with refractory bricks and timber crosses, while in the lower altitude villages, material is prefabricated panels, having glass fibres inside for heating isolation. However, these small houses have not been renewed, so most of them have been being used as storage rooms. Although most of them seem heavily damaged depending on earthquakes over years, as well as lack of renovation, it is possible to see many of these houses standing after earthquake with partial collapses or without any collapse...

Figure 60: *Refractory brick houses built after 1971 Bingol earthquake, Yukarıkanatlı village*

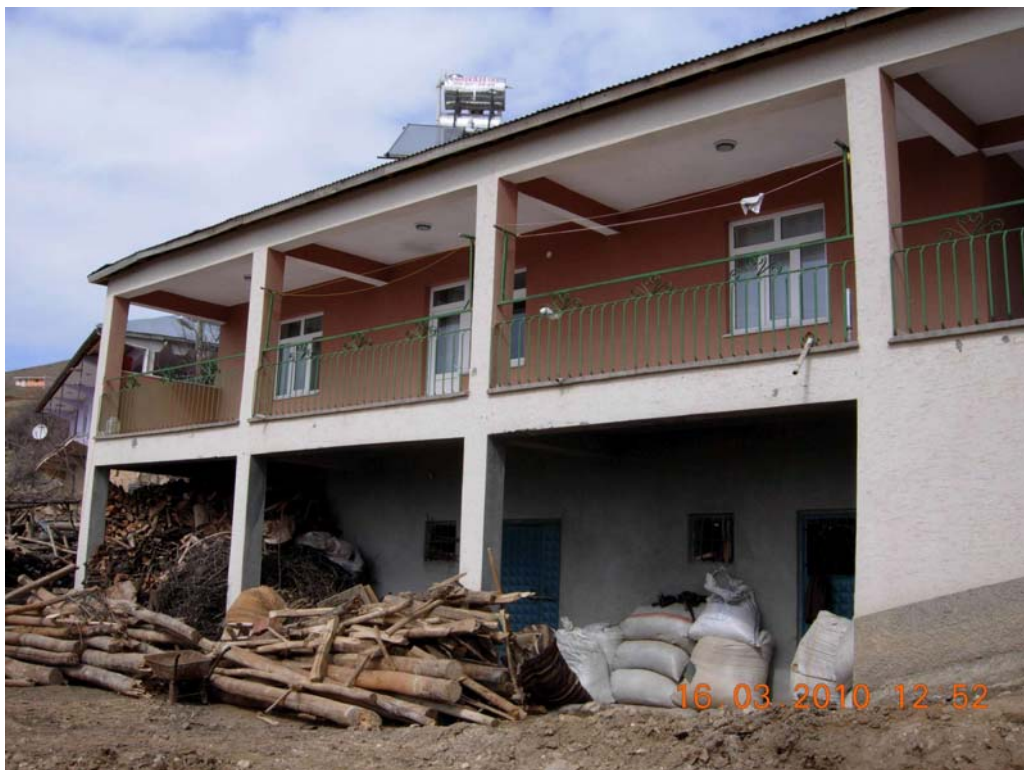
Figure 64: RC house, without any damage in beam-column joints, Okcular village
