**KANDİLLİ OBSERVATORY and EARTHQUAKE
RESEARCH INSTITUTE**

***March 08, 2010 BAŞYURT-KARAKOÇAN
(ELAZIĞ) EARTHQUAKE***

**Prepared by; Dr. Doğan Kalafat
Dr. Can Zülfikar
Res. Assist. Eren Vuran
Res. Assist. Yaver Kamer**

**March, 2010
İSTANBUL**

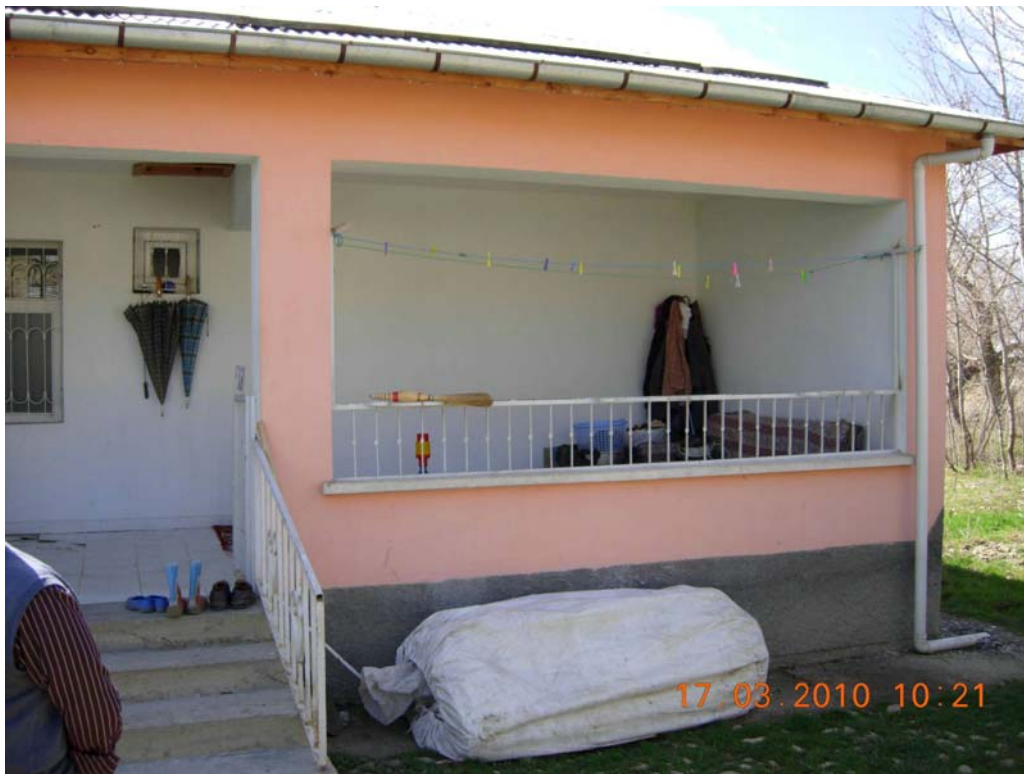
- Most of them are standing without any damage after earthquake. However, some minor damages are visible in few of these RC houses, such as the ones suffered from differential settlements in Incedal, which is a village constructed on saturated soft soil conditions.

Figure 67: RC house, built by government, after 2003 Bingol earthquake, Incedal village

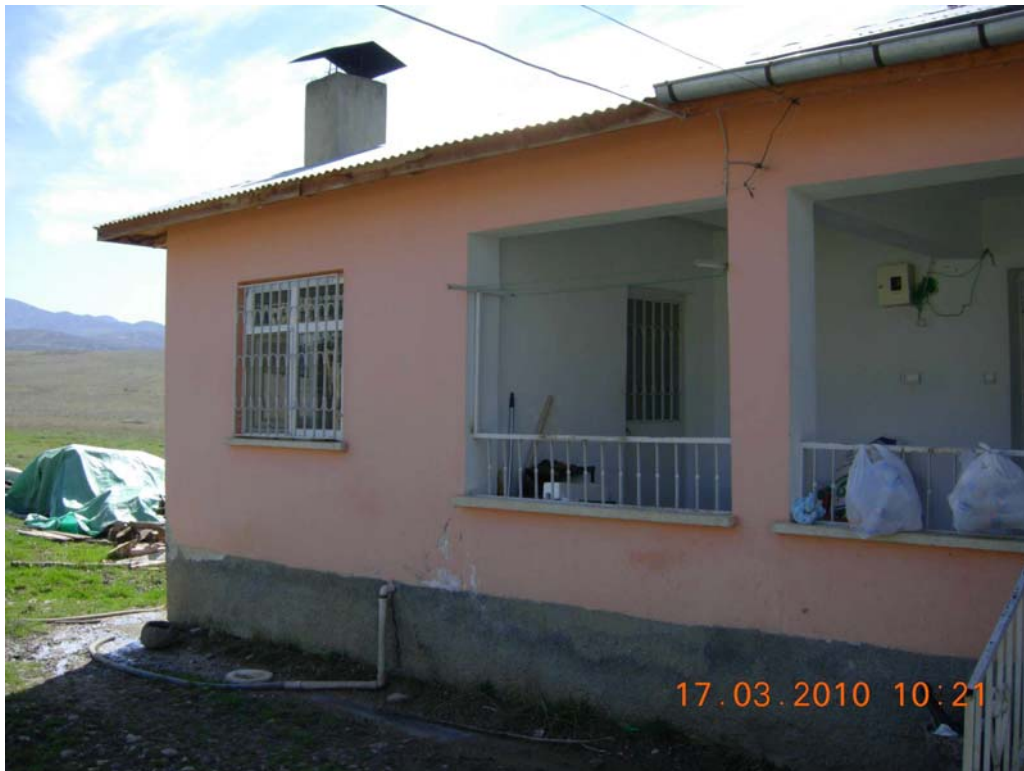
Figure 68: RC house, built by government, after 2003 Bingol earthquake, Incedal village

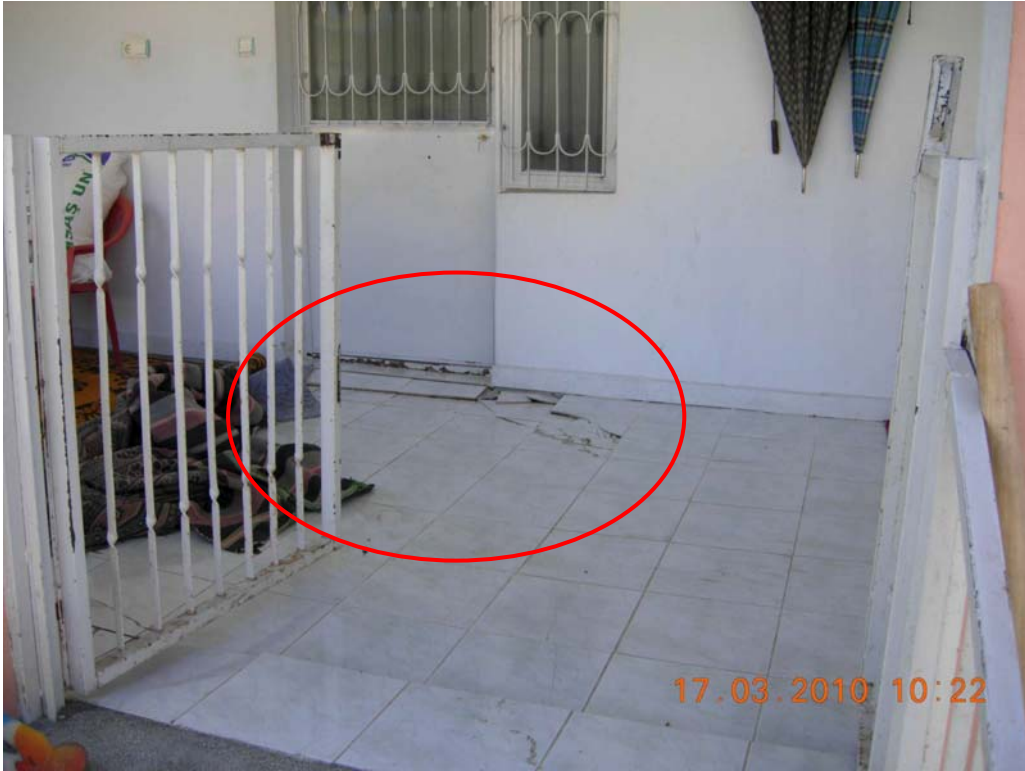
Figure 69: RC house, built by government, after 2003 Bingol earthquake, Incedal village

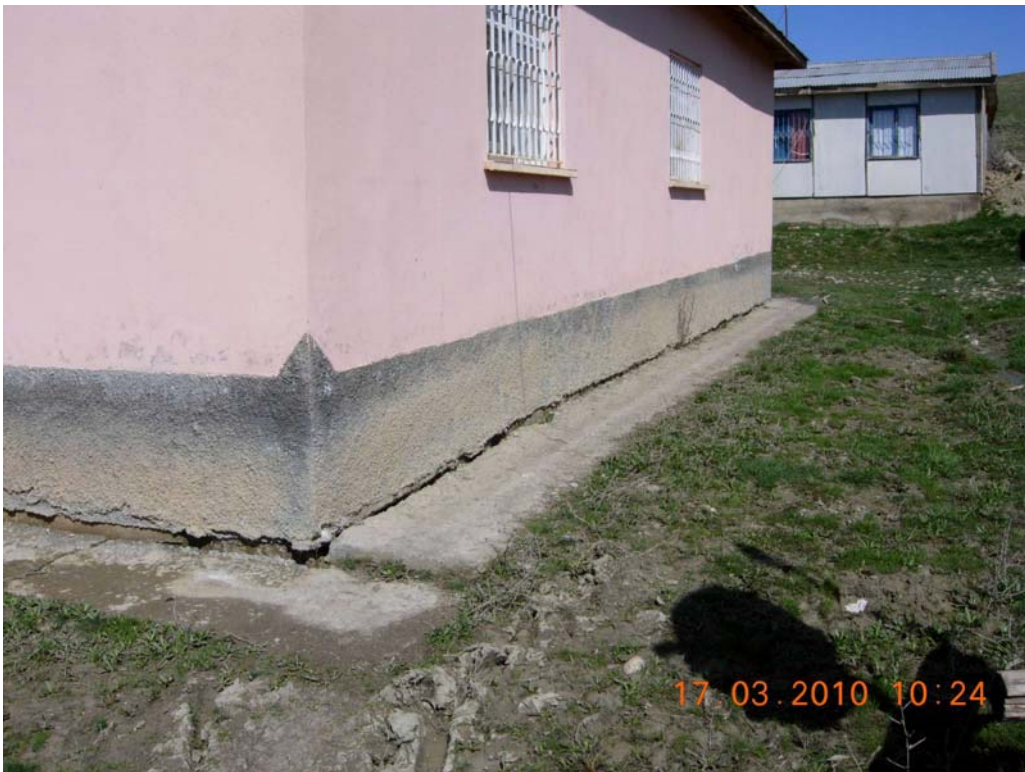
Figure 70: RC house, built by government, after 2003 Bingol earthquake, Incedal village

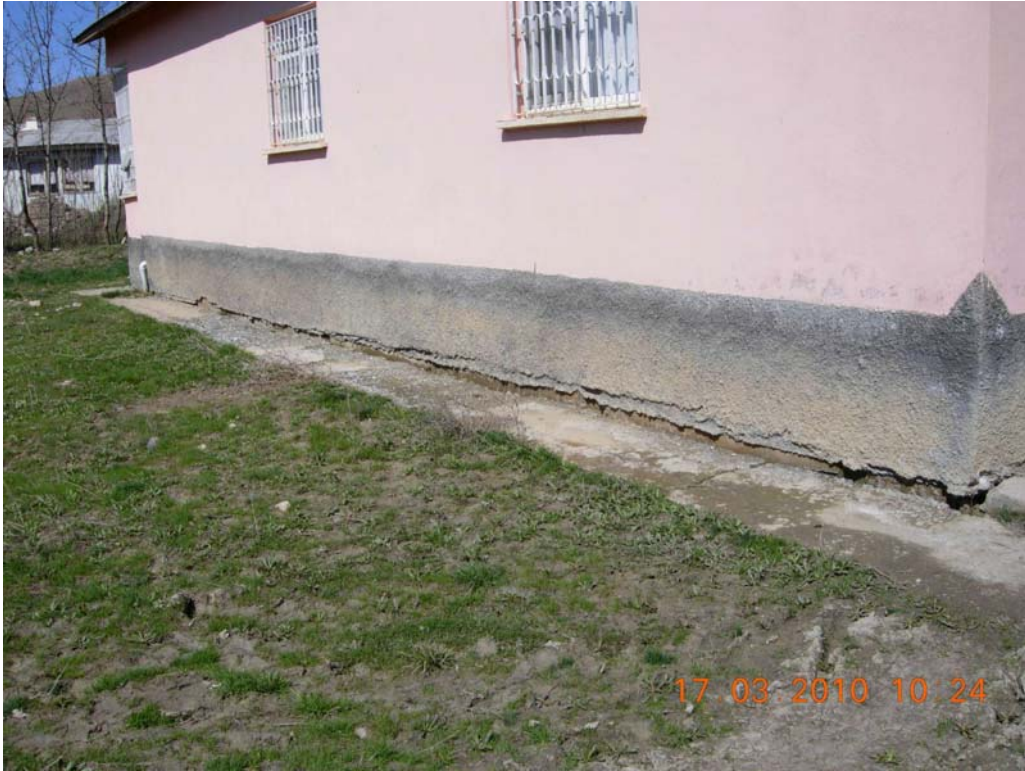
Figure 71: *RC house, built by government, after 2003 Bingol earthquake, Incedal village*

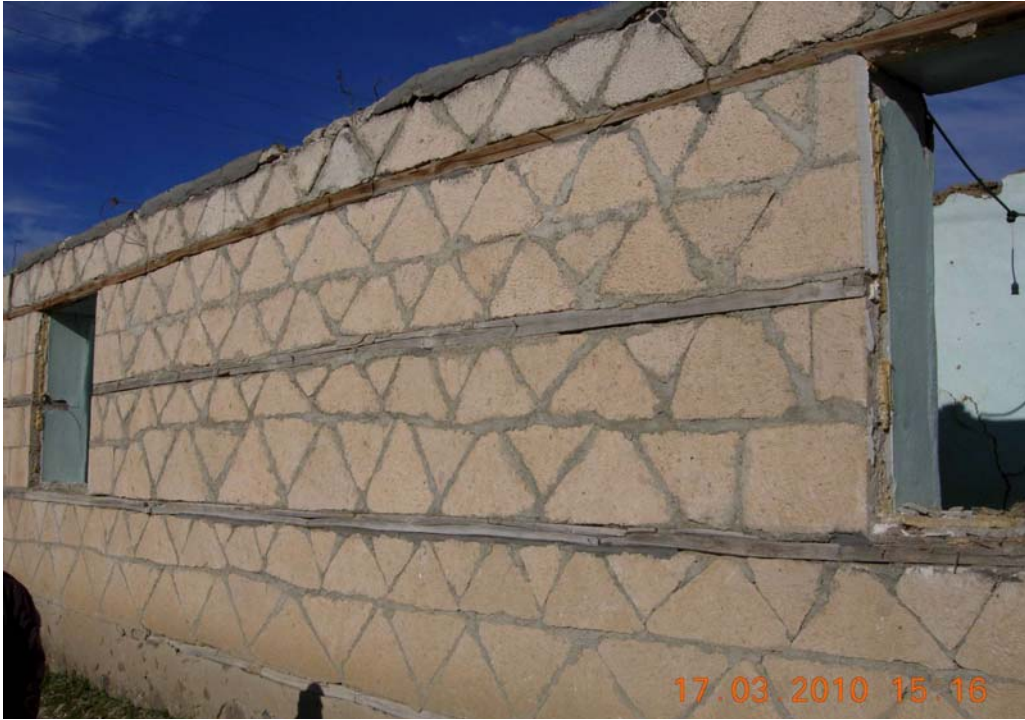
Figure 85: *Single example of properly arranged, layered, triangular shaped, one story house, inside walls are soil bricks, Tabanözü village*

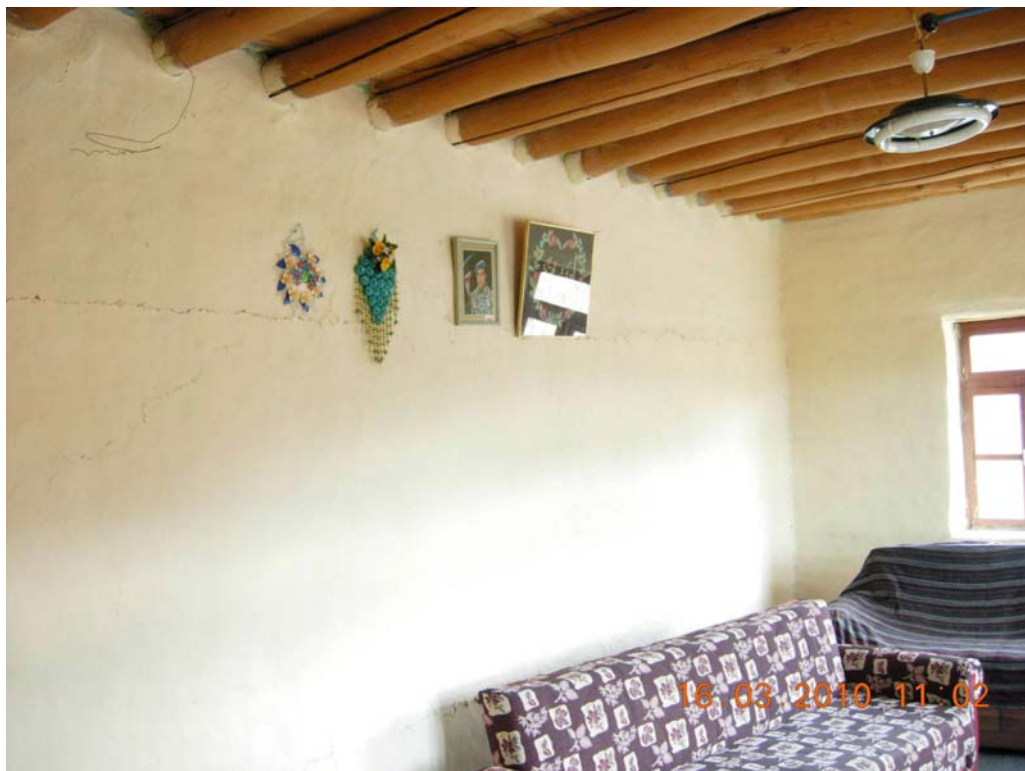
Figure 88: Inside view of two storey soil brick house in Kökan-Bayramyazı-2

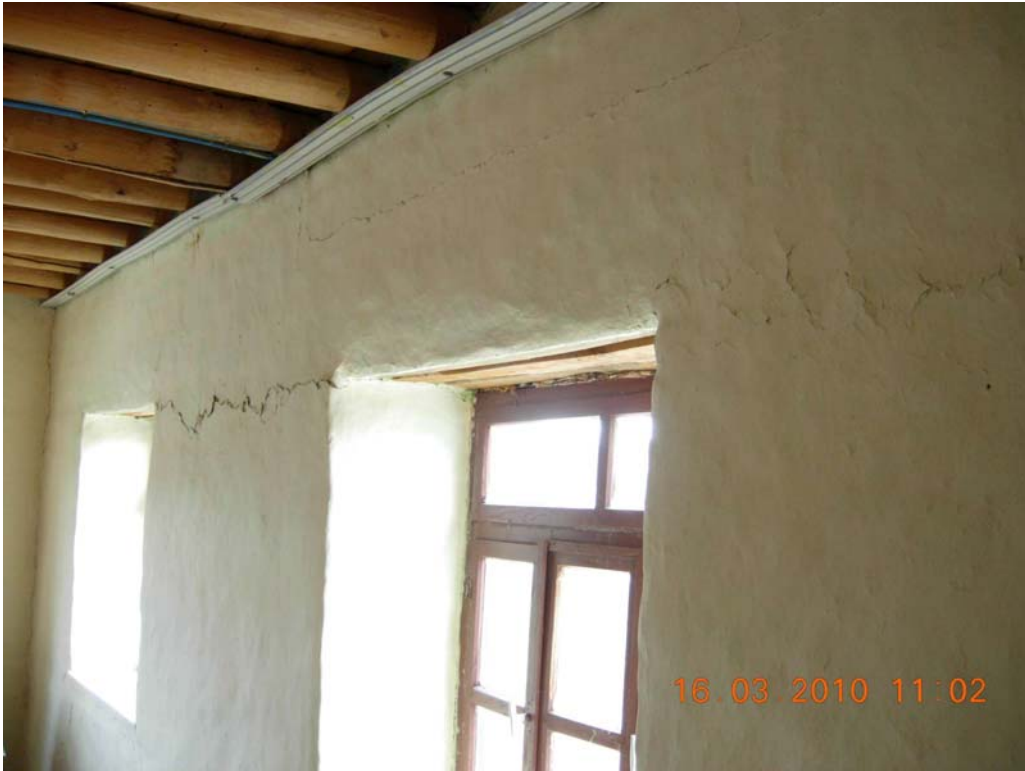
Figure 89: *Inside view of two storey soil brick house in Kökan-Bayramyazı-3*

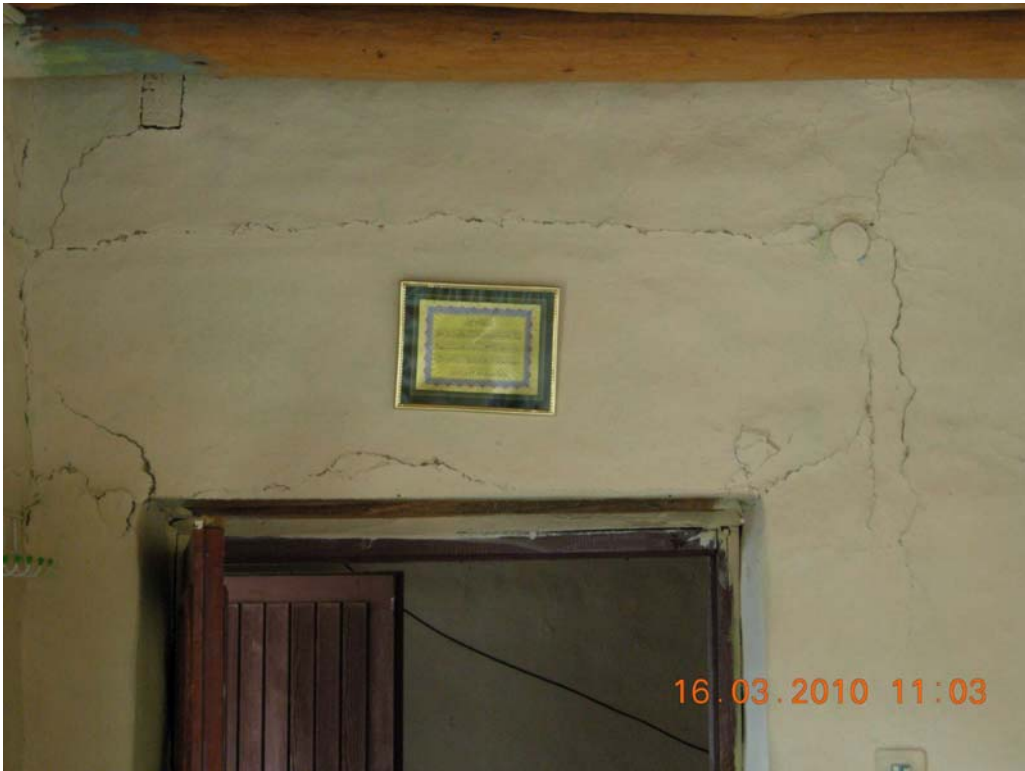
Figure 91: *Inside view of two storey soil brick house in Kökan-Bayramyazı-5*

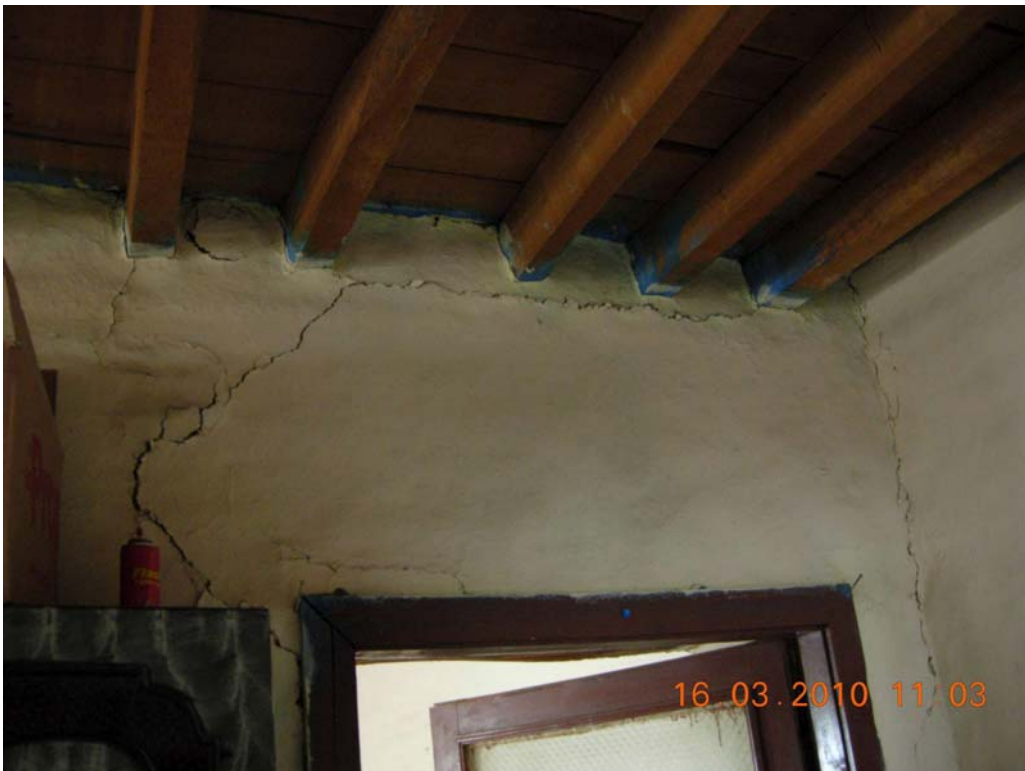
Figure 92: *Inside view of two storey soil brick house in Kökan-Bayramyazı-6*

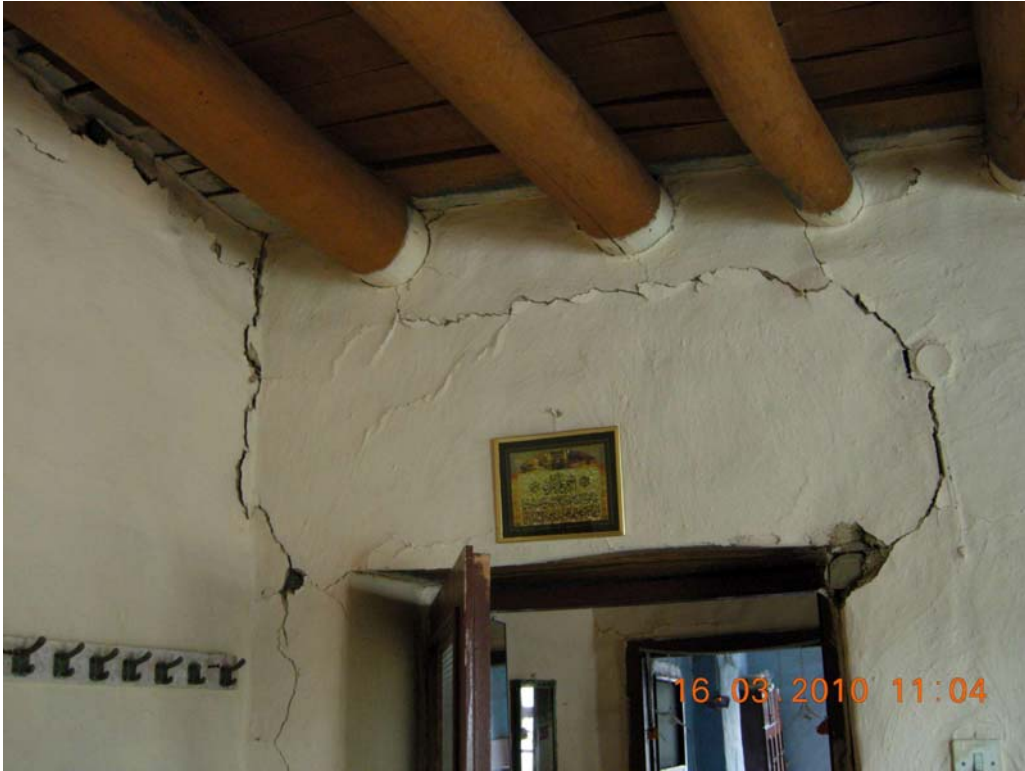
- In the following nine figures, damage patterns on walls of a two storey sun-dried soil brick house are shown. Heavy damage is not so obvious from outside, however, inside pictures show the inconvenience for usage.

Figure 93: *Inside view of two storey soil brick house in Kökan-Bayramyazi-7*

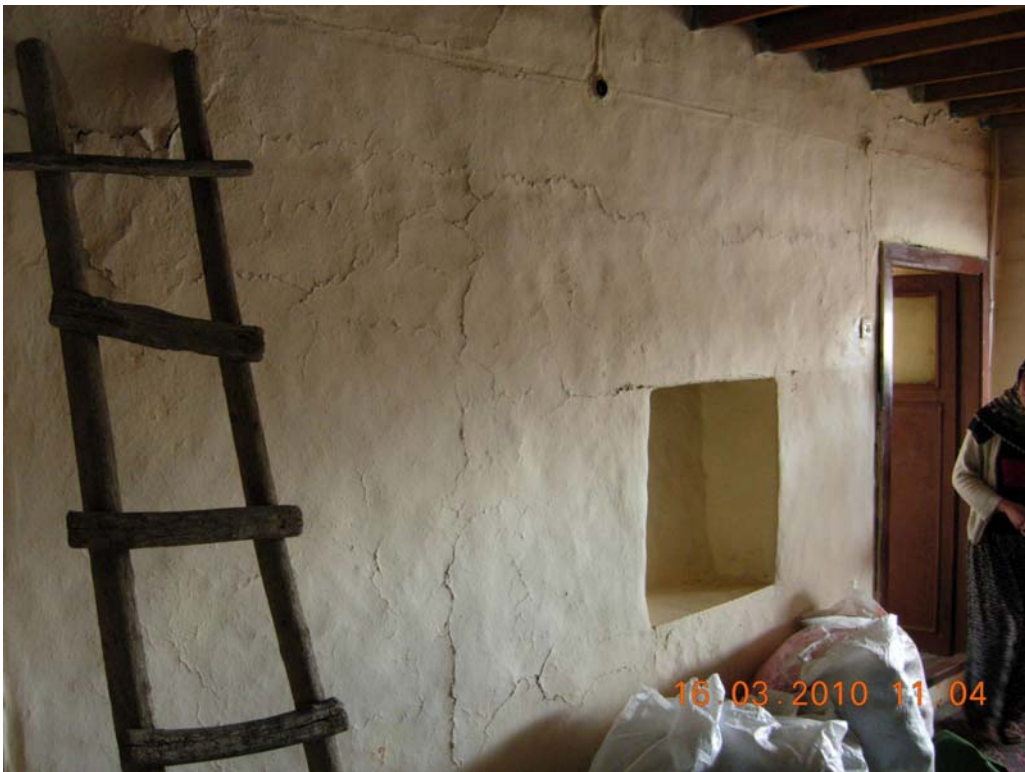
Figure 94: *Inside view of two storey soil brick house in Kökan-Bayramyazi-8*

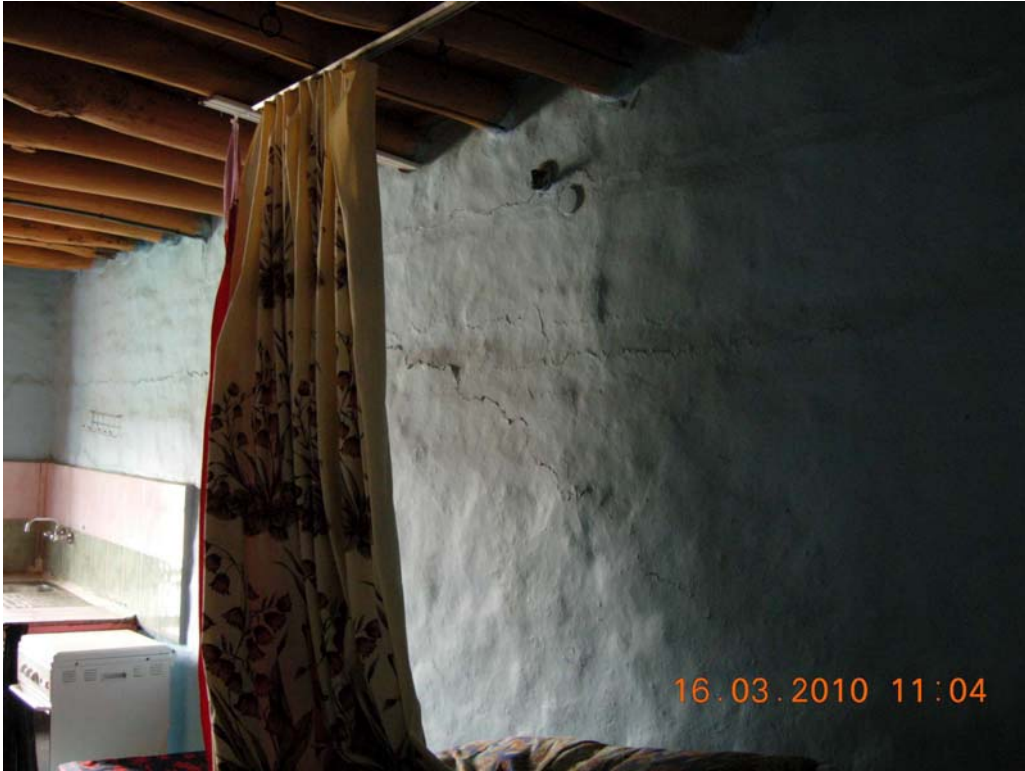
Figure 95: *Inside view of two storey soil brick house in Kökan-Bayramyazı-9*
