**KANDİLLİ OBSERVATORY and EARTHQUAKE
RESEARCH INSTITUTE**

***March 08, 2010 BAŞYURT-KARAKOÇAN
(ELAZIĞ) EARTHQUAKE***

**Prepared by; Dr. Doğan Kalafat
Dr. Can Zülfikar
Res. Assist. Eren Vuran
Res. Assist. Yaver Kamer**

**March, 2010
İSTANBUL**

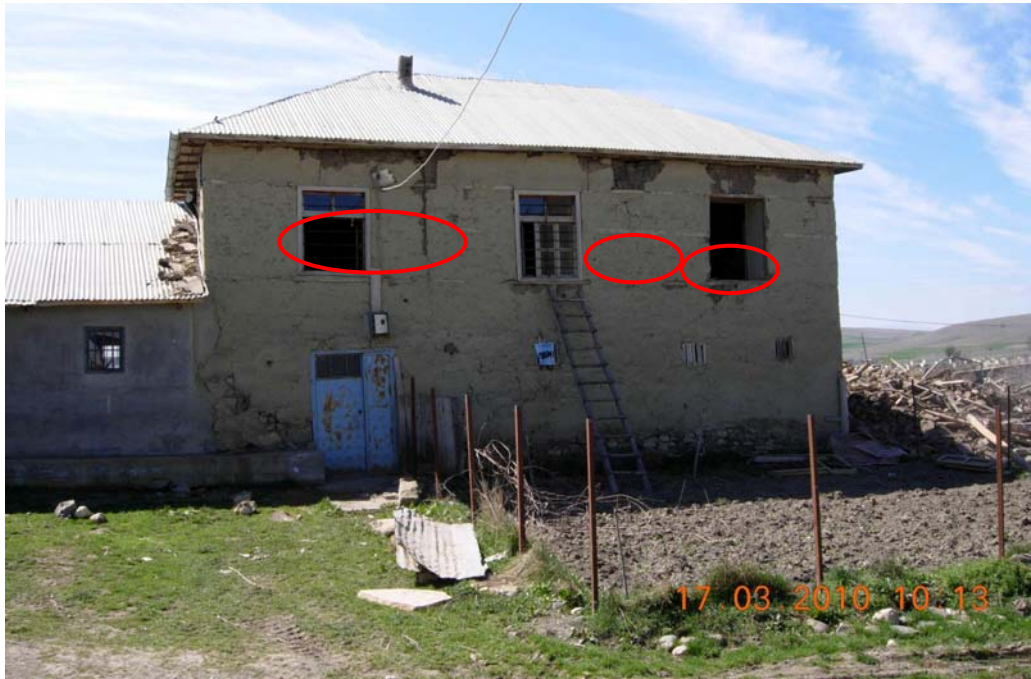
Figure 21: Two storey soil brick house in Incedal village-backside view

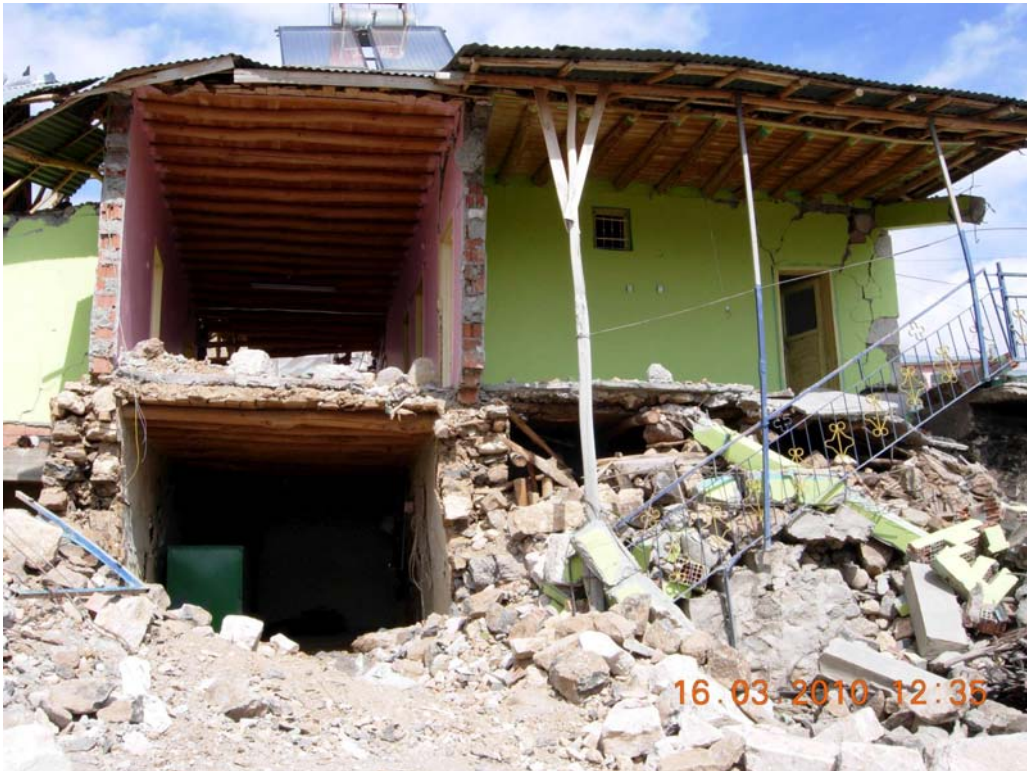
Figure 33: *Two storey light stone house, Okcular village*

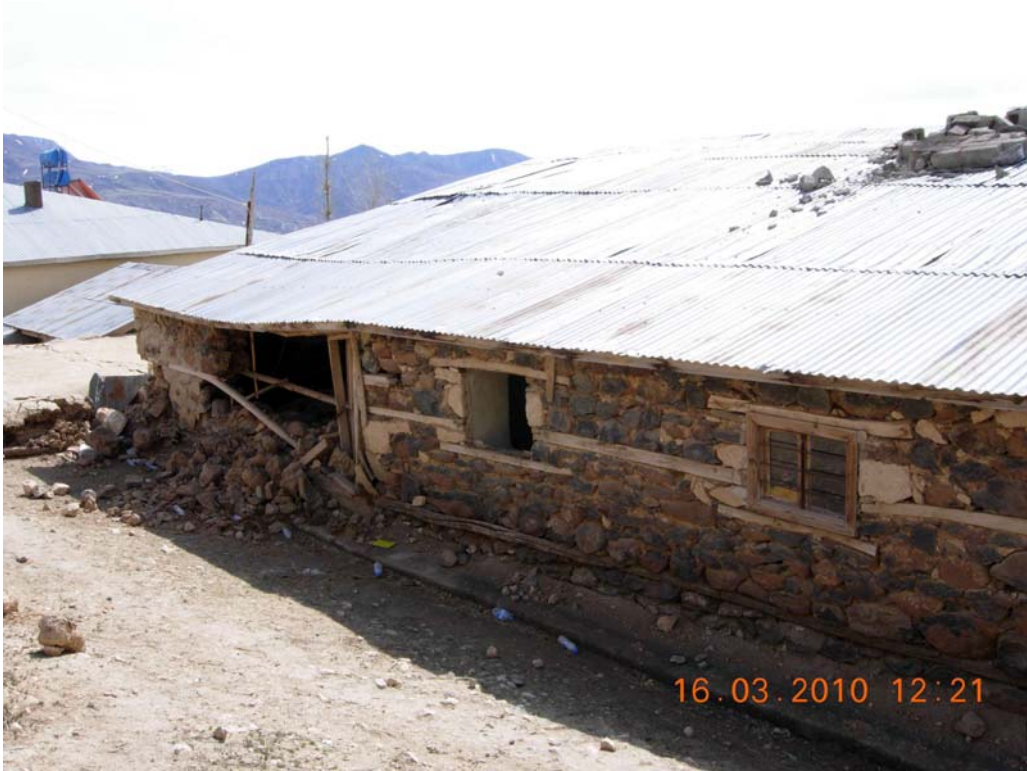
Figure 34: *Two storey heavy stone house, back side view, Okcular village*

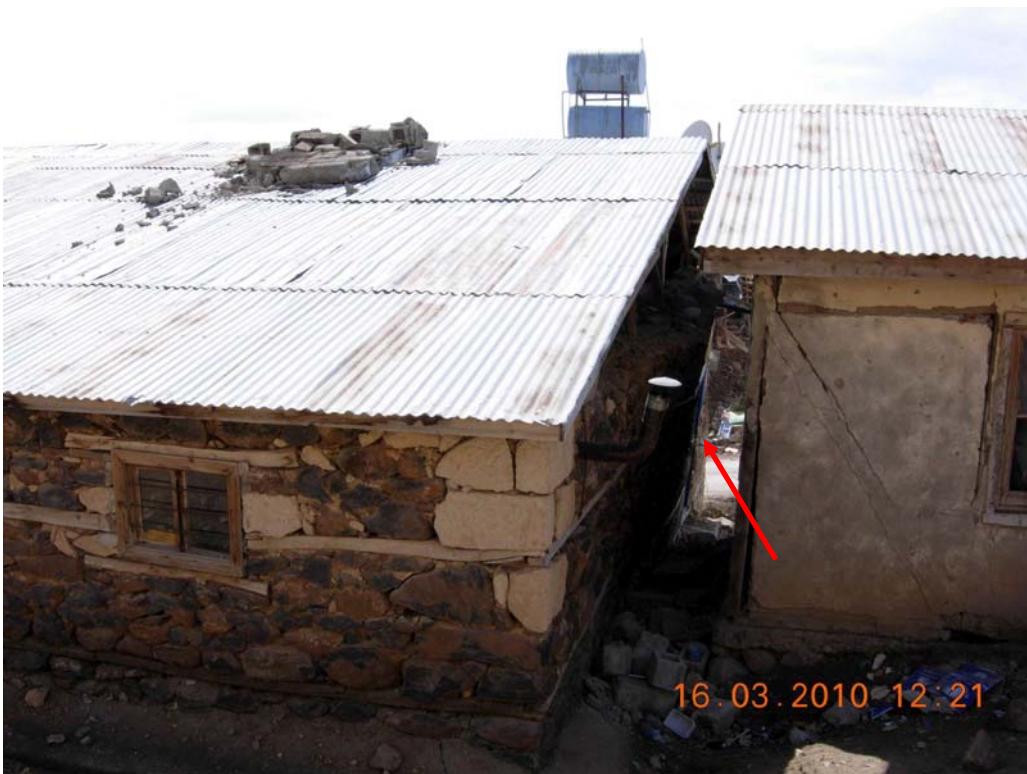
Figure 35: *Two storey heavy stone house, side view, Okcular village*

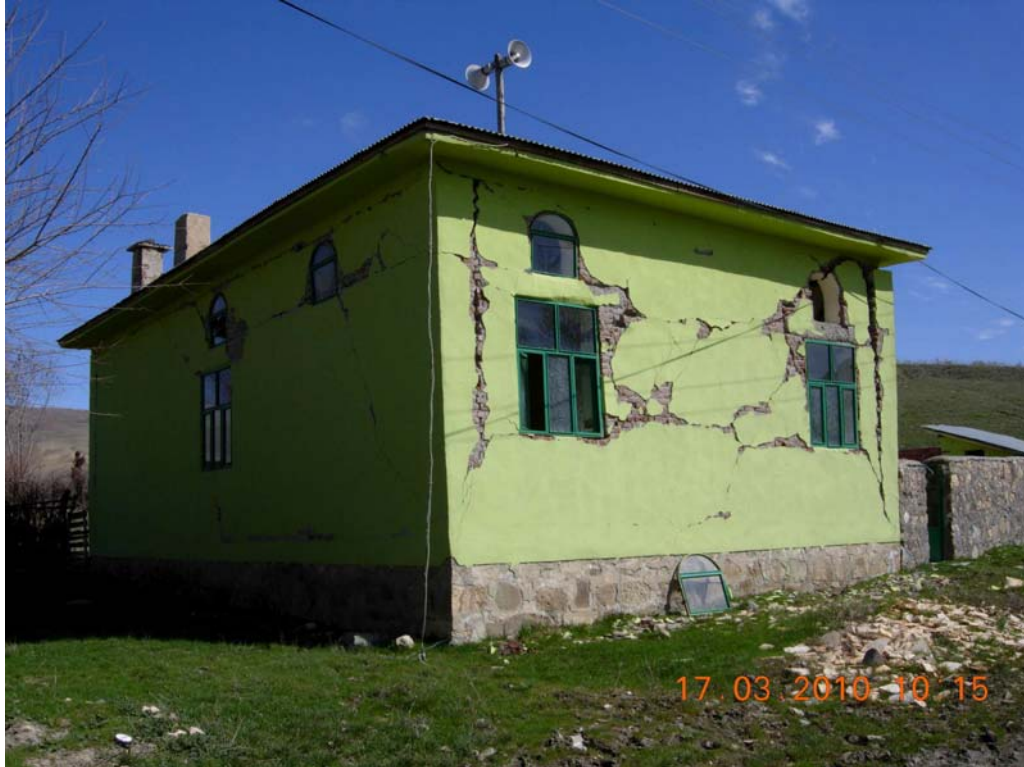
- Refractory bricks have not been commonly used in that territory, except few examples. One of the examples is a mosque in Incedal village, built in 1982, shown below.

Figure 49: *Outside view of the mosque, Incedal village*

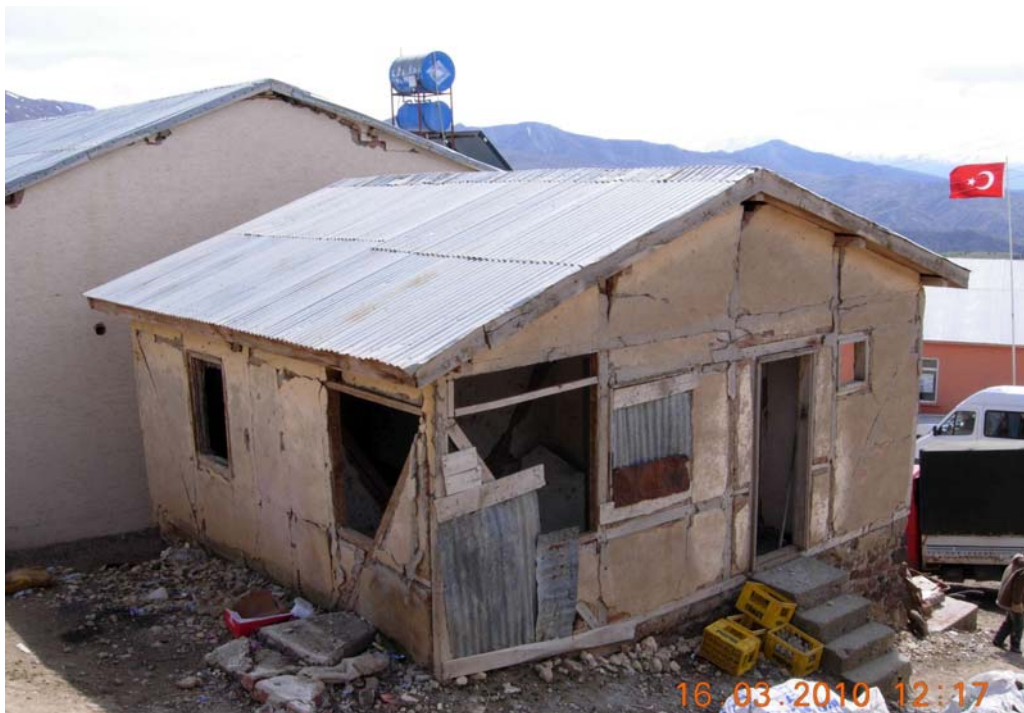
- Another building type, which is constructed with refractory bricks, is single story houses, constructed after 1971 Bingol earthquake. In higher altitude villages, these houses were constructed with refractory bricks and timber crosses, while in the lower altitude villages, material is prefabricated panels, having glass fibres inside for heating isolation. However, these small houses have not been renewed, so most of them have been being used as storage rooms. Although most of them seem heavily damaged depending on earthquakes over years, as well as lack of renovation, it is possible to see many of these houses standing after earthquake with partial collapses or without any collapse...

Figure 57: *Refractory brick houses built after 1971 Bingol earthquake, Okcular*

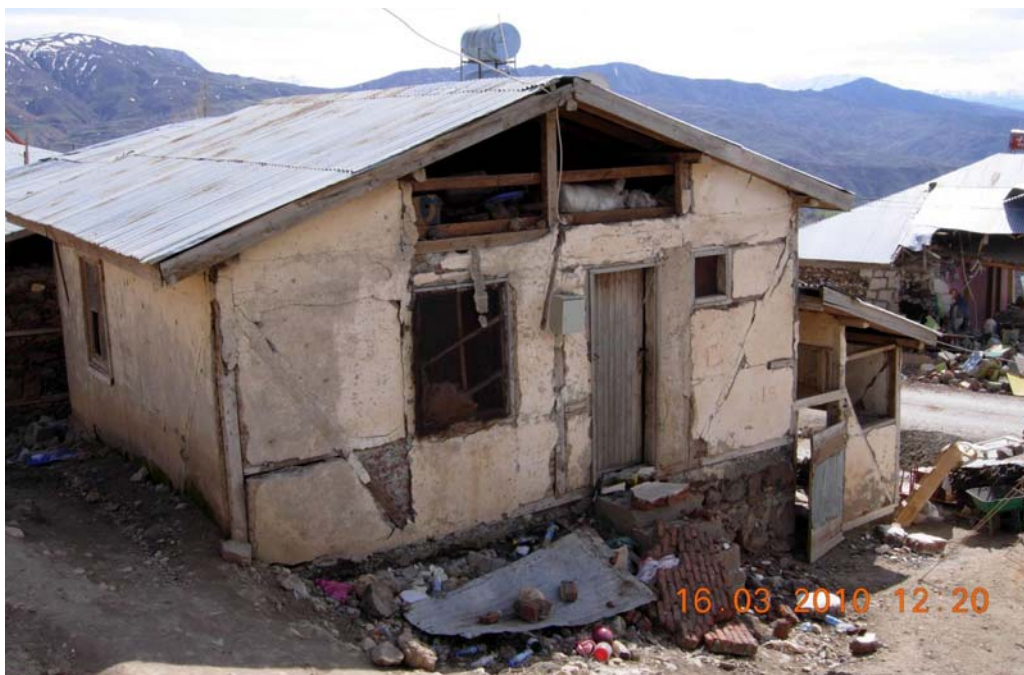
Figure 58: *Refractory brick houses built after 1971 Bingol earthquake, Okcular*

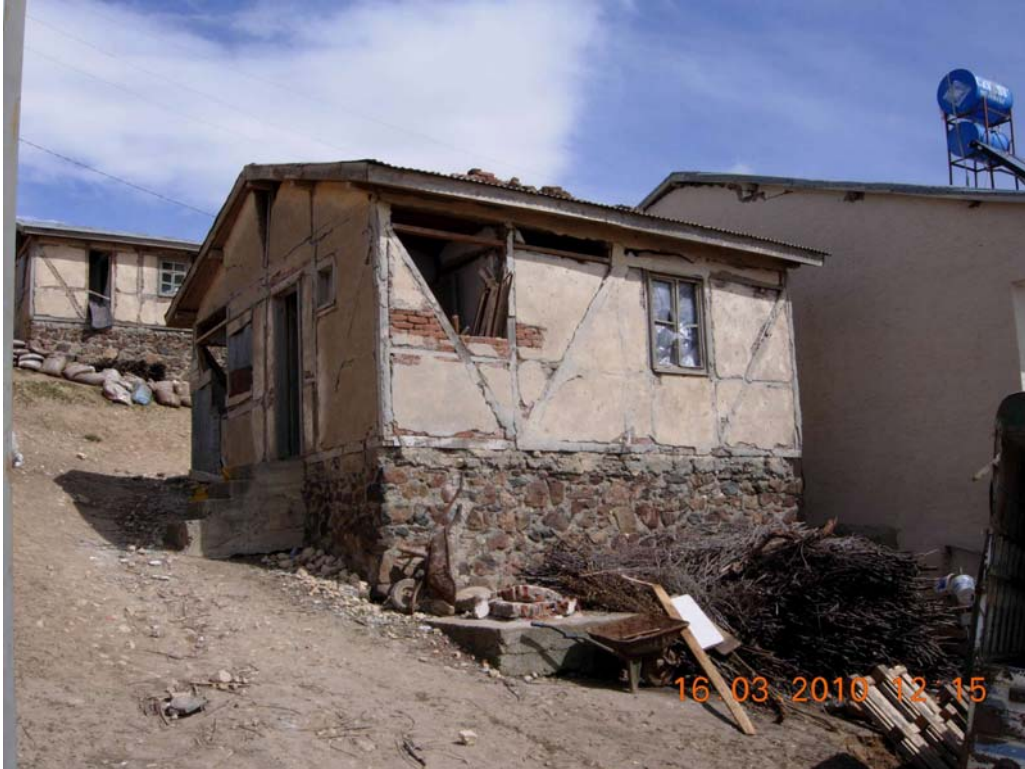
Figure 59: *Refractory brick houses built after 1971 Bingol earthquake, Okcular*

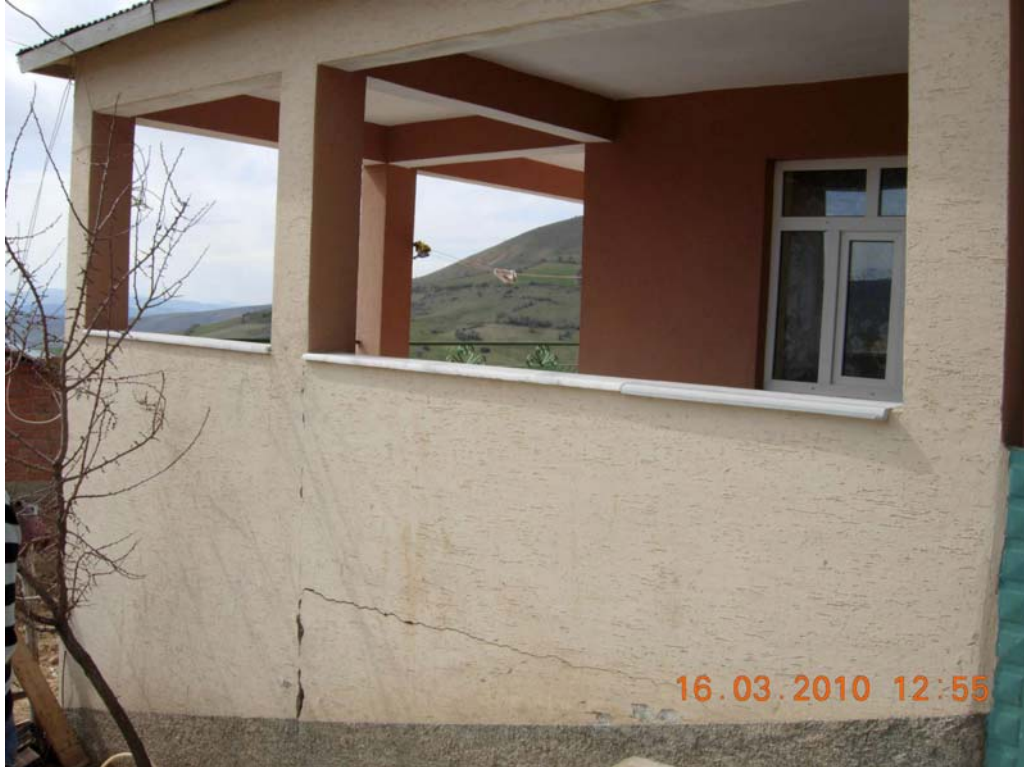
Figure 63: RC house, without any damage in beam-column joints, Okcular village

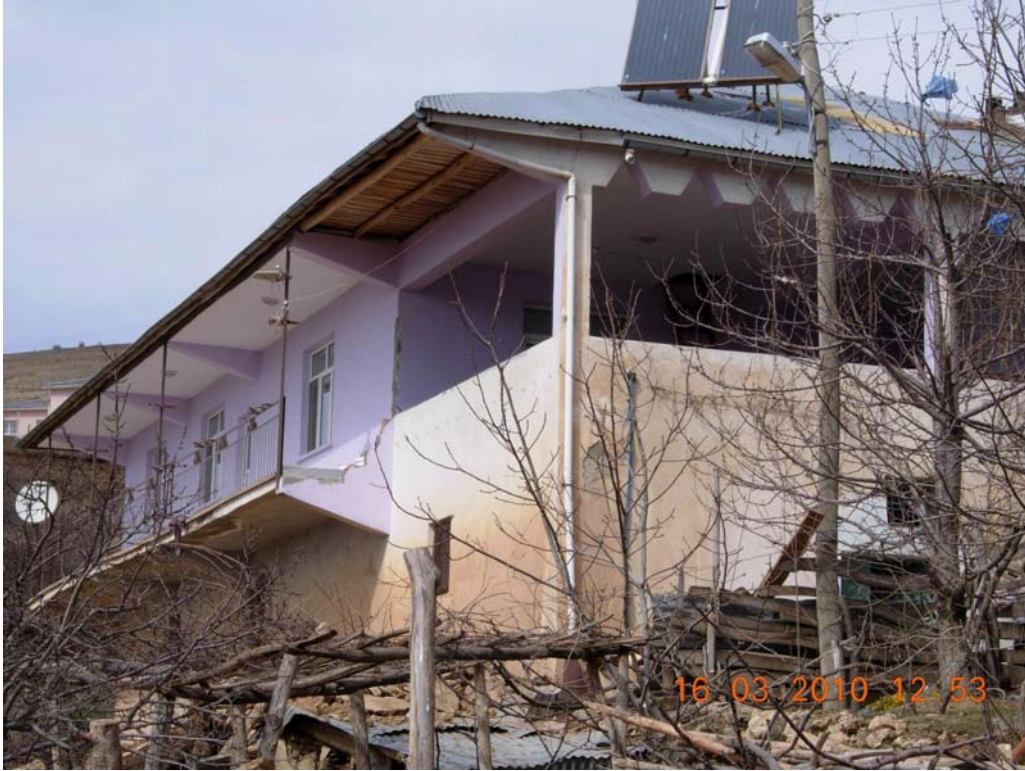
Figure 65: RC house, without any damage in beam-column joints, Okcular village

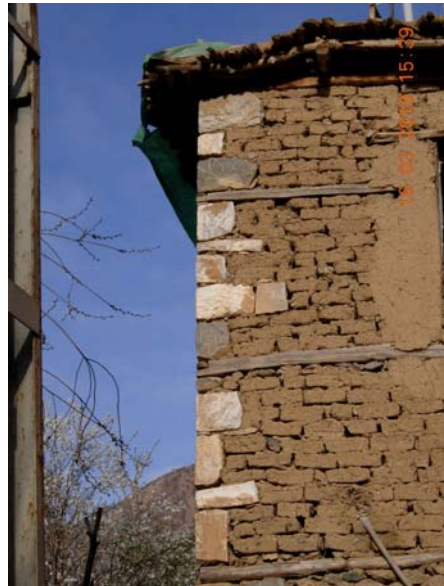
- The most common damage type is partial collapse of load bearing walls due to “out of plane” behaviour.
 - One reason of this failure type is “incapable connections” between outer walls and outer walls with perpendicularly connected inside walls.

Figure 72: Only vertical lintel application ever seen, Beyhani-Palu
